Situation of the Yukarıköy's Traditional Stone Masonry Houses Affected by 2017 Ayvacık Earthquakes

2017 Ayvacık Depremlerinden Etkilenen Yukarıköy Geleneksel Taş Evlerinin Durumu

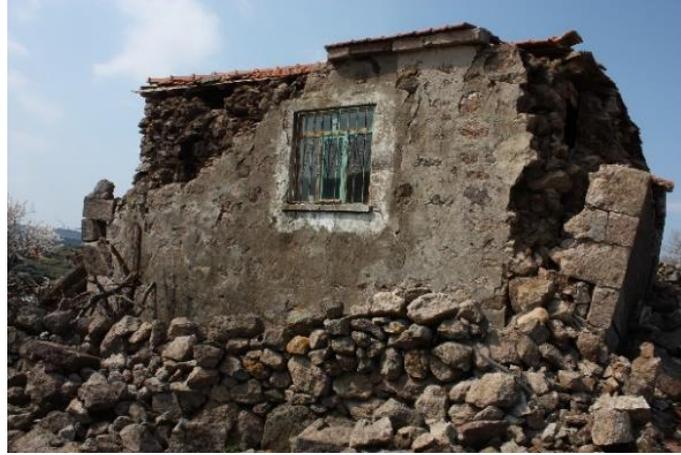
In a structure, it is the corner points that are mostly forced under horizontal loads. In masonry stone structures, using larger and better-quality stones at corner points is a necessary detail to be applied. "If structural elements are used with different dimensions, care should be taken to use large elements and masonry techniques in the joining areas during the construction" (Koç 2016). The stones placed on top of each other in an interlocking manner with the effect of friction ensure that the structure remains standing without disturbing the integrity of the structure during the earthquake. The size of the stones and the connection details should prevent the deformations occurring in the structure during the earthquake and the possible destruction due to vertical deviations. If this condition is not fulfilled, the first and most damage and destruction are expected to take place in corner joints during the earthquake.

"The forces that push the structures in earthquakes are not one way. Constructions are forced with horizontal forces at the same time in both prime directions. This condition causes stress accumulations especially at the corners of the structures where the walls coming from two sides intersect." (Bayülke 1980). Figure 6 shows the damaged corner details determined after the earthquake in the study area.

Figure 6: A Damaged Corner Detail

The clamps placed in the reinforced concrete beam are placed in two directions and two levels to prevent the walls from moving out of the plane. Figure 19 shows suggestions to prevent the damage caused by the corner deformation of the structure.

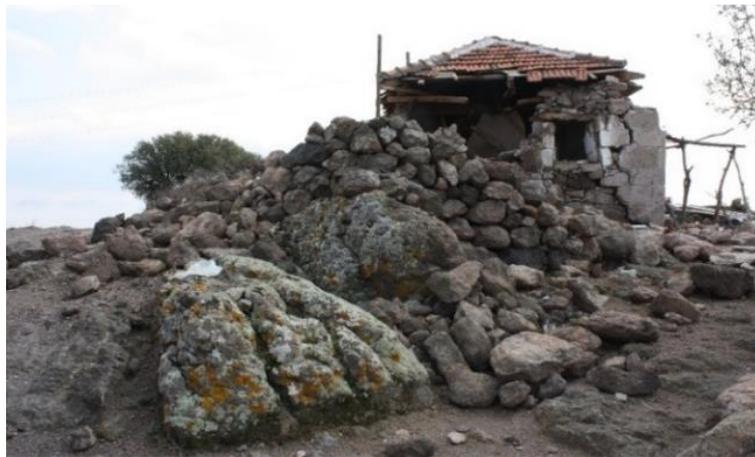
The majority of the structures built on rocky grounds at high levels in Yukarıköy were damaged severely. It is thought that rigid masonry stone structures built on hard grounds is one of the main reasons for the largescale damage to the building upon resonance during an earthquake. The structure-ground relationship in the region is shown in figure 7.

Figure 7: Ground-Structure Relationship

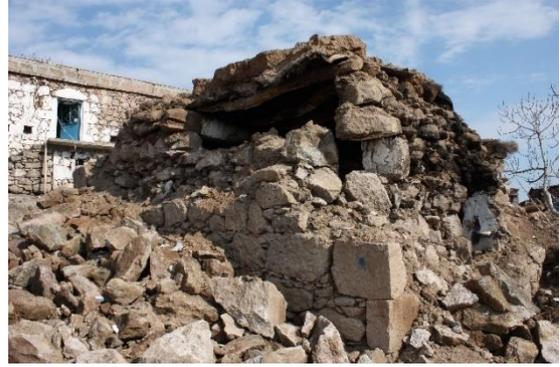
The inner and outer double walls, which are not connected to each other, move independently of each other under the influence of the vertical loads in the amount exceeding the capacity of the wall. In this case, the bearing capacity of the wall weakens and causes damage to the structure during the earthquake (Figure 8).

Figure 8b: Example of a Damaged Wall with Double Wall in a Structure in Yukarköy

It is necessary to prevent double-walled walls from moving independently of each other. In figure 23, a block stone connecting the two sides of the wall at regular intervals is proposed. In this way, the two layers work together.

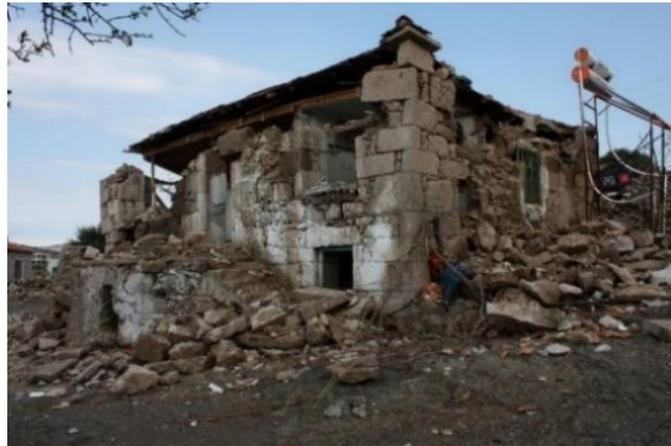
The quality of the mortar that connects the blocks used in walls is an important factor affecting the behavior of the wall during an earthquake. It was determined that additive-free soil mortar was used in all of the severely damaged structures in the study area. Figure 9 shows a damaged soil mortared wall in the area. When the structure is made of a low strength mortar, the strength of the wall, which plays an important role in the masonry structure, is very low and can totally collapse under horizontal loads.

Figure 9: Damage to a Structure with Low Strength Soil Mortar

Cement-lime mortars or at least lime mortar should be used as binder mortar. Various mortar mixture ratios are suggested for the structures in the region in the table below.

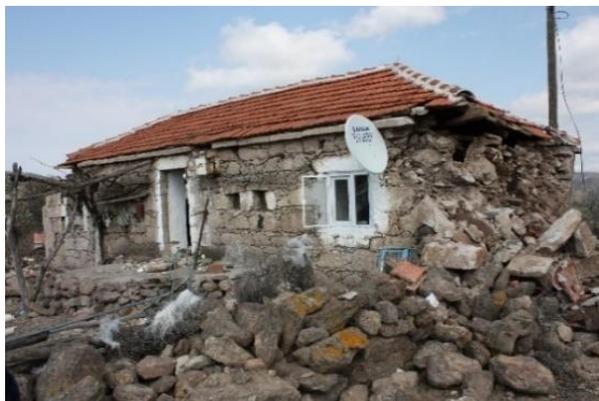
It was determined that none of the damaged structures in Yukarıköy had horizontal beams. This caused the extent of the damage in the buildings to grow. Masonry building walls, unless flooring and beam connections done in sufficient rigidity at the upper part, cannot withstand the loads to their planes perpendicular as well. It is necessary to make horizontal beam connections at units such as subbasements, doors, window loungers, and floor loungers in walls according to the technics (Çırak 2011). Figure 11 shows examples of the structures with beams or with no beams at all in the region.

Figure 11b: Example of damaged beam-less structure

Corner points are the parts of a structure that are pressured most during an earthquake. Horizontal beam recommendations are presented in figure 19 within the framework of the terms envisaged by Earthquake Code ([Earthquake Regulation 2007](#)) in effect in Turkey. With the recommended horizontal reinforced concrete beams, the provision of the following areas is intended:

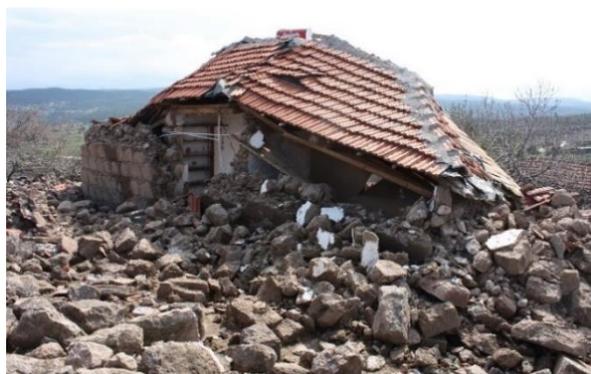
In most of the structures built in rural areas, floor beams are placed on the wall with no connection to the wall. The circular cross-section of these beams also reduces the friction effect and weakens the diaphragm function of the floor by facilitating the movement of the beam. In this case, the wall does not support the floor and structure can collapse due to this deformation. Figure 12a shows the typical wall-beam relationship applied in the region and a damaged structure is displayed in figure 12b due to this application. Furthermore, the friction forces between the stone surfaces are marginal, since the stones are of irregular shapes, not prismatic, and the contact surfaces are not sufficient to cause adequate amount of friction. Additionally, wooden beams of roofs are aligned in one direction and the beams are supported by two walls opposite to each other. Therefore, the weight of the heavy roof and corresponding horizontal earthquake loads are transferred to these walls (Celep et. al 2011).

Figure 12b: Collapsed Structure in Yukarıköy

The proposal developed in this study recommends the ceiling-wall connection detail as shown in figure 21. In the detail presented in the figure, “TÜBİTAK approved insulation material” (Kanca 1977). is recommended instead of earth roof which is used as thermal insulation in rural buildings.

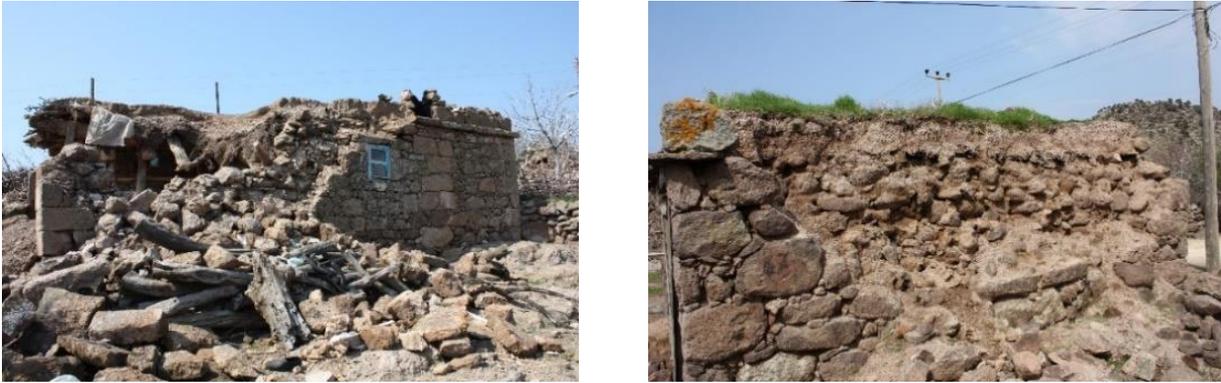
The beams bearing this roof are not connected to the supporting walls, so they move independently of the wall during an earthquake. "Cross cracks in the walls of masonry structures with heavy-weight roofs usually arise from the effect of shear force. Conically shaped breaks on the upper sides of the common corners of the walls are actually the intersection of two crossed cracks cutting the wall. It has been observed that such structures rise up from the ground due to the overturning effects of the wall ends" (Budak 2004). The additional weight of the soil cover naturally caused the structures to be affected by the earthquake more. "The ceilings of rural structures with mud-brick and stone walls are generally covered with mud. One-meter square weight of the wooden bearer and earth covering of the ceiling is about 750-1000 kg. Therefore, a huge ceiling load presses on the walls. The walls are already forced hard, during an earthquake due to their construction, so it is inevitable that they will be damaged during earthquake because of heavy ceiling" (Ergünay 1978). Same types of damages are seemed at the 2010 Kovancılar and Palu (Elazığ) Earthquakes and 2011 Van Earthquakes in Turkey. The features of the roof cover in the structures examined are shown in figure 13. In addition, figure 14 shows the examples of heavily damaged earth roof structures.

Figure 14: Damaged structures with soil roof

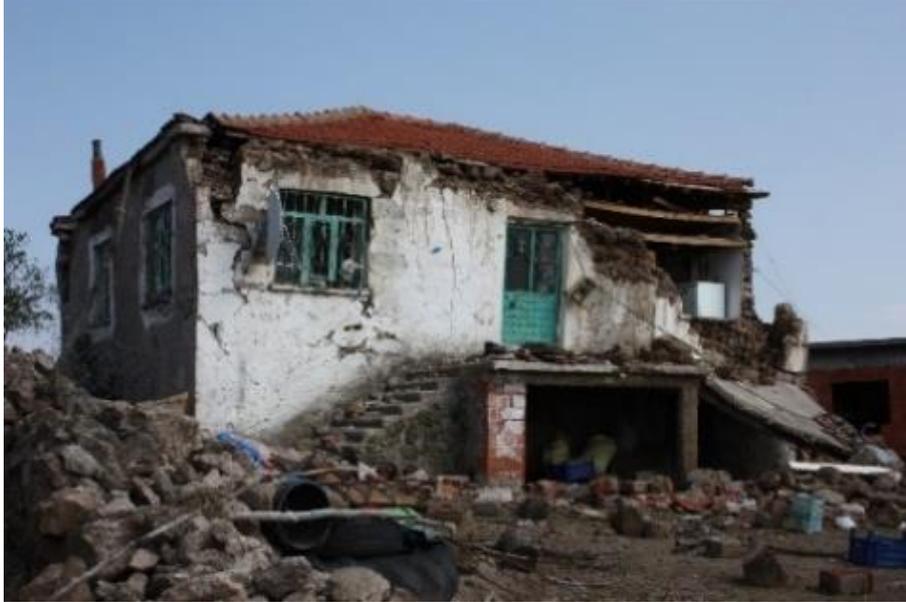
The architecture which developed due to topographic features caused some buildings to be built together with a partial basement (Figure 15). This situation, which is considered to be an irregularity in the section, affects the behavior of the building negatively in terms of earthquake loads. It has been determined that part of the damages arose from this reason. "It should be avoided to construct partial basement which is a cause of significant damage" (Önal 2005).

Figure 15: A damaged structure built on sloping land

The foundations of the buildings built on sloping grounds need to have a gradual structure. Figure 22 shows the foundation details to be built on sloping lands in earthquake areas.

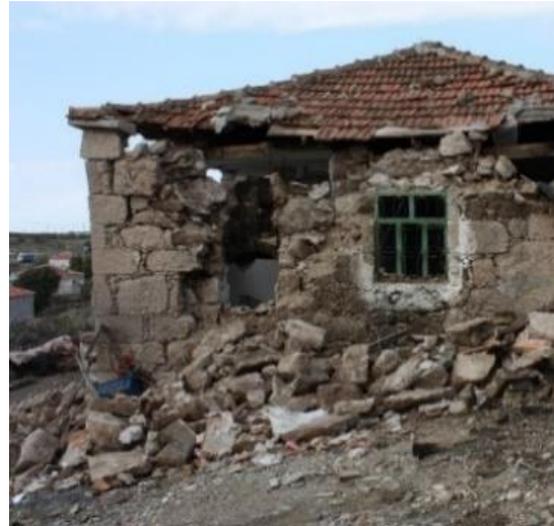
The opening to the wall for the chimney weakens the wall section and increases the risk of damage to the double-walled wall under horizontal loads (Figure 16 and 17). 89% of the damaged structures that studied were damaged due to the chimney opening in the bearing wall.

Figure 17: The damage caused on the wall by the chimney

When the chimney is located inside the supporting wall, the cross-section and strength of the wall reduce. Chimneys located on the outer wall also cause heat loss and condensation. For this reason, the chimney is suggested to be located outside the chimney wall section and on the inner wall as proposed in figure 19.

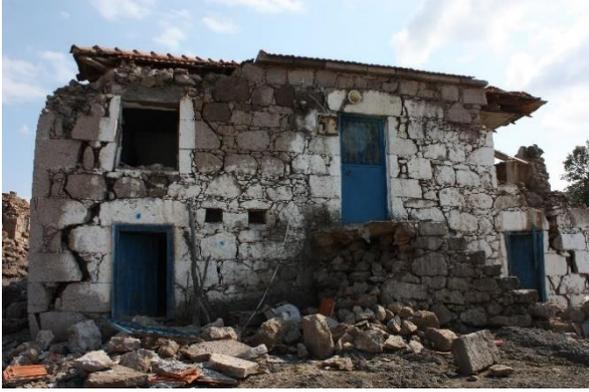
It has been determined that a large part of the damaged structures in Yukarıköy area were built with no regard to the location and size of the spaces. Figures 18a and 18b illustrate this situation. “The design process of masonry buildings needs more regularity compared to other supporting systems, because resisting system must have continuity and regularity in order to take the stress of the shear from an earthquake. In rural areas, however, traditional fireplaces have been used in buildings, and they are built within the wall by decreasing the wall thickness or curving the wall outward. In such cases, irreversible damage is inflicted on the wall because of decreasing shear resistance” (Livaoglu et al. 2018).

Figure 18a: Damaged building in Yukarıköy

"In masonry structures, one of the most important structural details that provide earthquake resistance is the existence of adequately filled wall between windows and door openings. While these walls provide the area required for the transport of both vertical and horizontal loads, a wide wall will help control the vertical and shear stresses" (Bayülke 2011). In this case, the location and total length of the spaces to be opened on the wall must be taken into consideration. Figure 20 shows the location and length of the spaces to be considered in 1st, 2nd, 3rd, and 4th degree earthquake zones as defined in Earthquake Code (Earthquake Regulation 2007).

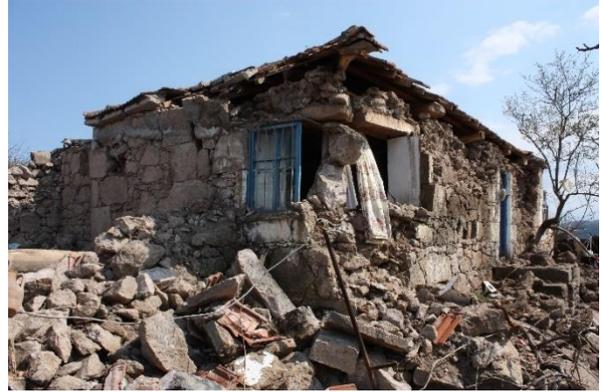
Figure 18b: Collapsed building in Yukarıköy

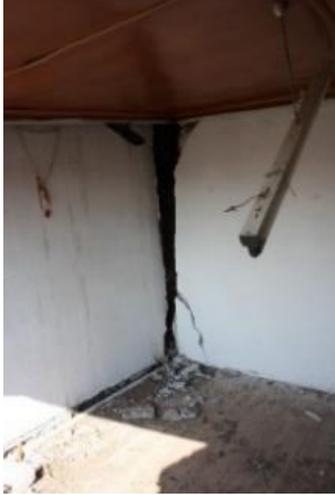
It was observed during the study that the connections between the inner and outer walls were inadequate in all of the damaged structures in the region. These walls suffered significant damage after the earthquake. Figure 24a shows the damaged structure in this respect. In figure 24b, the alignment of the stone blocks is shown as a proposal for connecting the inner and outer walls against horizontal loads.

Figure 24a: Inner-outer wall with poor connection
