Heritage Building Roof Element Conservation: Penang Old Town Hall Case Study

This paper presents roof elements defects of heritage buildings and their causes. Figure 1 shows Penang Old Town Hall in 1900s and 2012. The Old Town Hall was a British colonial building and the oldest Municipal Building in Penang, which construction started in 1879 and was completed in 1880. It fronts the famous Esplanade in Penang Island. After the completion, Penang

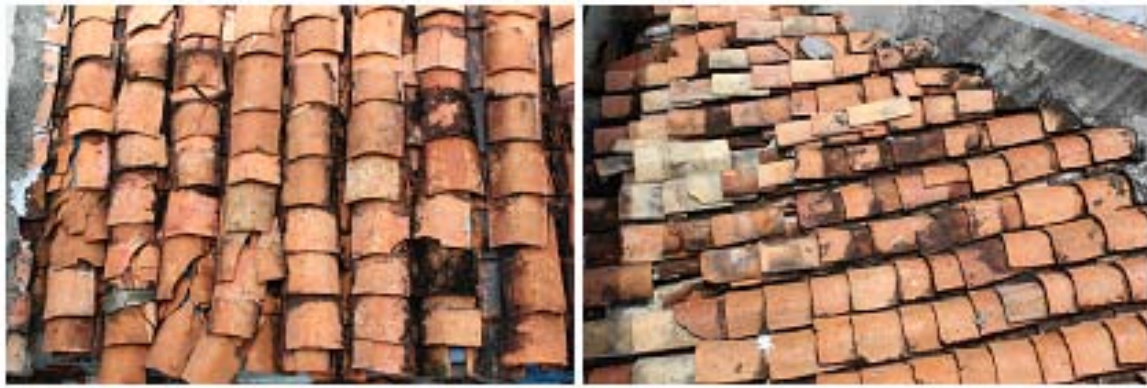
Broken and missing roof tiles were found on the roof of the heritage building. Besides, the tiles broke because the workers stepped on them, while doing the installation. The maintenance officers confirmed that the roof tiles were broken due to the crows pecked on the roof tiles. Malaysian weather, as well as the expansion and contraction of tile caused the tiles break.

Roof tiles in the heritage building were missing due to the heavy rains that made the tiles slip off. The tiles were also missing because of the poor workmanship and violation of tiles vigilantly by the contractor during the installation. Figure 2 shows the broken and missing roof tiles that can lead to the leaks.

Figure 2: Broken and missing roof tiles

Conservation of roof elements of heritage building is important because roof is one the most important element of any construction. The roof collapse or damage affects the whole building. The roof of this building is in poor condition especially the roof tiles. It should be replaced as soon as possible with the same material in order to maintain its aesthetic value. Other defects should be also submitted by using the method, employed by contractors and conservators in Malaysia. The main cause of all defects is the weather, as the roof is exposed to rain and sun. As the roof tiles are broken, fungal stains will appear and leaks will occur during rain. Even though conservation is still new in Malaysia, efforts to protect buildings against damage and preserve them for the future generations have been taken.

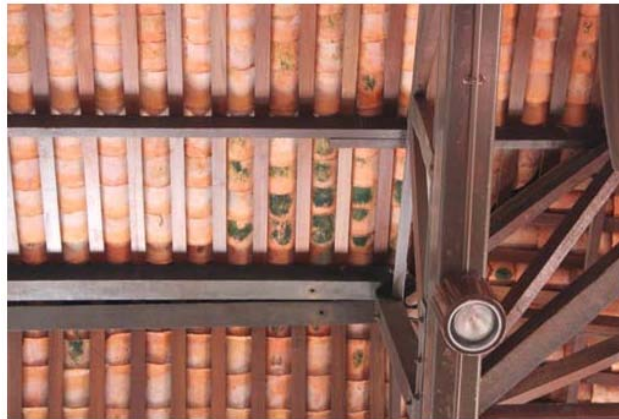
Fungal stains also appeared on the roof tiles and along the roof parapets. Generally, fungal stains can diminish the aesthetic value of the building. If there is water or high moisture in the roof tiles and roof parapets, the fungal stains or mold will appear. This defect can be identified by changes in original color and the appearance of the building elements. Figure 3 shows the fungal stains that appeared on the roof tiles that from inside of the building.

Figure 3: Fungal stains at roof tiles

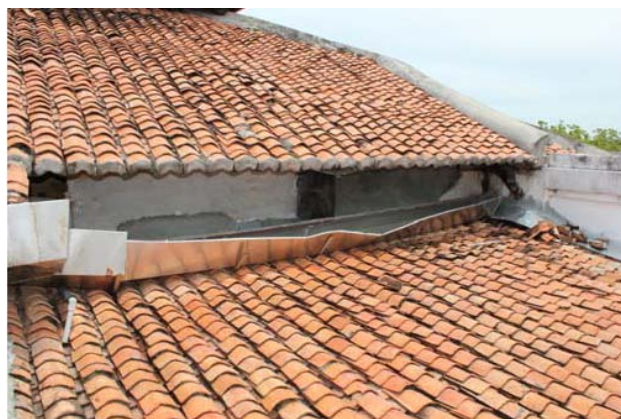
The common problem with the roof gutter is the gutter damage. Figure 4 shows the broken and damaged gutter, as it lies on the roof tiles. The possible cause of the gutter damage and brake is of the overflow of water due to the heavy rain. The timbers that suppose to hold the gutter are also deteriorated.

Figure 4: Gutter damage

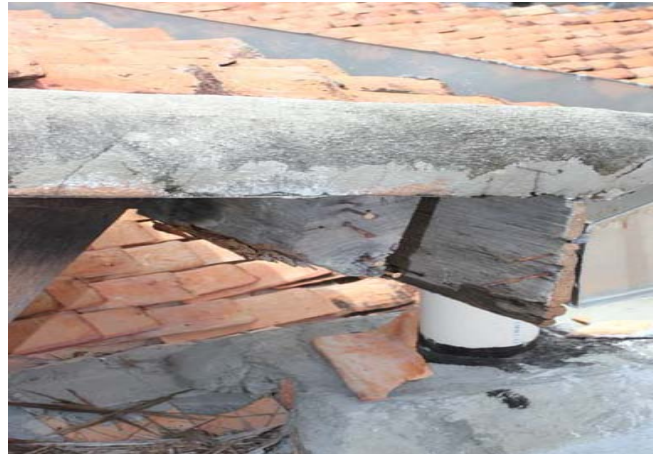
The timbers of this building were also decayed. The timber was decayed due to the weather. The weather conditions, such as rain and sun caused the timber deterioration. Figure 5 shows the timber decay on the beam.

Figure 5: Timber beam decay

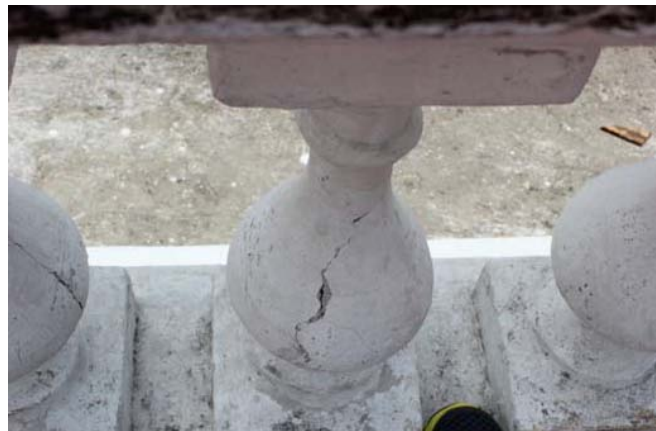
The causes of building cracks can be detected by the inspection. Thermal variations caused expansion and contraction of building materials and resulted in cracking. Historic buildings cracks decrease the aesthetic value of the building and contribute to other defects, such as water absorption, as well that may cause adhesive failure. Figure 6 shows the baluster cracks at the roof parapet.

Figure 6: Baluster cracks at the roof parapet
