THE IMPACT OF LOW EFFICIENT EVACUATION PLAN DURING COSTA CONCORDIA ACCIDENT

MOHAMED NABIL ELNABAWYBAHRIZ & MOHAMED HUSSEIN NASSAR HASSAN

Arab Academy for Science, Technology & Maritime Transport, Egypt

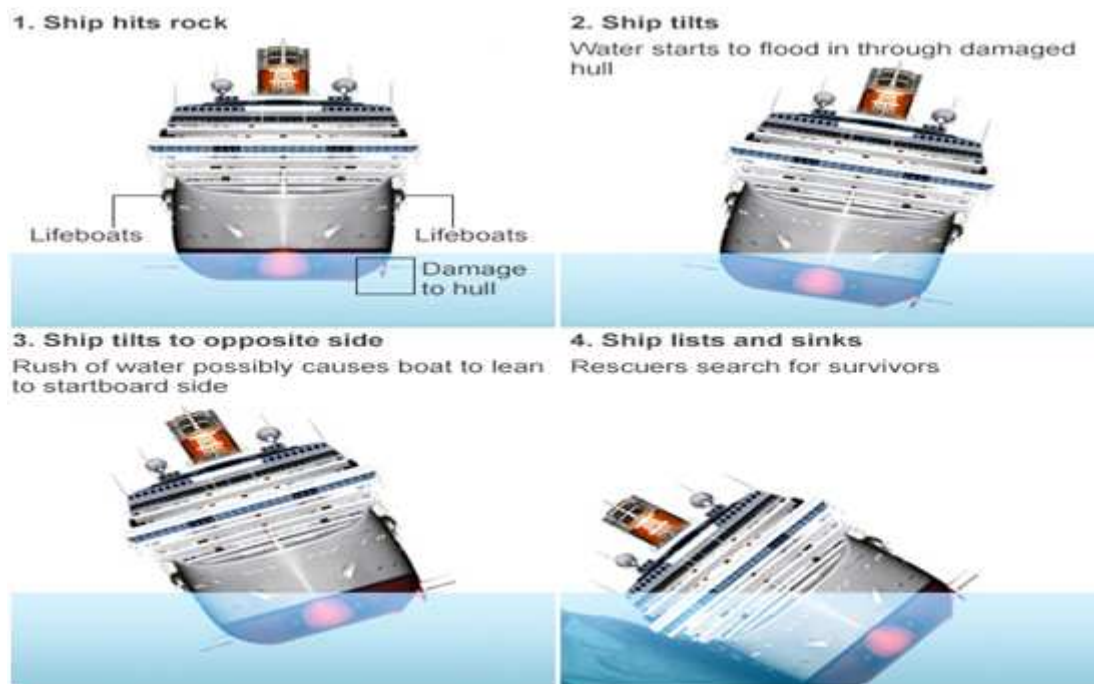
Figure 1

From the analysis carried out under the direct coordination of the Master, the seriousness of the scenario was reported after 16 minutes. After about 40 minutes (22: 27) the water reached the bulkhead deck in the aft area. (MIT, 2012)

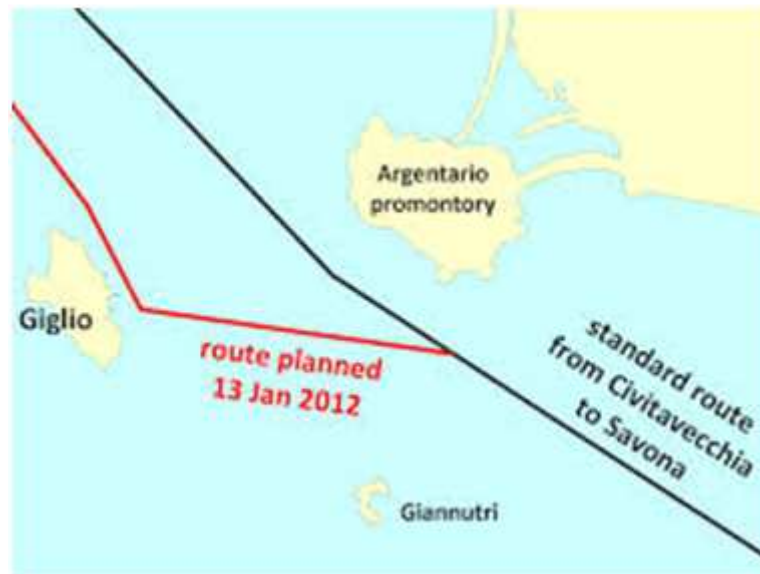
Figure 2

Approaching the shore, she collided with the "Scole Rocks" below the waterline on her port side, which led to the damage of 5 watertight compartments (WTCs). In addition, the electric propulsion motors, all diesel generators as well as the main switchboard were damaged. The initial list was to port due to the leak being on that side and because of the heeling moment caused by the rock, which stuck amidships after the impact. After a while, the flooding became almost proportional and the ship went upright again. (MIT, 2012).

Having been damaged in compartments vital for power generation, power distribution and propulsion, the ship was soon adrift without electricity. Even though the emergency diesel generator started up, it did not work reliable enough to provide power. Therefore, emergency power was supplied by UPS (Uninterruptible Power Supply) batteries. However, the steering gear did not function and thrusters needed more than the emergency power provided. Due to wind and current, the vessel was ultimately moved north of Giglio harbor before the forces of nature turned her around 180 degrees and pushed her in the direction of the island until she grounded a second time. (OMAE, 2014)
