Geological investigation and mitigation suggestion of slumping localities in Saiha town, southern Mizoram, India

Laldinpuia

ABSTRACT

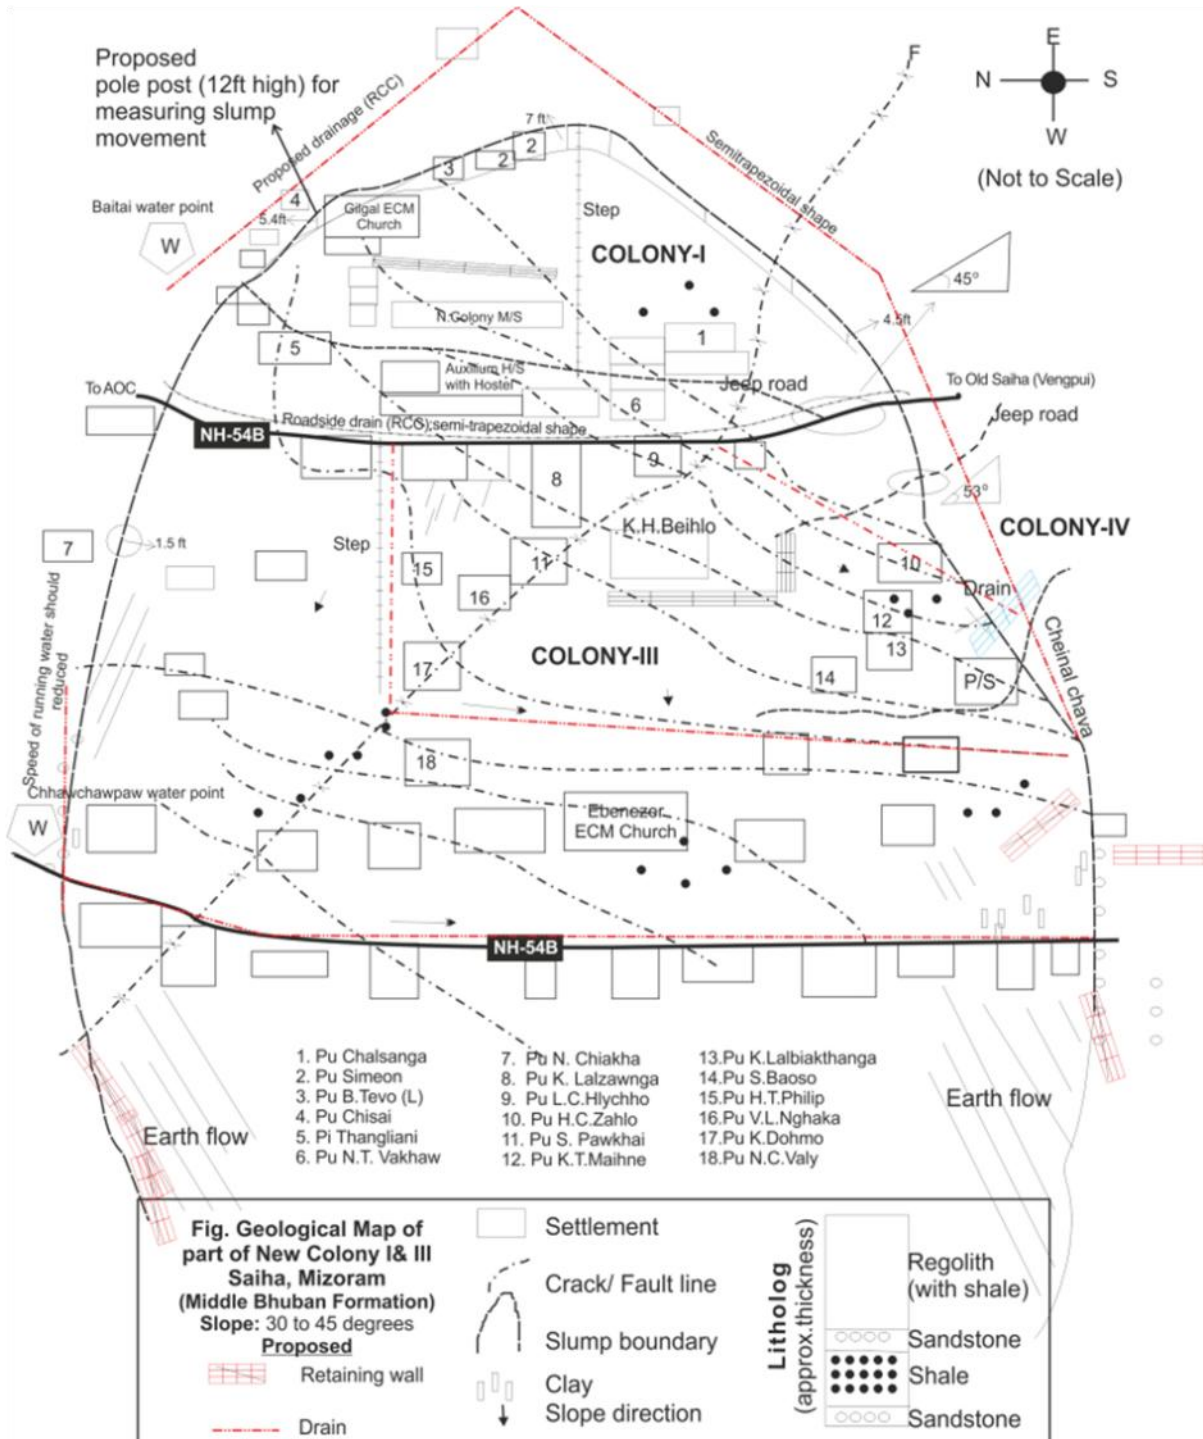
coordinates between N22°29' 32.34"-E092°58'48.48" at 979 m in south and N22°29' 31.8"-E092°58' 54.9" in north. The height of main scarp to the down thrown ranges from 1.5 to 7 ft respectively, and the height distance between the main scarp at N22°29' 26.46"-E092°58' 53.94" (1078 m) and toe (bottom of earth flow) at N22°29'41.7" & E092°58'45.78" (881 m) is 197 m. The area comprises two village councils viz. New Colony-I and New Colony-III respectively (Fig. 2).

According to local people, the northern side of New Colony-I & III area suffered huge landslides in around 1920, again in 1960 and 1995. Transverse cracks were noticed from 23rd July, 2002. 10 transverse cracks along NE-SE & NS direction were identified during geological field work on October, 2010. About 180 houses were affected including one boarding school, i.e. Auxilium H/S, one middle school, i.e. New Colony M/S and one primary school, i.e. New Colony-III P/S, and ECM Church, Gilgal. These transverse cracks were about 1 to 13 inches wide and about 5 to 32 m (Photo plate 3). One big transverse crack (fault) along NW-SE direction was observed, which severely affected four residential houses. Reconstruction of Cheinal chava (*chava* means 'stream') was suggested to catch the drains from upper crown of the slump (Photo plate 5). ECM Church (Gilgal) situated at the border of northern slumping area was badly affected, and the District Disaster Management Authority (SDMA) ordered on the 17th June, 2013 to evacuated and dismantled the building.

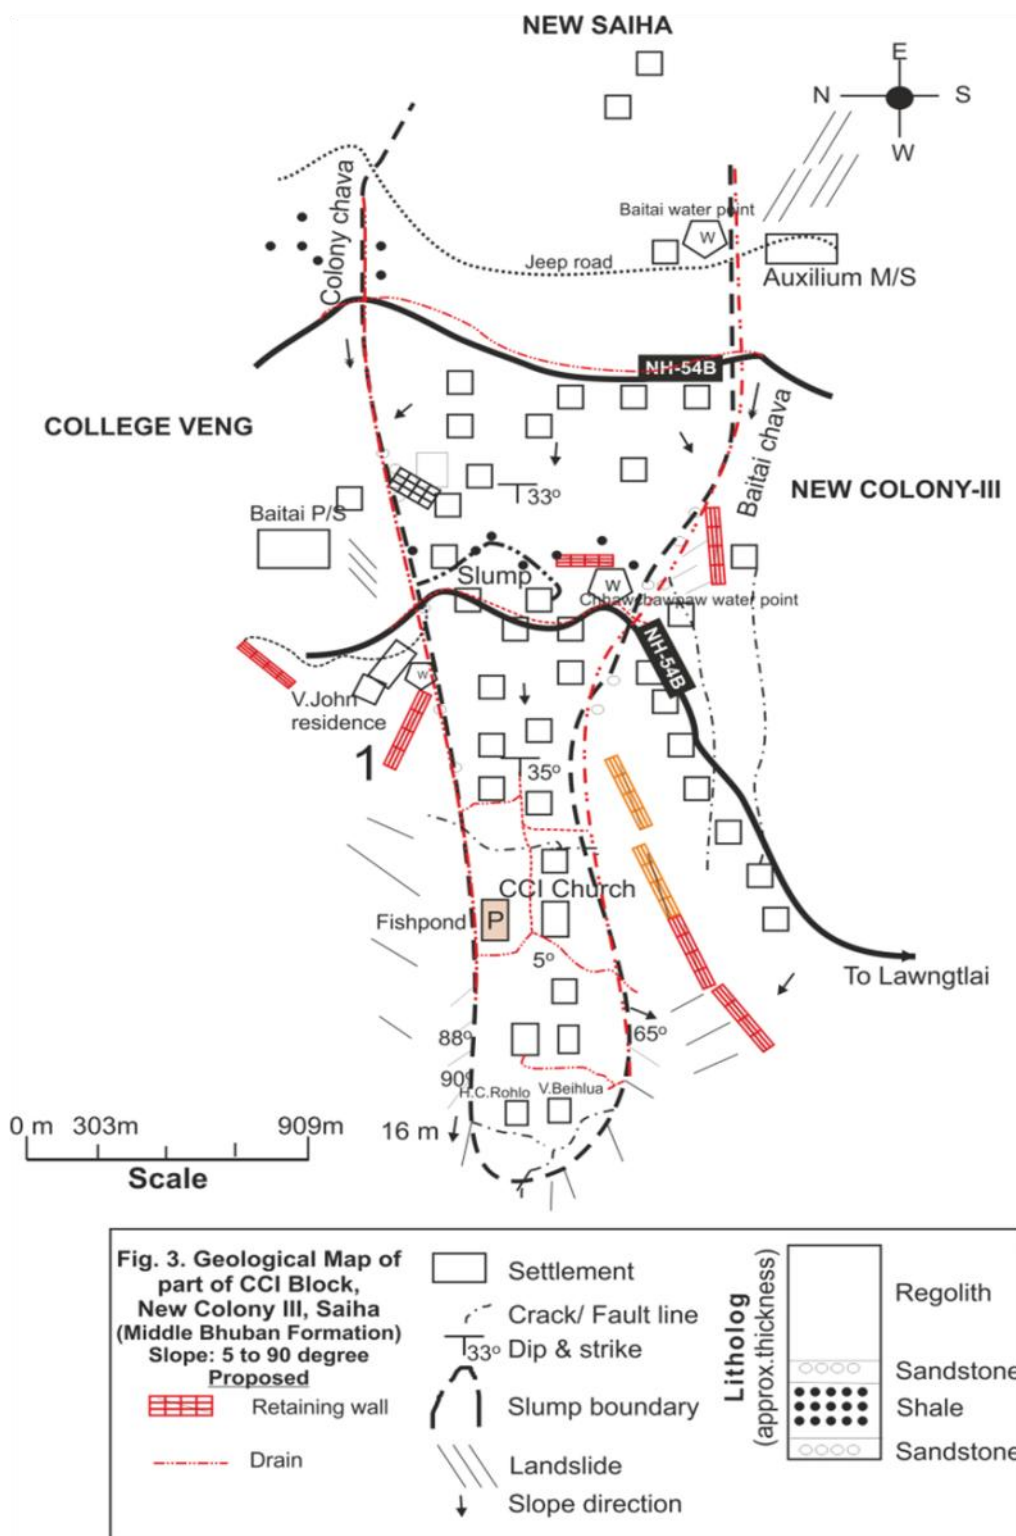
The CCI College Veng block of New Colony-III area was observed as the most vulnerable disastrous subsidence area in the town due to

weak resisting nature at the toe portion (Fig. 3). It was situated between N22°29'30.18" & E092°59'1.74" at the crown at the height of 1075m to N22°29'41.1' & E092°58'46.86" at the toe at the height of 880 m. No bed rock was observed, only thick regolith about 24m. The fishpond of about 70 sq m situated near CCI church may increase the gravitation force. The resisting force at the toe region was weak due to high erosion, thick regolith and no proper bedding. 4 transverse cracks of about 1 to 6 inches wide, along NW-SE direction were observed at the toe region. 2 houses situated near the coordinates between N22°29'37.44" & E092°58'51.24" at the height of 968 m are highly vulnerable to sliding shown in Fig. 3. After suggestion with detailed geology², DRDA Saiha constructed check dams at the toe region in the year 2012. These check dams observed as 'positive' i.e. decreasing the rate of slumping at this respective area (Photo plate 4).

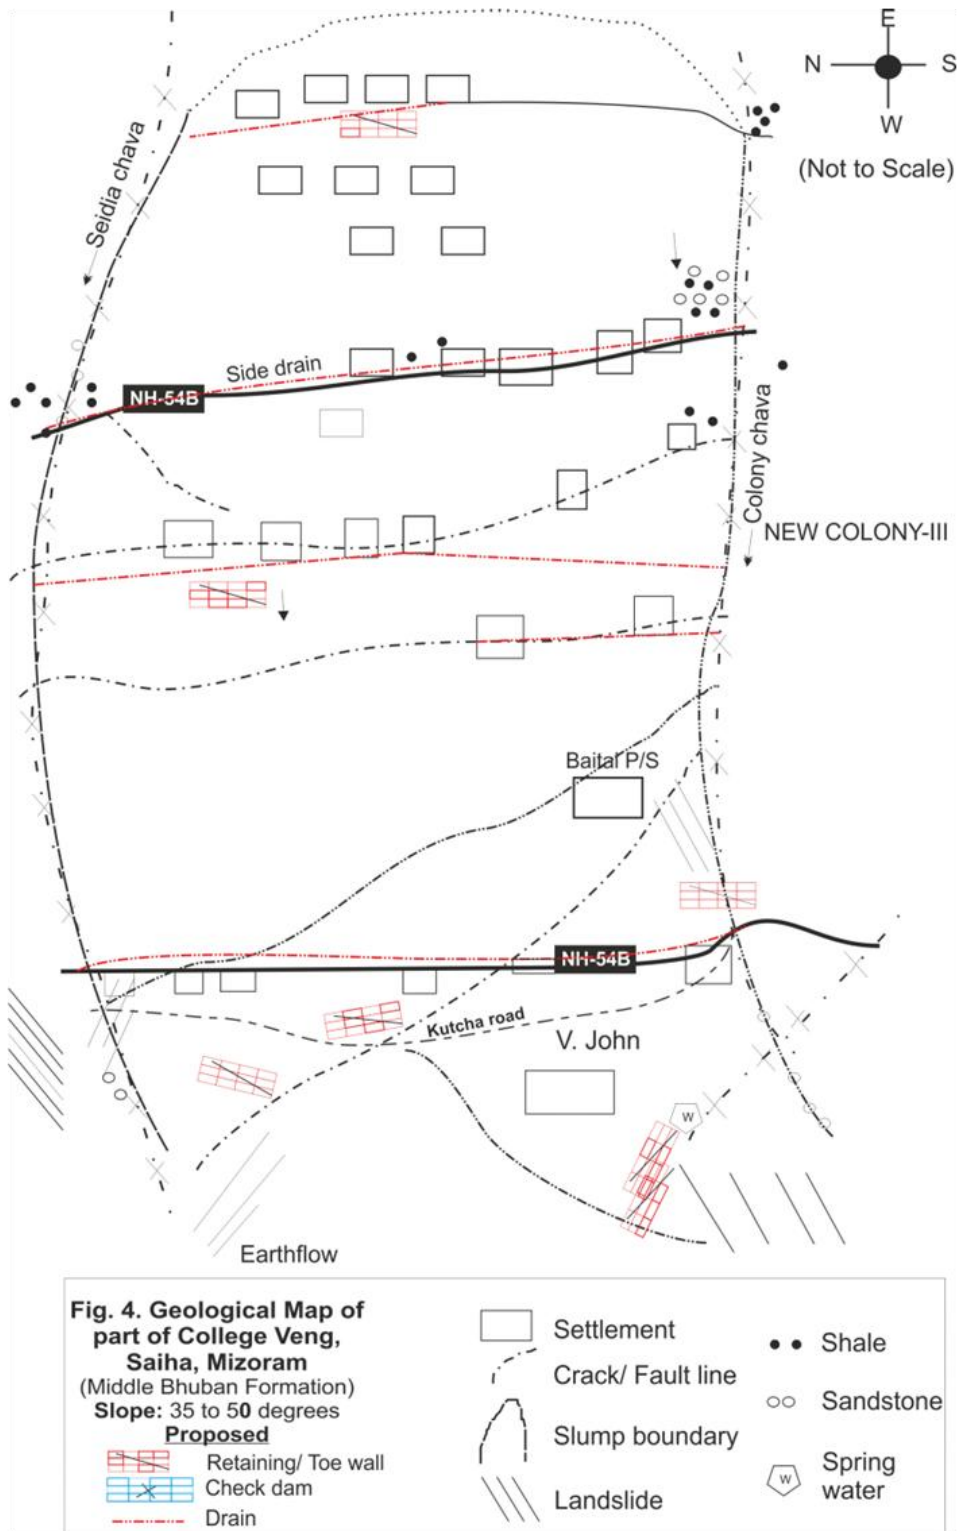
About 60 houses affected by slumping in College Veng area (Fig. 4). The area is situated between N22°29'32.16" & E092°59'2.7" at the crown at 1081m to N22°29'36.66"-E092°58'57" at the toe. 6 transverse cracks along NS, NE-SE, EW & NW-SE directions were observed. These transverse cracks are about 1 to 5 inches wide. At Seidia chava, at N22°29'35.94" & E092°59'5.94" at 1056 m, there was an exposure of shale bed along the NH-54 road striking N20°E and dip 17° W, this type of rock bed exposed again at N22°29'38.2' & E092°58'43.87" at 881 m striking N50°E and dip amount is 13°W. After suggestion⁴, check dam was constructed at Seidia chava at the side of V. John residential compound. The check dam was also observed as positive. Garbion wall type was suggest at above the bridge to increase toe resisting force, and to prevent slump along the road of National Highway situated at the height of about 80 m.

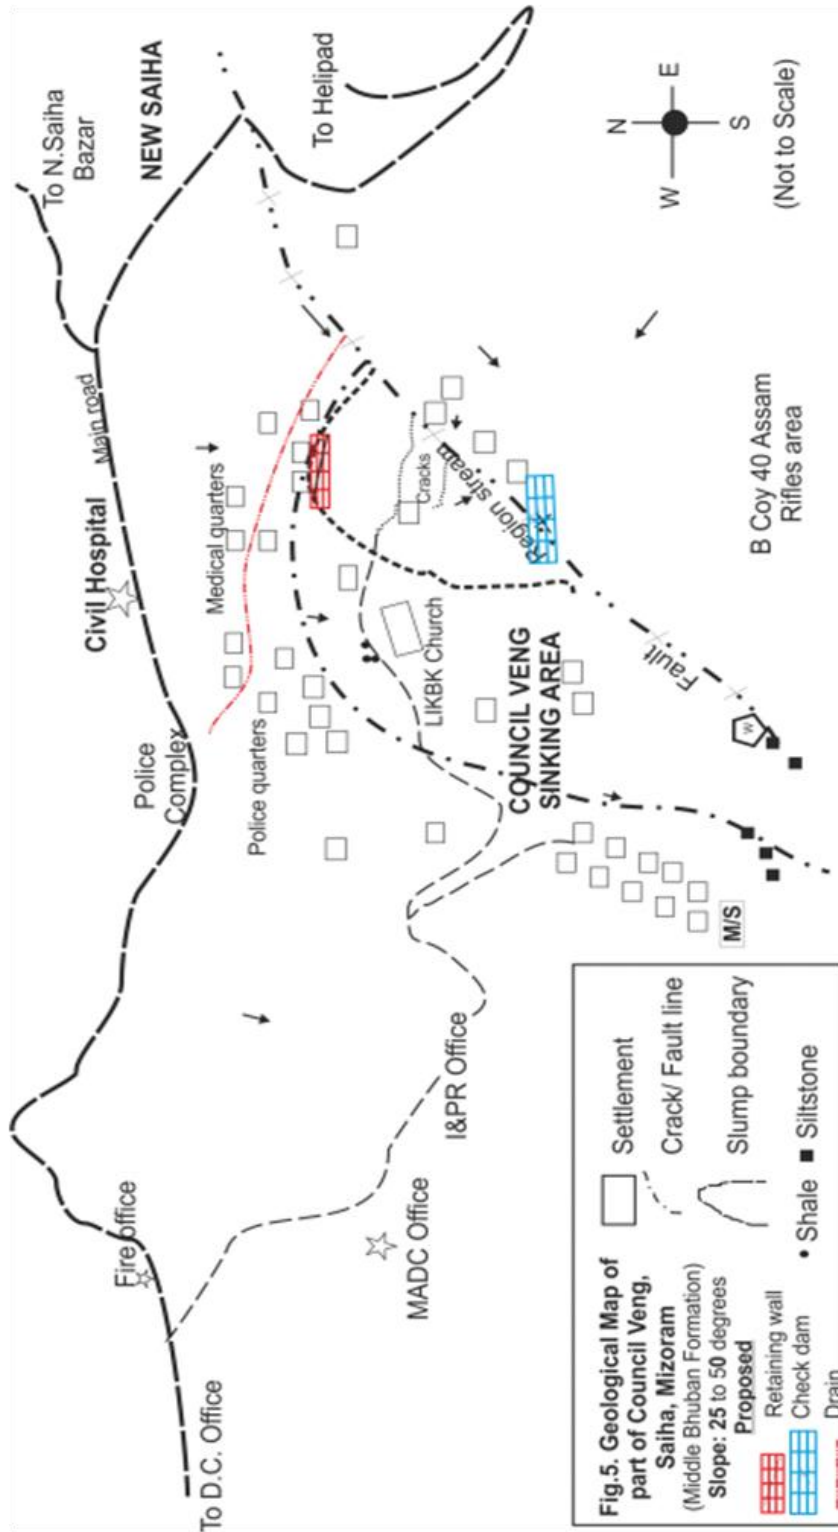
Council Veng subsidence area was noticed from 1989, and again in 1995. About 40 houses are affected in this subsidence. The main scarp situated at $N22^{\circ}29'16.92''$ & $E092^{\circ}58'58.8''$ at the height of 1136 m and the toe at $N22^{\circ}29'9.6''$ & $E092^{\circ}58'55.32''$ at 1020 m (Fig. 5). On September 2010, an area of about 20 sq m slumping was observed, destroyed one kutch house.

the height of 1126 m near the LIKKB church. One transverse crack was observed along NS-direction at the toe of Civil Hospital hill. The height of the main scarp to the nearest down thrown ranges from 8 to 20 ft.

To prevent infiltration of water and erosion in this area, new drainage system was suggested to construct along New Colony- Er. Chohmo road- DNS – CMO office, and beneath of Hospital canteen to Project stream. To increase resisting force at the toe region, 15 x 5 m check dam was suggested at the location of $N 22^{\circ}29.195'$ & $E092^{\circ}58.979'$ at the height of 1076 m.

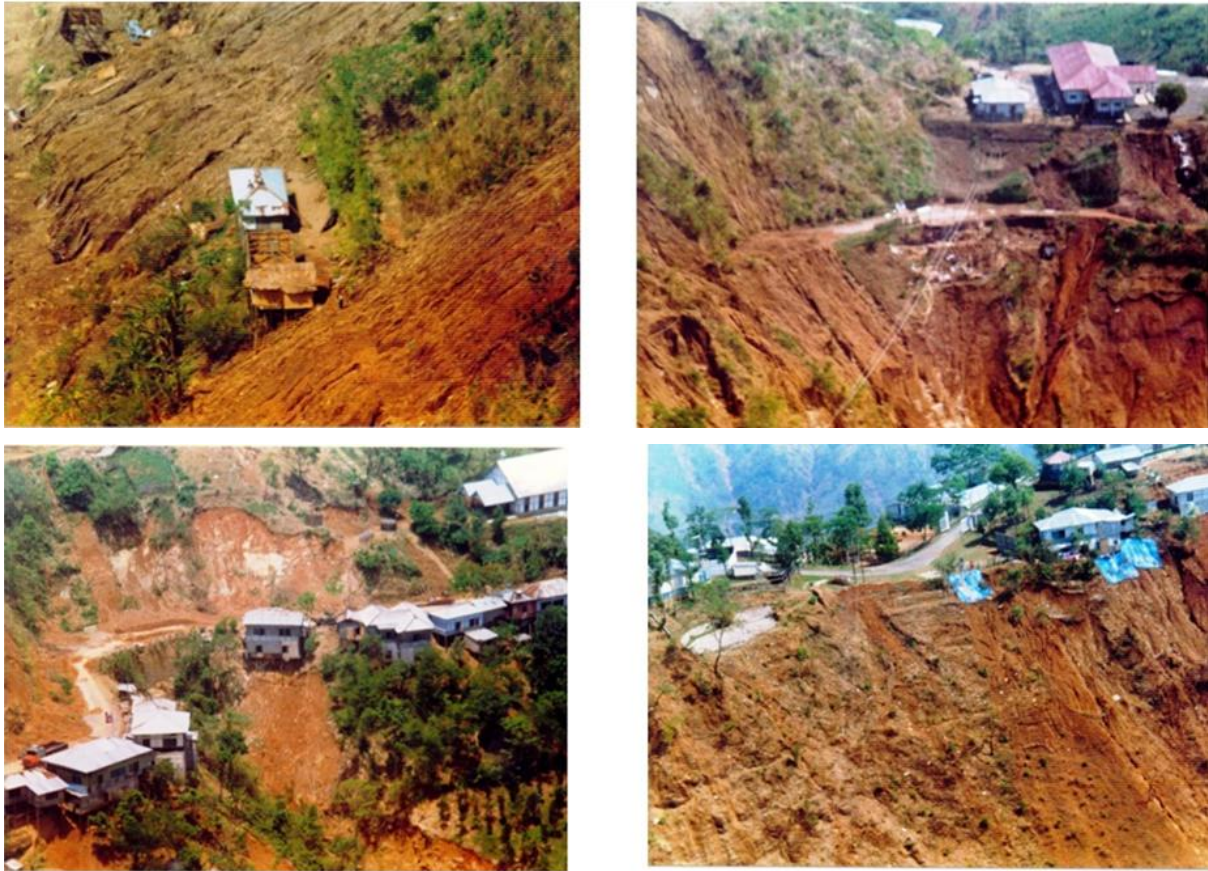
May, 1995 after cloud burst, and also due to no drainage system, geologically weak strata and poor vegetation (Photo plate- 1). 20 people lost their valuable lives, 13 people were seriously injured and 67 houses were completely destroyed in Saiha town.²

Photo plate 1. Largest mass movement at Saiha in May 1995.

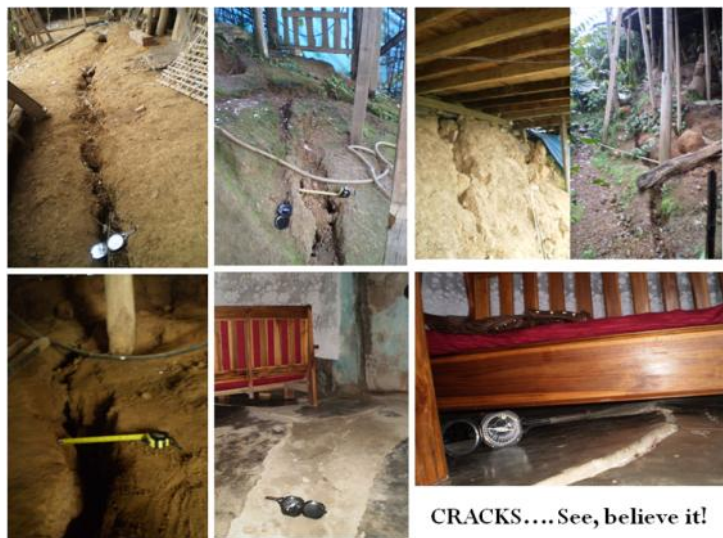
Photo plate 2. Some of the cracks observed at the settlement of New Colony & College Veng slumping areas.

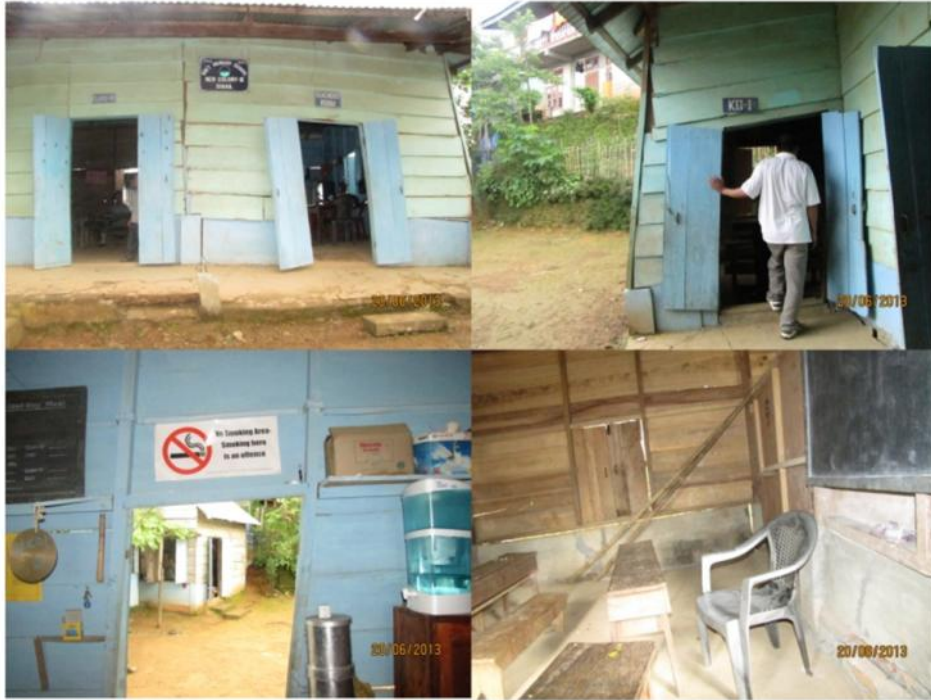
Photo plate 3. One of the affected School, Govt. Primary School, New Colony-III.

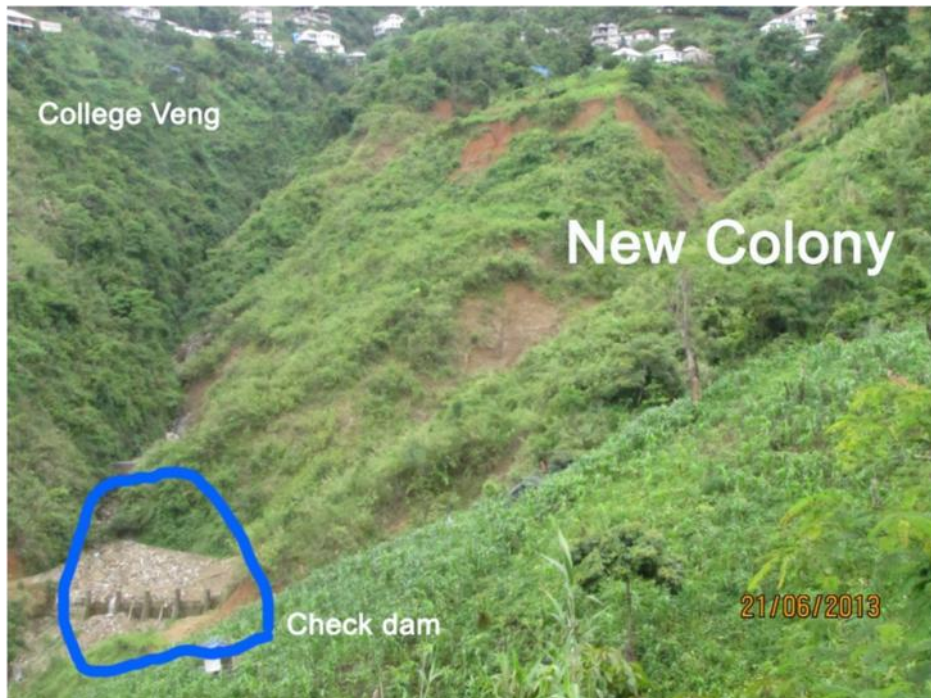
Photo plate 4. Check dam at the toe of College Veng - New Colony area, constructed by DRDA, Saiha.
