Application of Joint Inversion of Resistivity and Seismic Refraction Tomography to Investigate the Cause of Structural Failure in an Office Complex

Collins C. Chiemeké

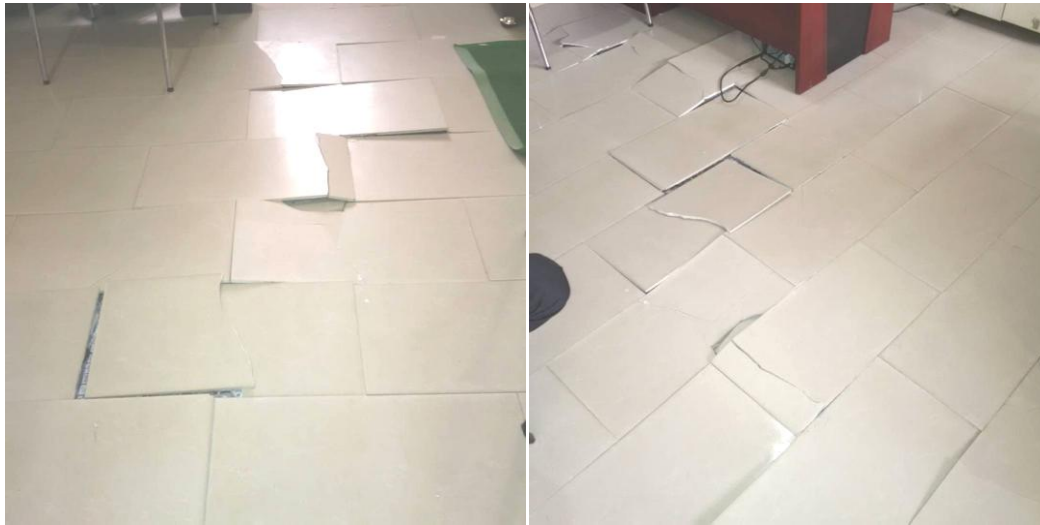
Figure 1: Structural failure of office floor, (16th, February, 2017) showing crack lines and displacement (a) Front view (b) Back view

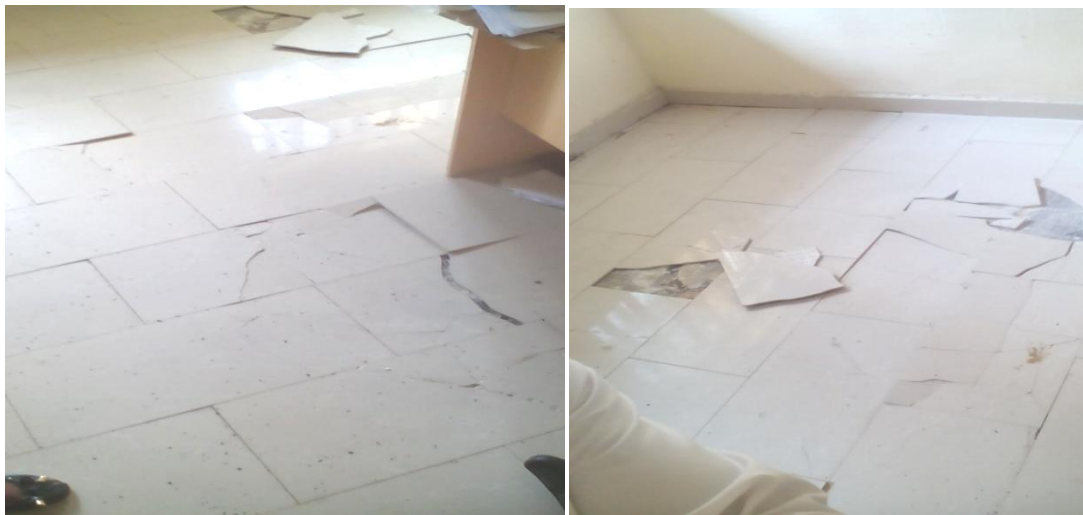
Figure 2: Structural failure of office floor, (16th, January, 2017) showing crack lines and displacement (a) Front view (b) Side view

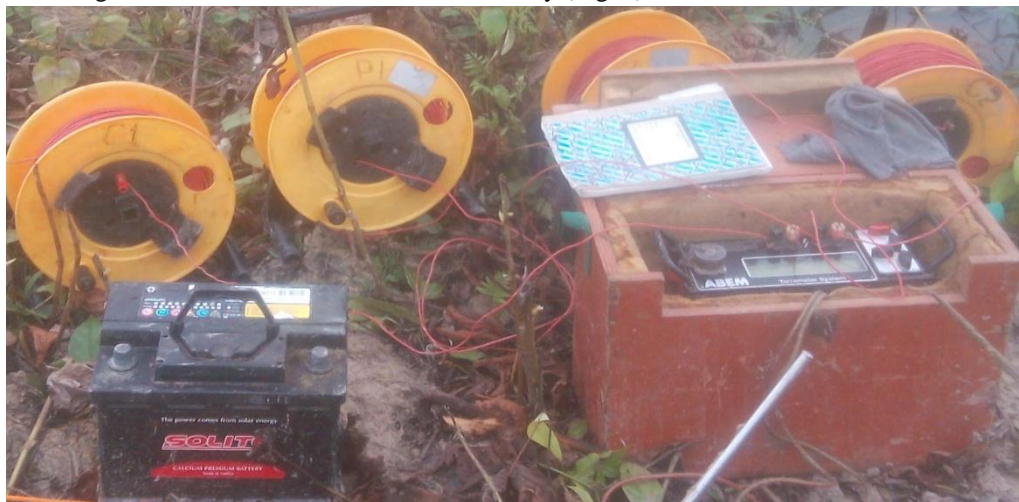
Figure 3: Resistivity Tomography Equipment

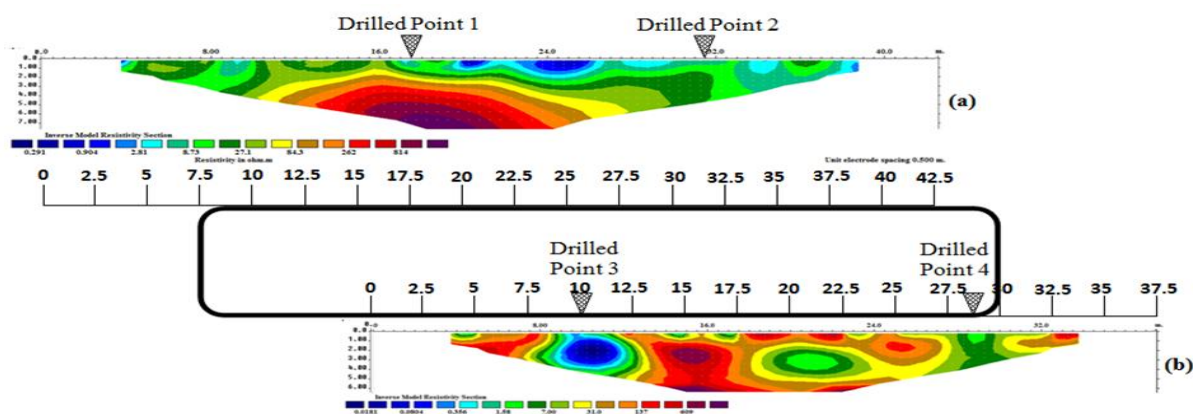
Figure 6: 2D Resistivity tomography models indicating profile lines around housing unit under investigation, (a) Profile 1 (b) Profile 2

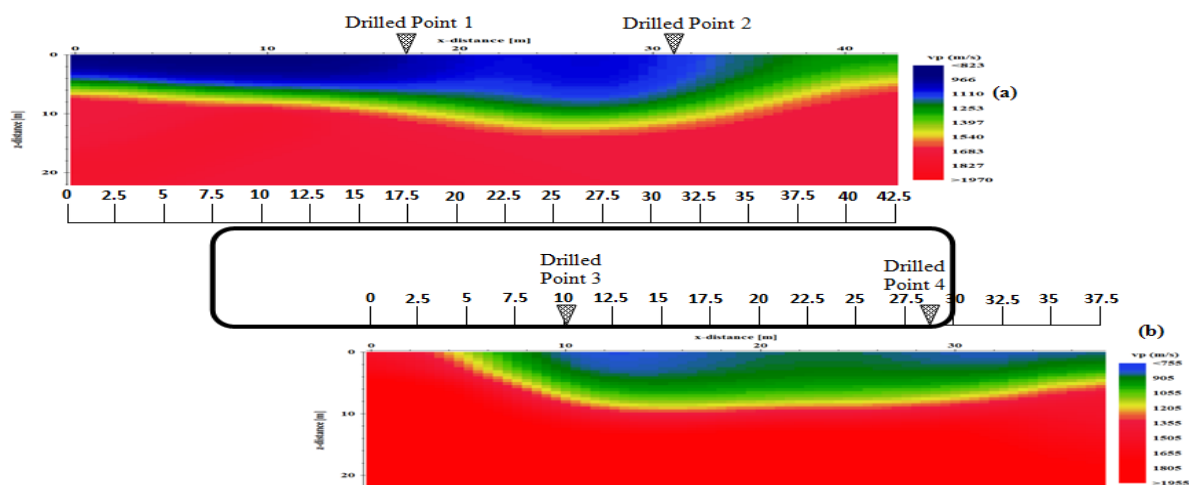
Figure 14: 2D Seismic refraction tomography models indicating profile lines around housing unit under investigation, (a) Profile 1 (b) Profile 2

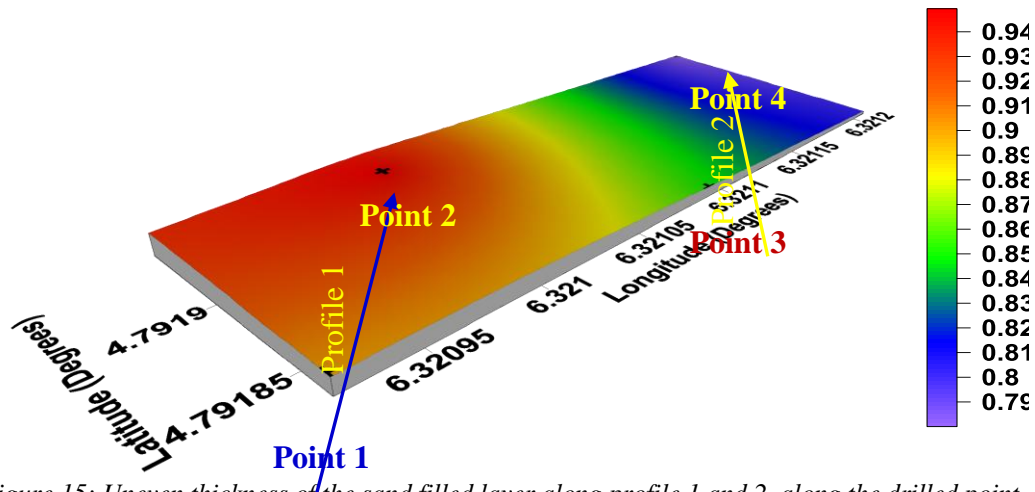
Figure 15: Uneven thickness of the sand filled layer along profile 1 and 2, along the drilled point

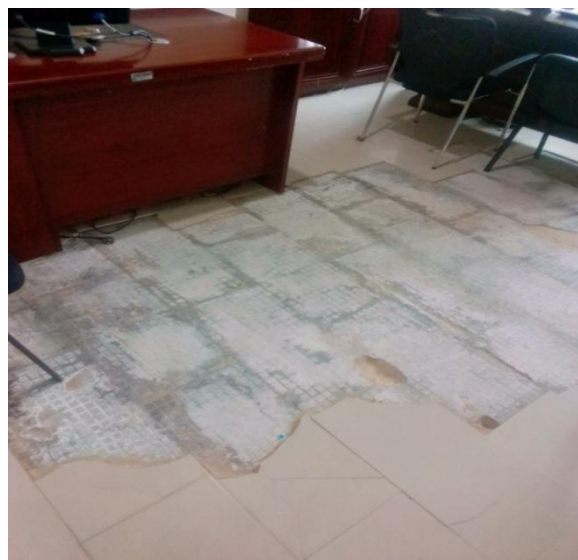
Figure 16: State of the office floor after the broken tiles were removed.
