Surface Rupture and Geotechnical Features of The July 2, 2013 Tanah Gayo Earthquake

Abstract - An assessment of surface rupture and collateral ground failures can help to evaluate the impact of future earthquakes. This paper presents the results of a field survey conducted to map the surface rupture and geotechnical phenomena associated with the ground shaking during the July 2, 2013 earthquakes in Tanah Gayo Highland. The objectives of this survey are to document and to characterize the surface ruptures as well as to identify types of earthquake-induced ground failures. Results of the survey identified four best sites of possible surface rupture. Two locations are obvious surface ruptures that can be traced on primary topographic feature of the active fault segment from the north to the south, crossing Pantan Terong Hill. The fault segment has a total mapped length of 19 km, with WNW trending zone and a dextral rupture offset. The ground shaking also resulted in landslides and liquefaction in areas underlain by very fine-grained tuffaceous sands. Based on the field survey, it can be concluded that the newly defined active fault segment, the Pantan Terong segment, is likely the se

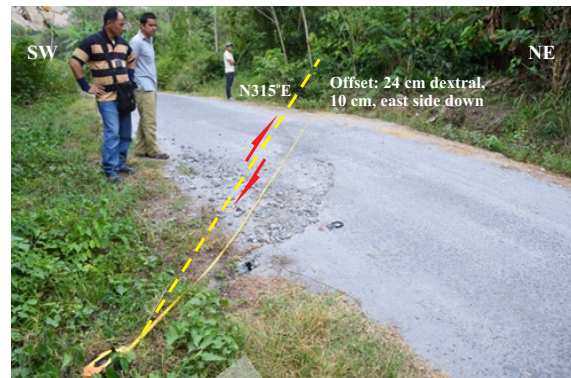
Site 1 - Kute Geulimai Surface Rupture

This surface rupture site is located on a steep hillslope, along the road between Kute Geulimai and Seurempah Villages. The surface rupture crosses the road with an orientation of 315°E exhibiting 24 cm of dextral offset and 20 cm of vertical offset with the eastern side moving down (Figure 4).

Figure 4. A photograph showing the surface rupture crossing the road between Kute Geulimai and Seurempah Villages. The rupture right-laterally displaced the road about 24 cm with a vertical displacement of about 20 cm, east side down.

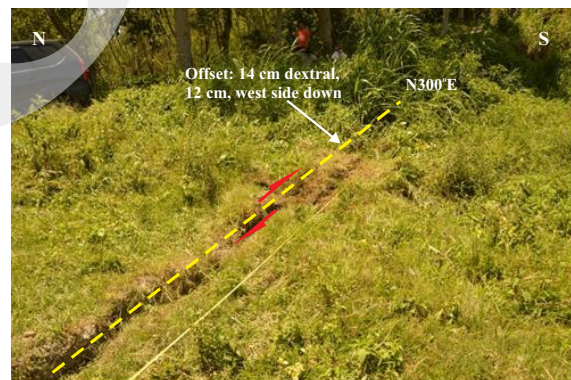
Site 2 - Kuta Malaka Surface Rupture

The surface rupture crosses a flat area at an elevation of about 940 m in Kuta Malaka Village. The group rupture is about 11 m long with an azimuthal trend of 300° , exhibiting a 14 cm-dextral offset and a significant component of vertical displacement of 12 cm with the western side moving down (Figure 5).

Figure 5. A photograph showing the surface rupture at Kuta Malaka Village with a 14 cm dextral displacement and vertical displacement of 12 cm, west side down.

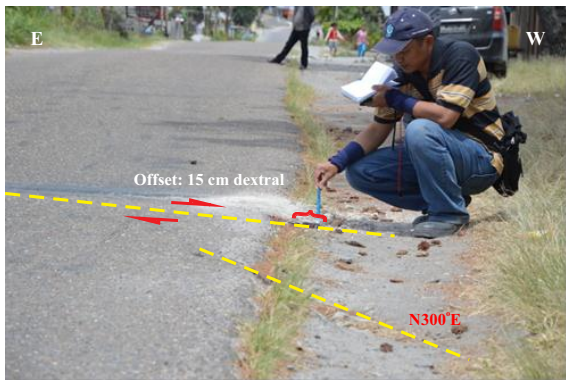
The ground surface rupture is located at Jamur Ujung Village. The rupture begins with an azimuth of 300°E , exhibiting 15 cm-dextral offset (Figure 6), then crosses the road with an azimuth of 85° , and cuts a brick fence (Figure 7). The rupture continues with the orientation of 320° , exhibiting 30 cm-dextral offset and 54 cm-normal displacement with the western side

Figure 6. A photograph showing the ground surface rupture at Site 3, Jamur Ujung Village. There are two ruptures with azimuthal trends of 85° and 300°. The inferred dextral offset is 15 cm.

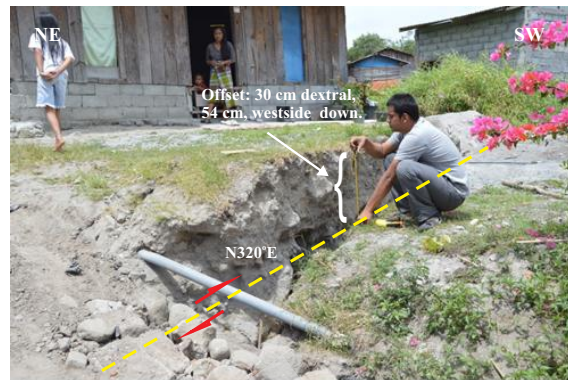
Figure 8. A photograph showing the change of Site 3 surface rupture orientation to 320°, exhibiting 30 cm dextral offset and 54 cm normal offset with west side moving down.

moving down of 54 cm (Figure 8). The surface rupture also caused the water in small pond to drain out shortly after the earthquake (Figure 9).

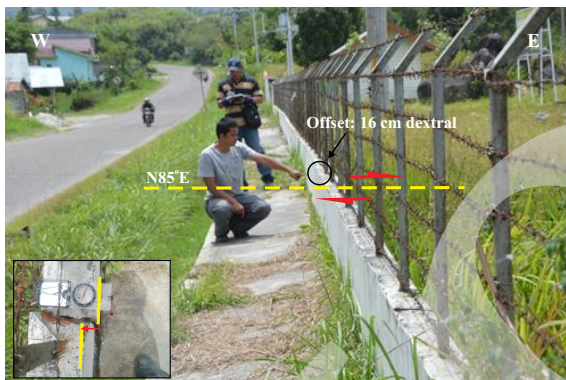
Figure 7. A photograph showing the Site 3 surface rupture continues through a bent brick fence with 16 cm dextral offset. The black circle indicates the centre of deflection of the brick fence. The inset photo shows the lateral offset of the brick fence wall, indicated by a red arrow.

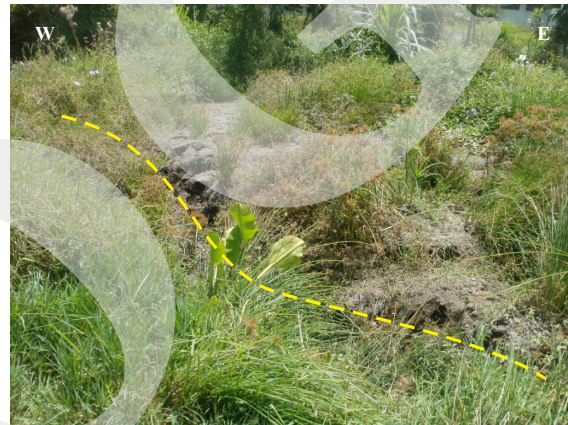
Figure 9. A photograph showing the small pond dried out due to the ground surface rupture at Jamur Ujung Village. The surface rupture track is indicated by a yellow dashed line.

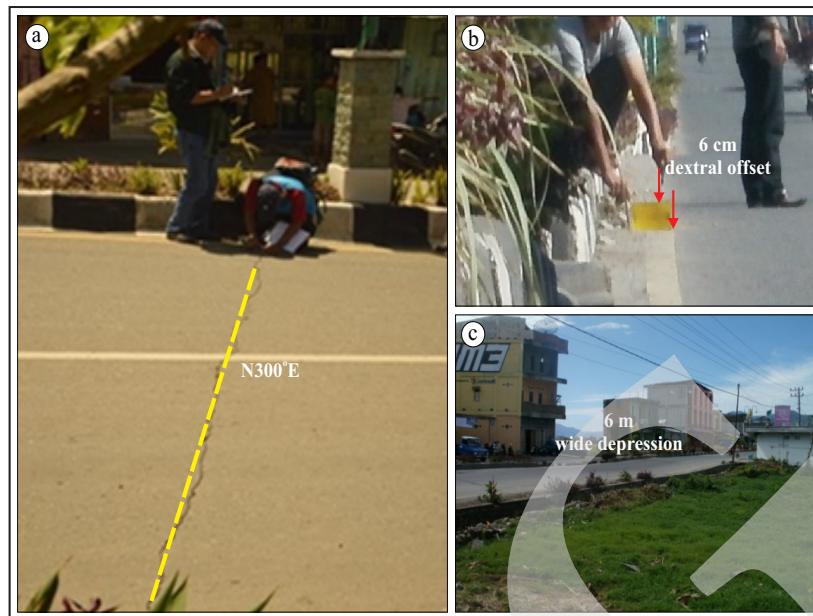
Site 4 - Mongal Surface Rupture

This surface rupture site is located in a flat area within Mongal Village, north of Takengon Town. A ground rupture crosses an asphalt road with an azimuthal trend of 300° (Figure 10a) and caused the road to right-laterally displaced about 6 cm without vertical displacement (Figure 10b). This rupture is associated with a 6 m-wide depression as observed on the road surface (Figure 10c).

Figure 10. Photographs showing the geometry and kinematics of the surface rupture in Mongal Village. (a) A rupture cut through the road with an azimuthal orientation 300°; (b) A 6 cm- dextral offset measured from the deformed roadside marker; (c) A 6 m-wide depression observed on the road surface.

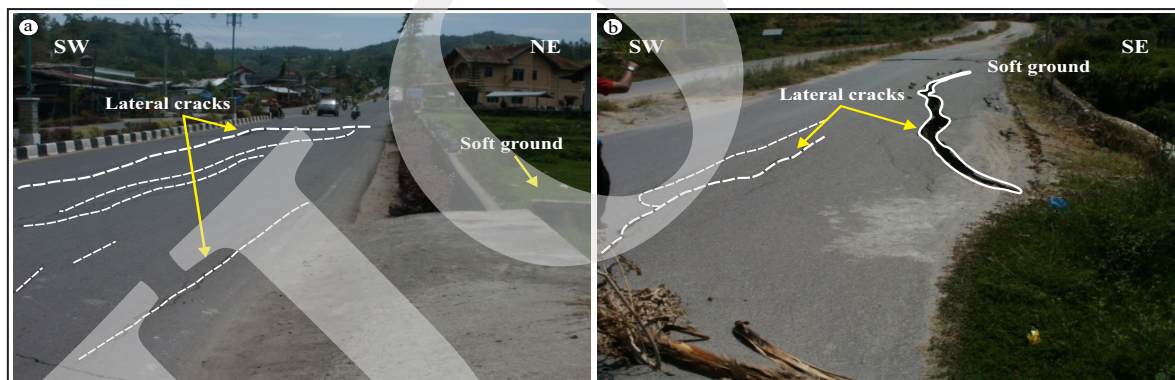
also triggered ground failures associated with liquefaction and landslide. Liquefactions, such as lateral spreading and sand boiling, were mainly found in flat areas within Central Aceh Regency. The lateral spreadings were commonly observed to occur in many road embankments constructed in soft soil ground. Some good examples of lateral spreading were evident in the road embankments in the vicinity of Takengon Town (Figure 11). This type of ground failures is influenced by the geological condition of Takengon flat area / lowland. According to the geological map of Cameron *et al.* (1983), the lowland is underlain by Quaternary lake deposits, especially in the areas around the Lut Tawar Lake. These young soil deposits have obviously low strength to withstand the ground shaking.

Figure 11. Photographs showing ground failures associated with lateral spreadings of road embankment around Takengon Town. (a) On the main road connecting Takengon Town and Bireun, (b) A lateral spreading on a new road connecting Takengon Town and Kute Panang.

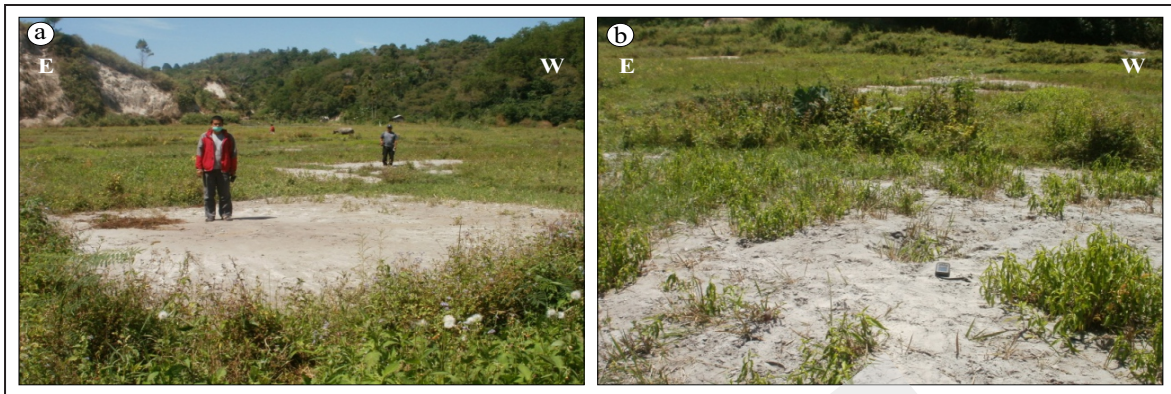
Another type of ground failure was associated with liquefaction as observed in Kuta Malaka Village at an elevation of 950 m above sea level (Figure 12). Numerous sand boilings were found in a flat area where the Kuta Malaka surface rupture is located. The local groundwater level is about 5 m below the ground surface. According to an eyewitness, the occurrences of sand boiling was seen to commence from the first earthquake event (Mw6.1) for two days. As seen in Figure 12, greyish white fine-grained sands spouted of the ground cracks in several locations in a flat

area surrounded by hills, probably associated with Quaternary tuffaceous sand-filled lake. The occurrences of liquefaction indicate the intensity of earthquake event of at least MMI 6 in this area. According to the Shake Map produced by USGS soon after the event, the earthquake intensity in the Central Aceh area ranged between MMI 6 and 7 (Anonymous, 2013).

Figure 12. Photographs showing the liquefaction induced sand boilings due to the July 2, 2013 earthquake (Mw 6.1) in Kuta Malaka Village. The white fine-grained sands were spouted out the ground cracks.

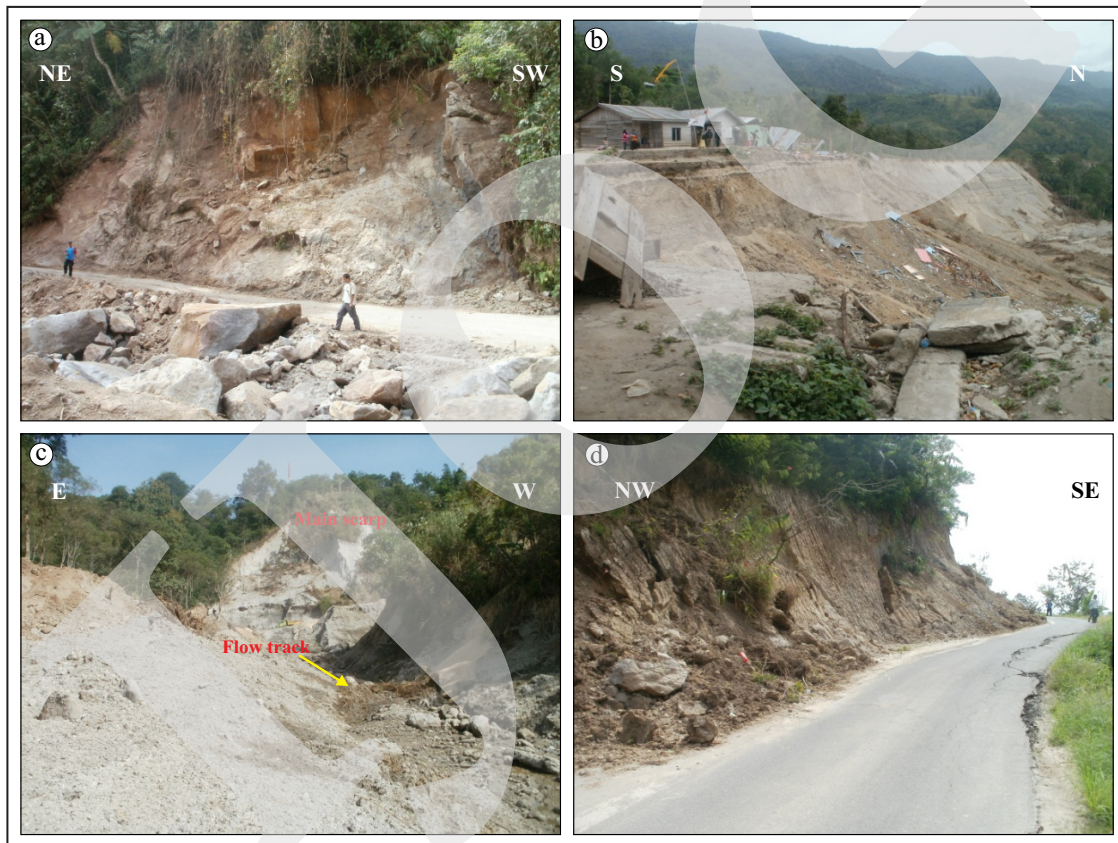
Figure 13. Photographs showing types of landslide triggered by the July 2, 2013 earthquake in a Gayo Highland area. (a) Rock fall of intrusive outcrop along the road to Kuta Panang, (b) A larger-scale landslide in Seurempah Village, (c) A dry earth flow triggered in the tuffaceous sand slope, (d) A surficial cut-slope failure along the roadside from Takengon to Blang Mancung.

Based on field observations, earthquake-induced landslides in this area can be categorized into four basic types. The first type is rock falls of igneous rock. This type of landslides occurred within a narrow area, controlled by the main rock fractures. Figure 13a shows the example of rock

fall of igneous outcrop with strike orientation of N60°E and dip direction of 48°.

The second one is large-scale slope failures that commonly occur in steep slopes (>45°) of loose tuffaceous sands. This type of landslides involves a large volume of soil masses. One of which occurred in Seurempah Village in Ketol Subregency, claiming eleven lives and destroying a twelve houses (Figure 13b). The landslide materials temporarily blocked and changed the flow of Air Pesangan River. As seen in Figure 13b, the tuffaceous sand deposits are horizontally layered; thus, the occurrences of the large scale landslide are mainly controlled by the slope morphologic factor. Other large-scale slope failure can also be seen in steep slopes along the Air Pesangan River such as in Bah Village located in the south of Seurempah Village. It is interesting to note that this type of landslides forms steep slopes.

Earth flows are also common throughout the surveyed area and are very well observed on the hillslope of tuffaceous sands. The occurrence of the earth flow is controlled not only by the slope geomorphologic condition but also by the looseness of the earth materials. The tuffaceous sands are evident to travel to a distance of tens to hundreds meters from the landslide sources in a dry state condition (Figure 13c). The fourth type of landslides is surficial slope failures, involving a thin surface soil material (Figure 13d). This type of landslide commonly occurs in unprotected steep cut-slopes along a road side. The mode of failure is a nonrotational slide and the soil materials are not travelled far from the failed slope. This type is capable of blocking the road, and triggering a hazard to down-slope areas.

The numerous landslide occurrences during the July 2, 2013 Tanah Gayo earthquake indicate that soil and rock slopes within the Gayo Highland are very susceptible to instability during earthquake events. Thus, hillslopes subjected to the July 2, 2013 earthquake are likely to have a low stability, and therefore, prone to landsliding during rainfall events. This hazard can cause risk to the people living beneath the slope areas. Public awareness is, therefore, important to reduce the risks of landslide disasters.
