Modelling of the Oil Spill in M/V LADY TUNA Accident and the Evaluation of the Response Operation in Simulated Condition with PISCES II

Deniz AYDIN & Murat Selçuk SOLMAZ

How to cite: Aydın, D. & Solmaz, M. S. (2019). Modelling of the Oil Spill in M/V Lady Tuna Accident and the Evaluation of the Response Operation in Simulated Condition with PISCES II. *International Journal of Environment and Geoinformatics (IJEGEO)*, Vol. 6(2): 213-224, DOI: 10.30897/jegeo.579066

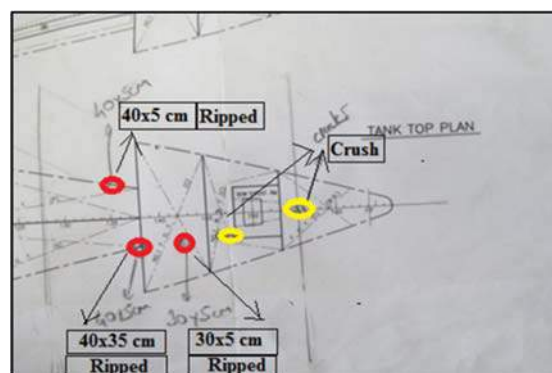
Figure 6. Damaged Parts of the Ship (AIB, 2017).

After the accident, the master of the ship informed to the agency about the oil pollution and reported that response operation was necessary urgently. There was no attempt by the ship to prevent oil pollution. After the soundings were taken from the tanks by the crew, it was determined that there were damages to fore-peak tank, No.1 center ballast tank, No.1 center fuel tank, No.2 port and starboard fuel tanks. There was leakage from the fuel tanks to the sea. Damaged parts of the ship on the Transverse Plan are shown in Fig. 6. (AIB, 2017)

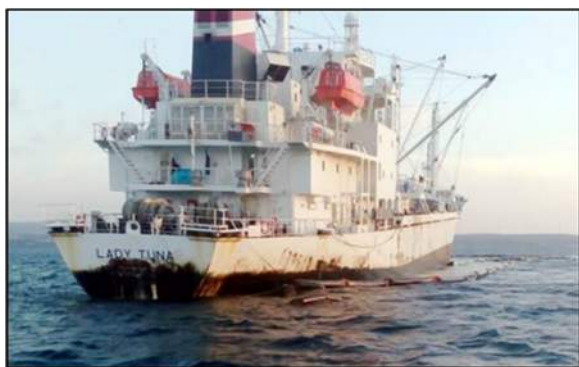
Figure 7. Containment of Spilled Oil by Barriers (www.seanews.com.tr, 2017).

pollution response activities at 17:30 LT (4 h after the accident). Most Shipping started to encircle the fish farms with barriers at 20:30 LT and they completed to encircle the ship to the containment of pollution with barriers with two skimmers at 22:30 LT (Fig. 7) (9 h after the fuel oil leakage from the ship). As of 12:00 LT on 19th December 2016 (about a day after the accident), another company “Mare Marine Cleaning Service Company” started to work for pollution response. (AIB, 2017)

However, according to the captain's statement, the time of the accident was recorded in the ship's logbook at 13:30 LT. The insufficient boom was encircled to the ship at 00:30 LT on 19 December 2016 (11 h later) to control the pollution arising from the ship. Because of the bad weather condition, the second barrier was encircled 20 h after the spillage. (Sunlu, Kayacan and Küçükgül, 2017)

It shows that there are differences and inconsistencies in the documents of the official institutions about how fuel oil pollution started in the events and how they manage the response operation following the spillage from the ship.

- The response company reached the accident region 7h after the accident, but firstly they began to encircle the fish farms with barriers. About 9 h after the spillage, they began to encircle the ship around with a barrier (which is not efficient in high sea condition). However, first of all, they should have started the response operation against the leak source. As a

result, the response operation was delayed at least 2 h. This caused more than 10 tons of the fuel to spill.

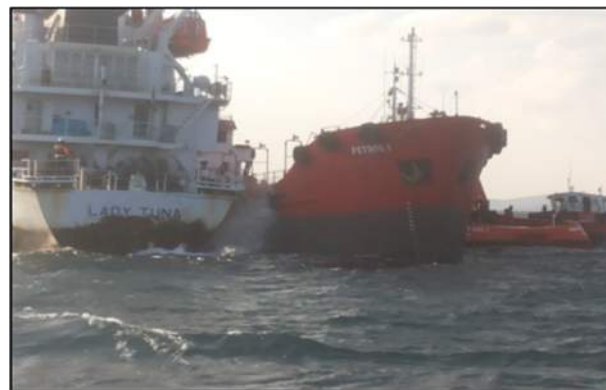
Figure 9. Transfer Operation (AIB, 2017).

On 24th December 2016 (6 days after the accident), tanker ship Petrol-1 (Fig. 9) came alongside M/V Lady Tuna in order to discharge the fuel in her damaged parts. The discharging operation was completed on 26th December 2016 (8 days after the accident). Salvage operations were started at 09:00 LT on 27th December 2016, 9 days after the accident. (AIB, 2017)

- On 24th December 2016 (6 days after the accident), the tanker ship discharged the fuel in her damaged tanks and discharging operation was completed on 26th December 2016. The weather report shows that the violent storm increased three days after the accident. It created a greater danger to the damaged ship and the environment. The discharge operation of the fuel on the ship normally should be made shortly after the accident.

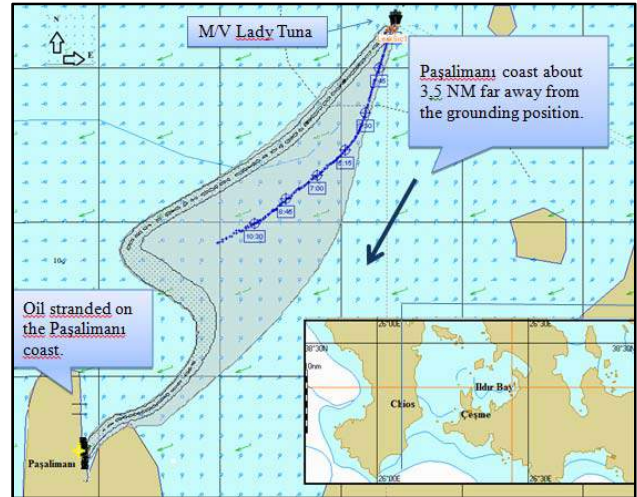
Figure 14. Scenario-1: The Oil Stranded on the Paşalimanı Coast (Δt: 12 h).

The area shown in gray color indicates the area where oil is spreading for up to 12 h from the beginning of the scenario (spilled oil; 60 tons) (Fig. 14). The program shows the information “Oil impact on land” on the window screen. The oil reached on the Paşalimanı coast (0,02 %) about 12 h later following the spillage (Table 5).

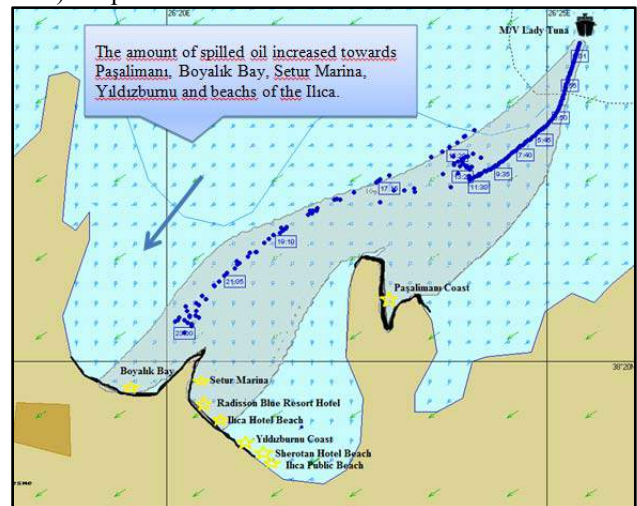
Figure 15. Scenario-1: The Movement direction of the oil slick (Δt: 36 h).

As a result of the scenario, the movement direction of the oil slick after 36 h from the accident is shown in Fig. 15. It is clearly seen that the oil was stranded at Paşalimanı coast, the Boyalık Bay, the Setur Çeşme Marina, the Radisson Blue Resort Hotel beach, the Ilıca Hotel beach, the Yıldızburnu coast, Sherotan Hotel beach and the Ilıca public beaches. The pollution and spill parameters (after 36 h) are presented in Table 6.

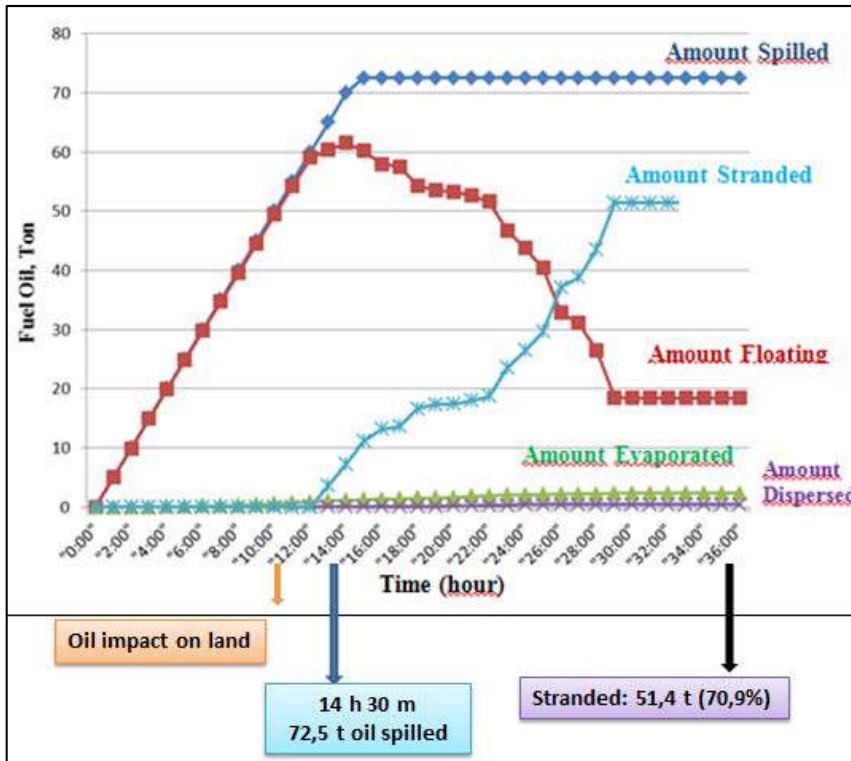
Figure 16. The Graphic of the Spill/ Pollution Statistics of the Scenario-1.

- After 14 h and 30 minutes following the accident, 72,5 tons fuel oil leaked from the ship's tanks (5 tons/per hour).
- The amount of stranded oil (which began about 12 h after the spillage), is 51,4 tons (70,9 % of the spilled oil) as well as the floating oil amount is 18,4 tons (25,4 % of the spilled oil).

- The amount of floating oil increased until 14 h following the accident. After this time the floating oil rate decreased because the oil reached on the coast as well as the fuel leakage ended after 14 h and 30 min.
