# Geotechnical site investigation and evaluation of 20 March 2019 Mw 5.5 Acıpayam (Denizli) earthquake

### Abstract

An earthquake with a magnitude of (M<sub>w</sub>) 5.5 occurred in Yeniköy village of Acıpayam district (Denizli) on 20 Mart 2019 caused heavy damages on masonry structures in Acıpayam basin. Groundwater level from ground surface in the basin varies between 1m and 11m, and soil structure of the basin is made up of silty, gravelly and sandy clay. Soil liquefaction was not observed in the basin after the earthquake. The main reasons of the heavy damage on the structures are mainly, high value of soil amplification, use of clayey adobe bricks and hollow bricks for building masonry houses, unpermitted construction of roof floors by using hollow bricks.

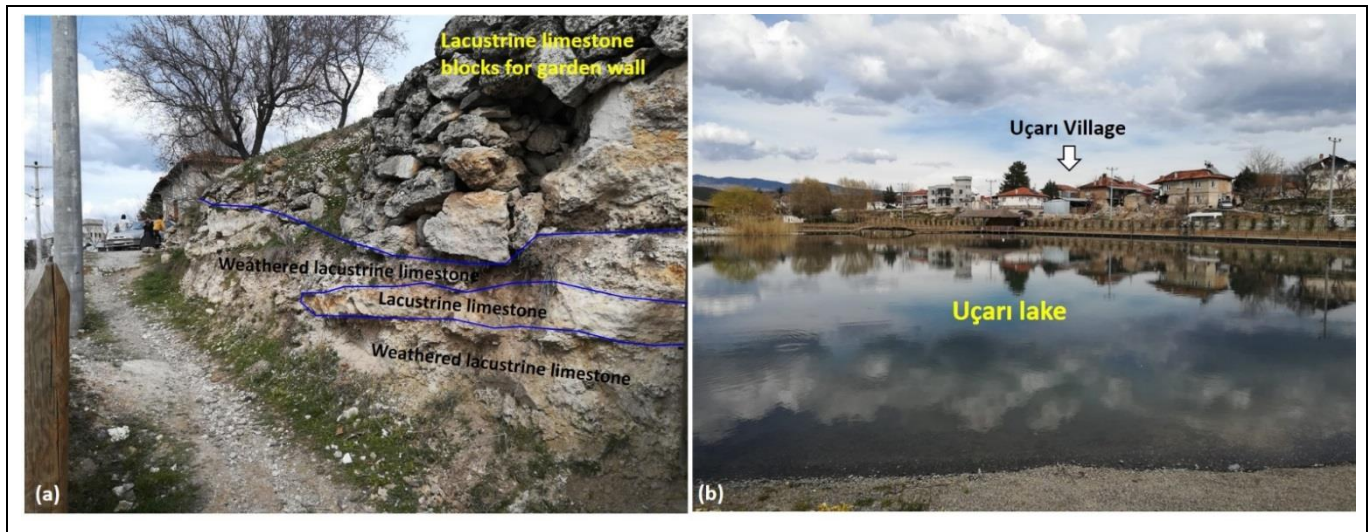
UKSK1 borehole was drilled in Uçarı village and 10 m in the lacustrine limestone was cut through the borehole. The groundwater level is 5 m deeper than the ground surface [30]. Lacustrine limestone is weathered and, has pores and karstic cavity (Figure 5). Groundwater discharging through karstic limestone in western area of Uçarı village forms the lake of Uçarı (Figure 6). Weathering, karstic cavity, groundwater pressure in lacustrine limestone and close distance to the earthquake epicenter location had an important influence on the heavy damages of the masonry structures in Uçarı village.

Figure 6(a): Field view of weathered lacustrine limestone in Uçarı village settlement area, (b): Uçarı village and the lake of Uçarı.

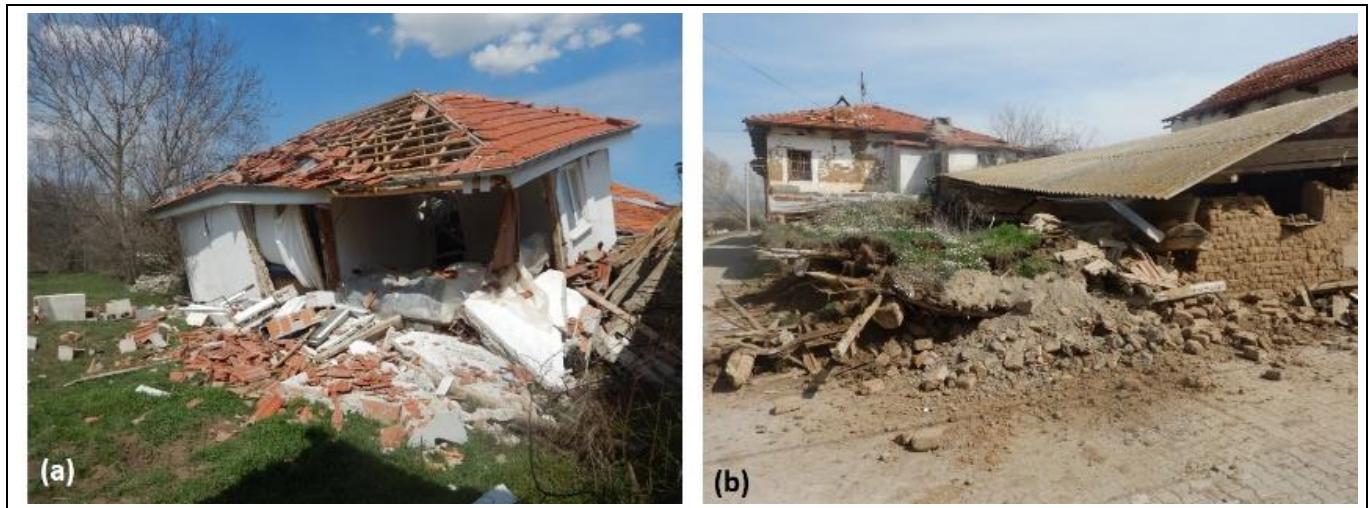
[33] equation gives lower A values than [32] and [34] equations (Table 2). Maximum A values of at KISK7, UCSK5 and OGSK1 locations are 3.68, 3.70 and 3.0 respectively and, they are in medium hazard level as given in Table 2 [38]. At these locations adobe, brick made masonry houses were heavily damaged due to earthquake. Reinforced structures were slightly damage and non-damaged (Figure 8a,b; Figure 9a,b; Figure 10a,b).

Figure 8(a): Heavily damaged hollow brick structure, (b): Collapsed adobe structure in Kirka village.

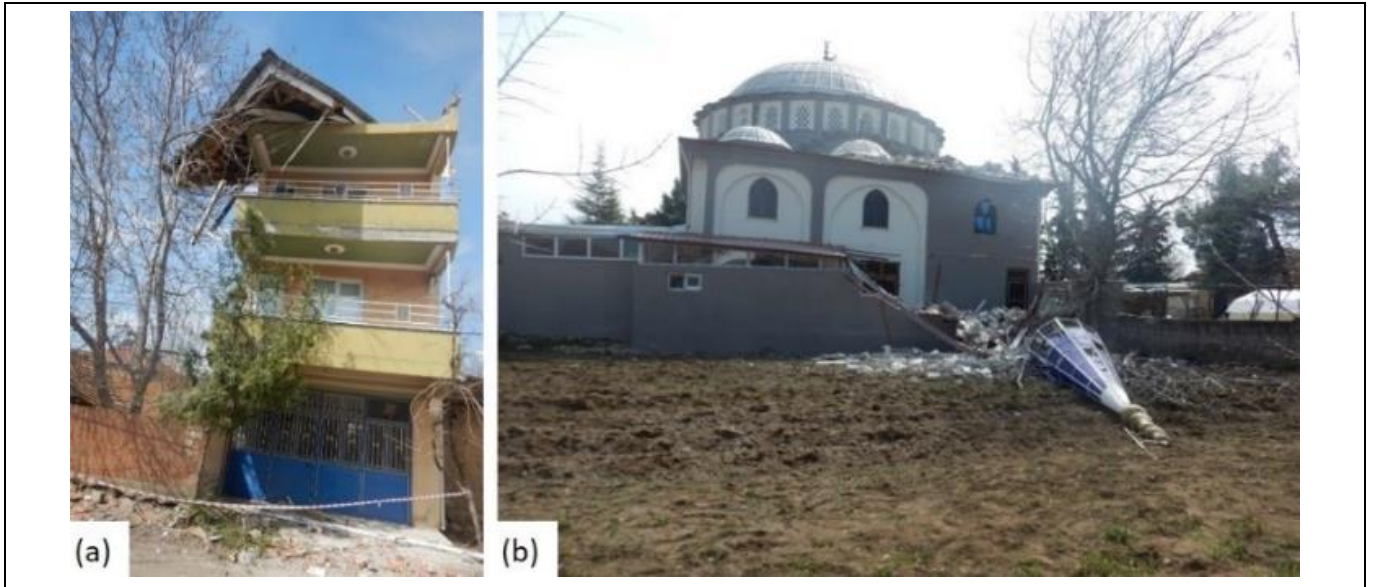
Figure 9(a): Hollow brick built roof floor failure of a reinforced structure. (b): heavily damaged masonry mosque in Oğuz village.

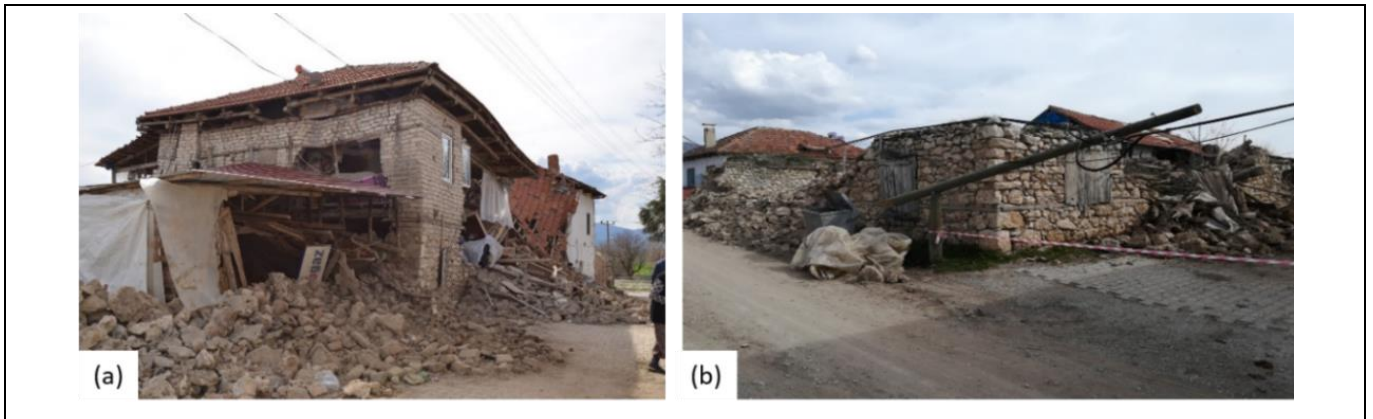
Figure 10(a): Collapsed adobe structure, (b): heavily damaged masonry structure and broken electric pole in Uçarı village.

Soil amplification factor of soils at UKSK1 location in Uçarı village is 1.79. At this location and in close area adobe, brick made masonry houses were heavily damaged and weak reinforced structures were moderately damaged. As the epicenter of the earthquake is 4 km close to Uçarı village, heavy damage on the masonry structures occurred during the earthquake.

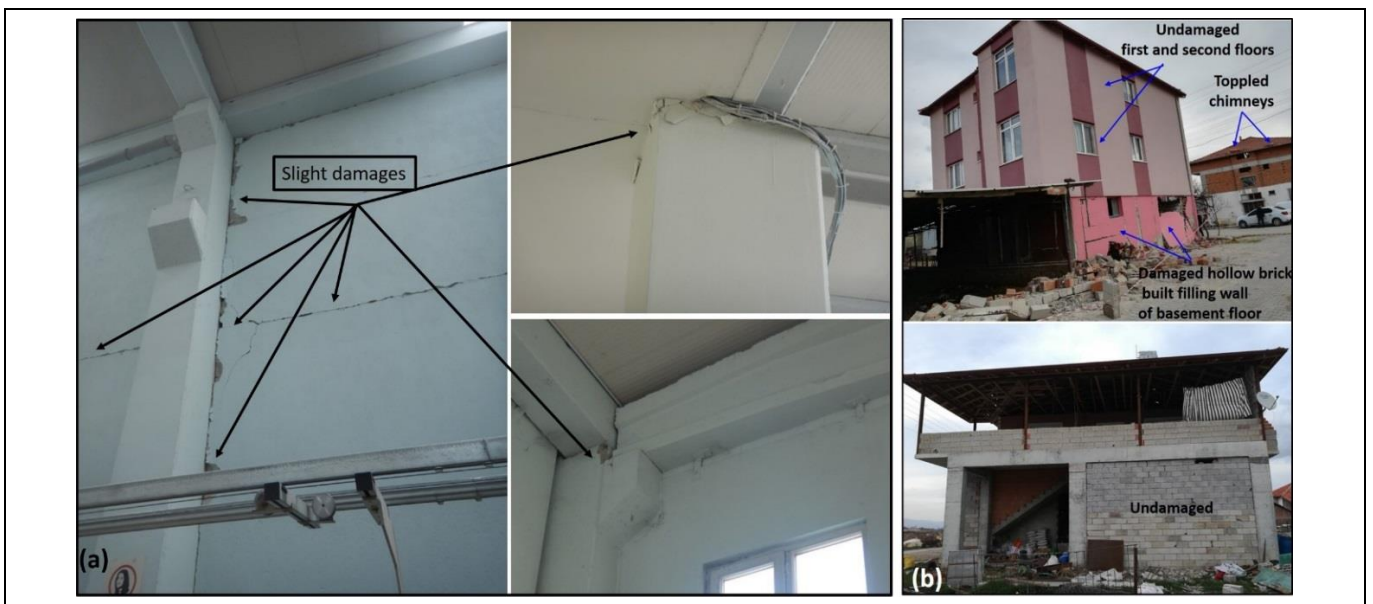
5.5 magnitude Acipayam earthquake caused slight damages on precast factory structures built on soft soils in the Acipayam basin. These damages are usually fissures and cracks at the connection parts of precast elements. Such as, beam and wall connections, beam and column connections, column and wall connections. There are also damages on suspended ceilings of the factory structures in the basin (Figure 11a). Single-storey reinforced structures, built on soft soil sediments in the basin, are usually undamaged (Figure 11b). However, multi-storey reinforced modern structures have damages on the hollow brick built walls in the basement floor (Figure 11b) masonry roof floor (Figure 8a). These reinforced structures had no damages on their beams and columns.

Figure 11(a): Damages on precast concrete modern textile factory structure in Yassihüyük village, (b): Partly damaged three-storey reinforced structure and undamaged single-storey reinforced structure in Apa village.
