Considerations on damage to bulb turbine shafts from iron Gates II

Abstract. During operation, the turbine bulb shaft is subjected to static specific stresses (tension, compression, torsion) and dynamic (fatigue, random vibrations). These stresses are the effect of hydraulic forces and moments developed on the rotor blade, the weight of the rotor (with or without oil) in the console and inevitable vibrations, which creates a rotating mass unevenly distributed over the axis of symmetry of the turbine. Observations made on the turbine bulb shafts of the Iron Gate II CHE have revealed cracks in the connection area of a shaft flange that engages it with the turbine rotor. Examination of these cracks leads to the conclusion that they are specific to the inevitable fatigue demands in exploiting the tree and enhancing the environment in which they work. Therefore, in the paper, a presentation and analysis of the damage of bulb turbine shafts from CHE Porțile de Fier II, after a significant number of hours of operation.

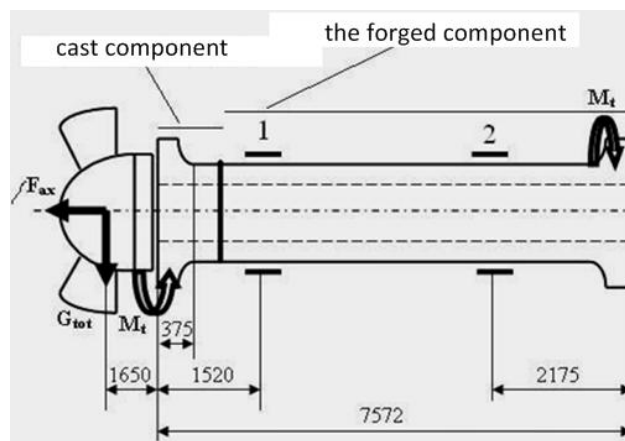
Figure 1. Bulb turbine shaft construction

The bulb turbine shaft, Figure 1, is made of two components: a casting consisting of the turbine rotor coupling flange and a cylindrical and a forged portion formed by the coupling flange with the electric generator shaft and most of the cylindrical part with which it engages and in the axial radial bearing.

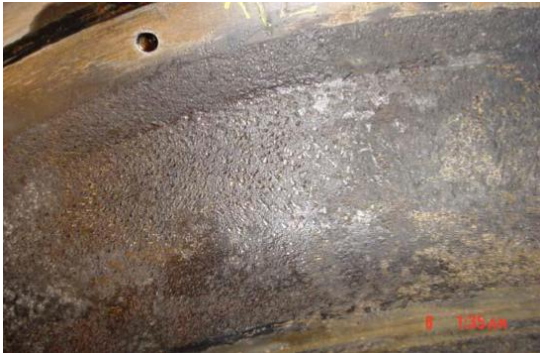
Figure 2. Surface Corrosion Points

The proportion of chromium and nickel (especially chromium) is insufficient to confer increased corrosion resistance including intercrystalline corrosion. Given the influence of manganese on crystalline grains, we appreciate that the main alloying element determines a rough structure of the flange blank. In the case of castings, this structure determines both large crystalline grains and some unevenness in their dimensions. Preserving the initial composition, with small percentages of chromium and nickel, makes the corrosion resistance, Figure 2, remain relatively low, which does not improve the propagation of the cracks initiated.

Also, turbine operation has been consistent with specific, continuous, controlled and controlled regimes. As a result, the incriminated areas were checked by non-destructive specific methods, at each stop of the Romanian aggregates. After a control of about 130,000 to 140,000 hours of operation, a network of circumferential cracks was observed in the coupling flange of the shaft with the turbine rotor. This has led us to appreciate that crack initiation was caused by specific requirements, material constitution, processing technology and working conditions (humidity), as seen in Figure 2.

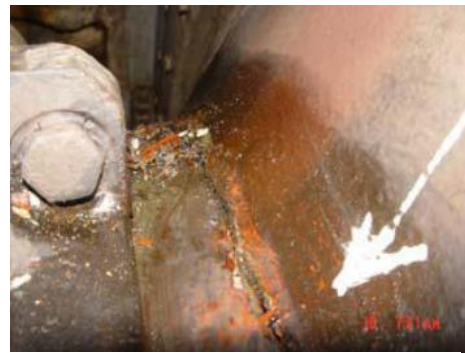
Figure 3. Cracks in the connection area of the shaft flange

- lack of macroscopic plastic deformations or dimensional changes (cracks, etc.), as seen in Figure 3;

The examination of the cracks in Figures 3 and 4, based on the photographs taken on the hydroaggregate tree no. 6, allowed to substantiate the causes that led to cracks in the flange connection area of such a magnitude.

Analyzing the image in Figure 3a we can see:

- The zigzag shape of the circumferential crack is more evident, reflecting the existence of micro-zones with increased strength that required circumvention;
- Chemical corrosion occurred even under the protective coating layer;
- There are cracks in areas close to the second radius of connection (near the arrow). This aspect shows the high degree of stress generated by the high stresses induced by the high stresses on which the tree part is in the console.

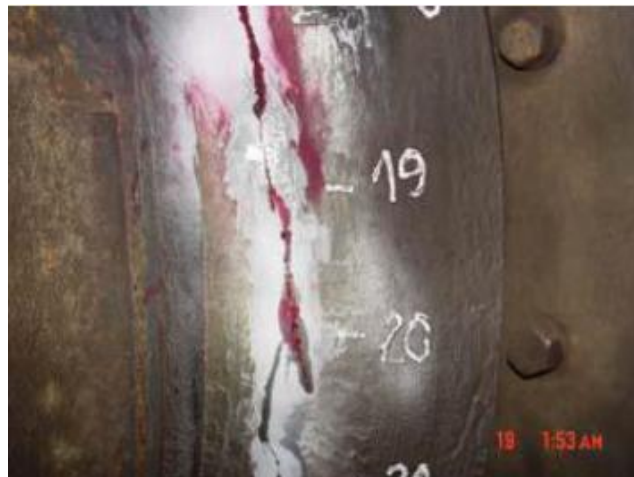
Figure 4. Macroscopic appearance of the breaking surface

- macroscopically, the breakage surface of the piece has two areas, one with a relatively smooth (even polished) appearance of slow crack propagation, and the second with the appearance of fracture breaks (grungy surface), as seen in Figure 4;

- the smooth zone exhibits some bumps that progressively increase with the removal from the crack initiation site (the best-polished area is in the immediate vicinity of the initiation point), as seen in Figure 4;

Analyzing the image in Figure 4 we can see the following:

- Cracks were generated and developed in different plans;
- The propagation path took place differently, perhaps due to the encounter of hard grains / harsh intergranular connections caused by the presence of manganese as the main chemical alloying element and that caused it to change;

- The shape of cracks is clearly a specific fatigue requirement;
- The darker color of the solution used to identify and assess damage indicates that the crack depth is significant, which in practice has forced the shaft out of service and repair the defect;
