INFLUENCE OF MOISTURE VARIATION ON THE BEHAVIOR OF INTERMEDIATE LAYERS OF SAND AND MEASURES TO PROTECT EXISTING BUILDINGS SITES

The article presents aspects of behavior damp sand layers (with high humidity) disposed as intermediate layers to clays and thus the effects on buildings. The case study presented is the ensemble of Rătești Monastery located in Buzău county, Berca - a monument of national interest class. The analysis made by the authors took place between May 2014 - September 2014, during which there were telluric movements triggered from 14 to 15 May 2014 and continued in June and July, moves that have caused damage affecting the building technical state.

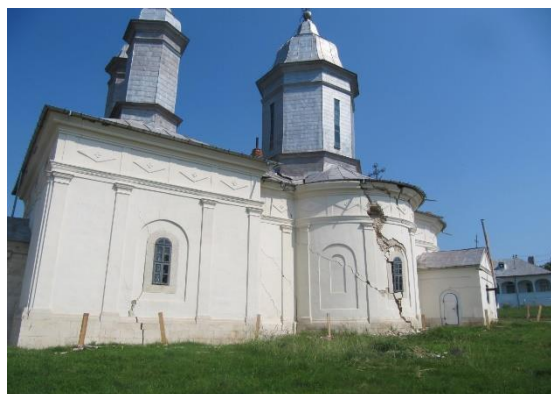
- cracks deployments - breaks in the masonry structure in the pronaos - these cracks have affected existing brick pilasters (figure 1);

If at an earlier date of the events, respectively in 2010, the foundation stiffness was partially altered by land humidity and its potential landslide, effects that have been made visible by studying vertical and inclined cracks propagated in its elevation, later on the foundation presented oscillations of level about 78-80 cm that generated separation fractures and dislocations.

Figure 1 - Failure of church structure by land scouring under the foundation.

The pilots execution will be done after supporting the church walls and masonry unbinding in the areas that lost their stability [5, p.23]. Equipment

vibrations near the church could generate new degradations even colaps. Pilots execution will be topometric monitored.

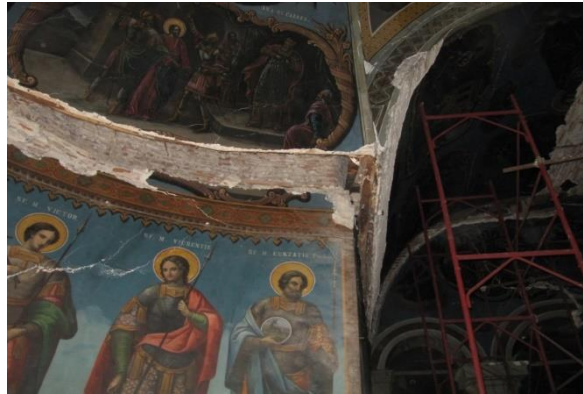
- local detachment of paintings, plasters and displacements of structural elements on respective areas (figure 2).

Figure 2 - Church interior image as a result of inspections dated 08/08/2014

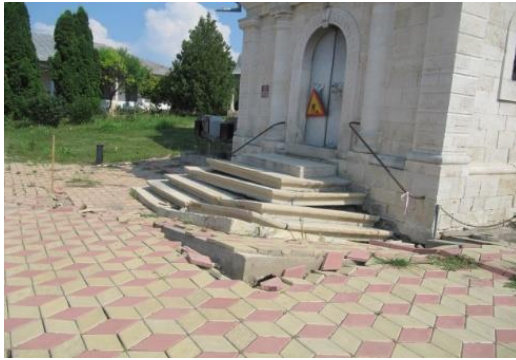
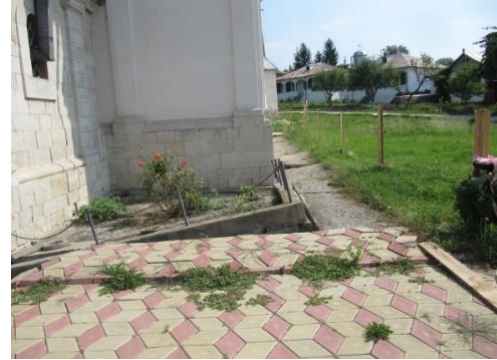
- develop cracks with vertical displacements in longitudinal walls, sloping cracks that emphasizes both land subsidence towards the church porch and the torsional effect (figure 3);

- detachment of pavement protection by cracking (figure 3);

Analysis of the land and buildings located near the site [7, p.7], highlights potential effects of landslides caused by heavy-duty drainage of rainwater [8, p.960, p.1215]. For the church resistance structure this is an aspect that was observed in the previous period (before the rain, since 2010) by separation of concrete pavement protection and the propagation of a cracking state specific to these deformations (figure 3).

Figure 3 - Highlights the vertical structure disposal/ failure at the porch entrance. The photo is made on 08.08.2014 when was recorded the maximum level of compaction

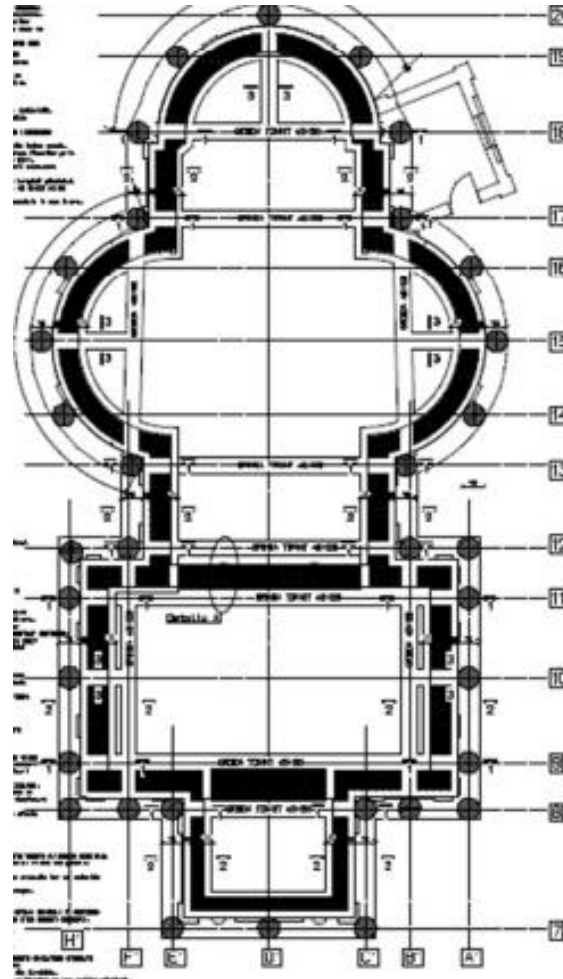
Figure 4 - Plan of pilots disposition for church consolidation

As a ulterior solution [6, p.60] it was proposed to create a piles curtain [10, p.350; 4, p.5, 10] according to (figure 4) to give diagrams according to (figure 5).

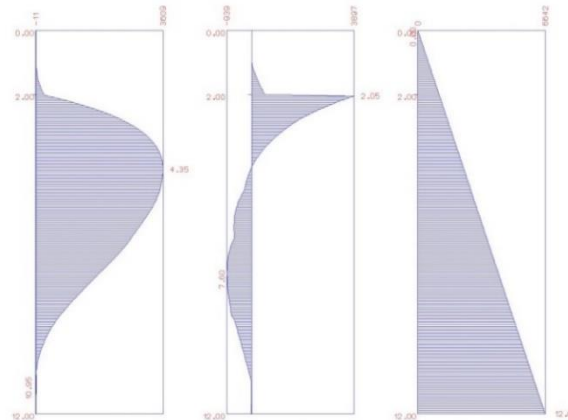
Figure 5 - Diagrams efforts for pilots dimension
