Avaria by the bottom of a bolt on a diesel of engine

Abstract. A drive from a diesel engine of a truck was broken into four parts during normal use. Damaged bolt caused longitudinal and transverse cracks. They started from the surface of the hole and stretched outward. The appearance of marginal signs and striations on the surfaces of all regions of origin of the crack indicate that fatigue breakage is the dominant damaging mechanism of the bolt. The surface of the hole and the outer surface are indicated to be cemented. Microstructure and microstructure profiles at the bolt surface and in the regions of the hole surface were examined to determine the thickness of the cementitious layer. However, not only there was no cementitious layer found on the surface of the hole, but also a serious decarburization occurred in the area. The appearance of decaying the surface of the hole greatly decreases the fatigue strength of this area, so the crack has started from the surface of the hole and stretched to the outer circle, eventually opening the tear. Inappropriate cementing technology is responsible for decarburation of the surface of the hole.

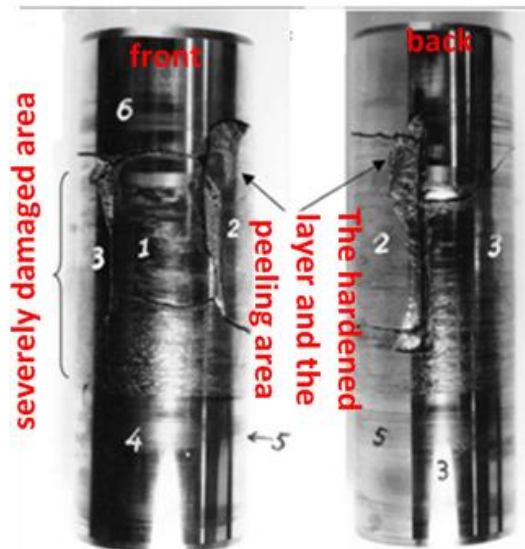
Figure 1. Recovering the broken bolt from fragments

The fragments were put together for the restoration of the destroyed bolt as seen in Figure 1. The bolt fractured into four fragments labeled 1, 2, 3 and 6 in Figure 2. To observe the bursting surface, the fragment 3 was carefully opened along the initial direction of crack propagation and separated into three labeled parts 3, 4 and 5, seen in Figures 1 and 2. Matching fragments is shown in Figure 3.

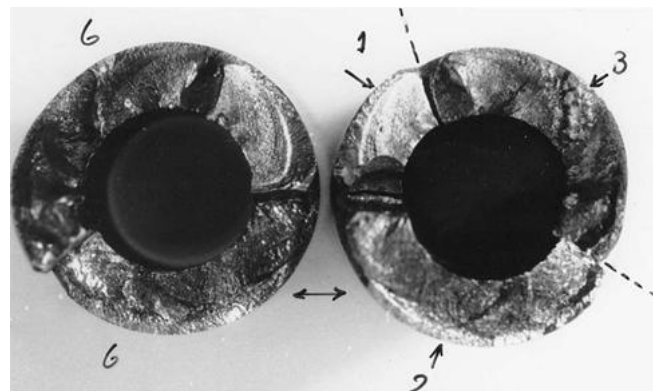
Figure 3. Surface breakage study (crack propagation areas)

All the cracks were initiated inside the hole and propagated outwardly to the bolt. Depending on the degree of wear of the deformation surfaces in different regions, it was established that the initiation

and propagation sequence of the 11 origins of the crack is as follows: D, C, G → I, K → A, B, H → E, F, J.

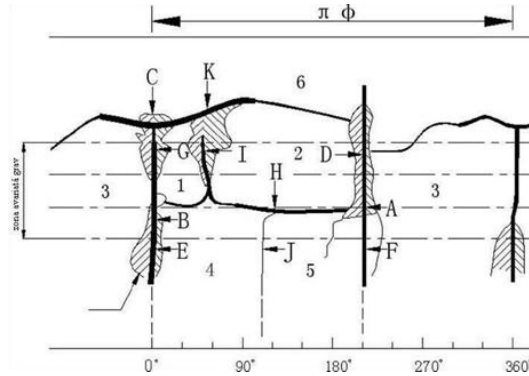
Figure 4. Plain scheme of crack extension

Observations indicate that the origins of the 11 cracks are located in the outer surface area which has been severely worn out and most of the outer cement layer has been exfoliated in some regions of origin of the fissured fissures in Figure 1 and the areas soaked in the figure 4.

Visual observations on the outer surface indicate that regions with a marked wear of approx. 23 mm, occur at both ends of the bolt and result from the wear produced at the contact between the bolt and the piston shoulders. At the center of the bolt there is a large worn wear area of about 36 mm in width, produced at the contact between the bolt and the bead.

According to the morphology of wear on the outer surface of the bolt, it can be deduced that the contact load between the bolt and the bolt is higher, but the condition of lubrication is defective in this area.

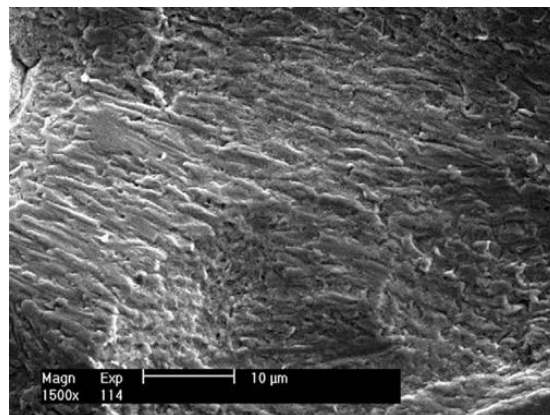
The morphology of the breaking surfaces in the origin regions of the crack was clearly observed with the SEM. The areas with typical fissure crack propagation striations appear at the origin of cracks C, H, K as seen in Figure 5. This suggests that the three cracks with origins in these areas have propagated in the radial direction through fatigue. The fracture areas of the longitudinal crack (G, I, D) have been seriously worn, so that beach marks or fatigue strings can not be clearly seen.

Figure 5. The SEM image of the rupture surface shows fatigue streaks (origin of crack C)

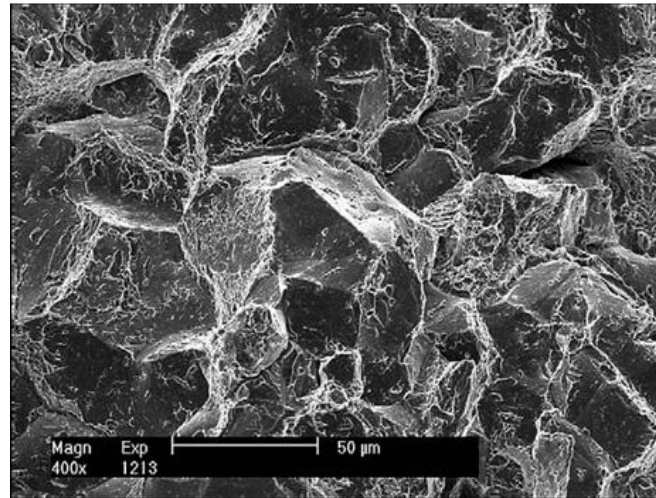
A morphology of intergranular cracking was found on the surface of the outer region as seen in Figure 6.

Figure 6 SEM image on breakage surface shows intergranular character

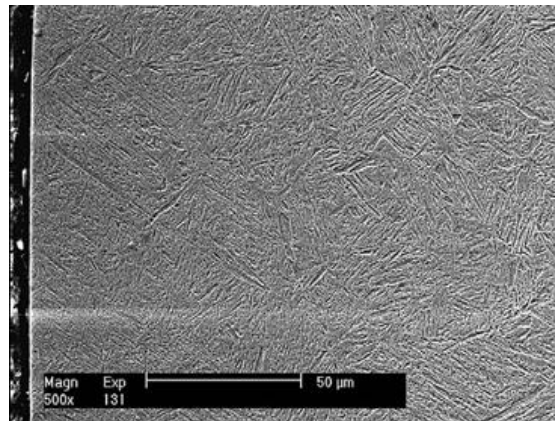
Transverse microstructures from different areas were observed with SEM. The results show that the microstructure of the hardened trough in the outer region is composed of tiled martensite quality. Fine needle martensite is typical of a high carbon level as shown in Figure 7. This suggests a low carbon content in the cementitious layer, which corresponds to the hardness of the.

Figure 7. The microstructure of the cemented layer from the outside of the bolt (cylindrical surface)

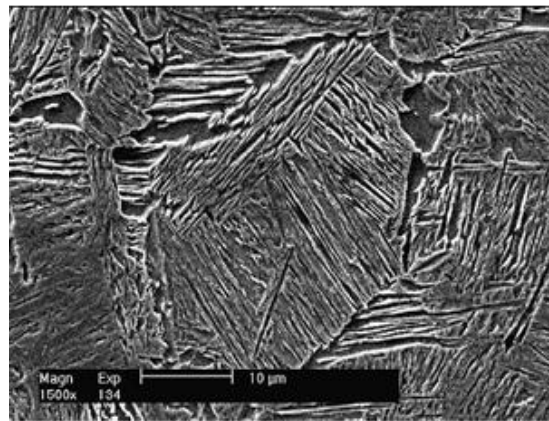
The base region is composed of martensite in the form of tiles, bainite, and a small amount of intergranular ferrite as seen in Figure 8. The microstructure in the region of the hole surface is shown in Figure 9. It can be seen that there is a completely decolorized layer, about 0.02 mm, composed of ferrite and beneath it was a half-decoloured layer of about 0.50 mm, composed of intergranular ferrite and bainite. It is also noticed that the layers from the outer surface as well as from the inside of the bolt have been decarburized.

Figure 8. Microstructure of the core region

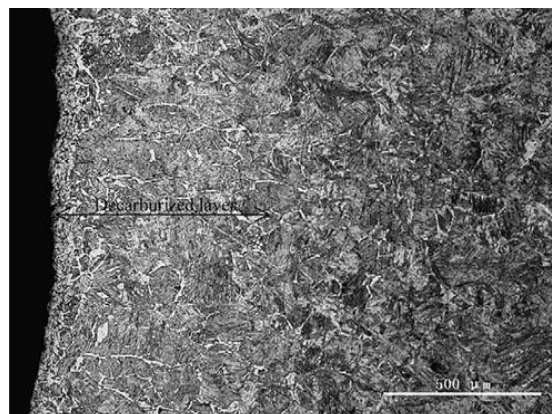
Figure 9. The microstructure of the hole surface area, with the emphasis on the decarburized layer

- A suitable cementitious technology must be provided to prevent decarburization and to obtain the appropriate depth of the cementitious layer so as to increase fatigue strength in the internal surface area of .

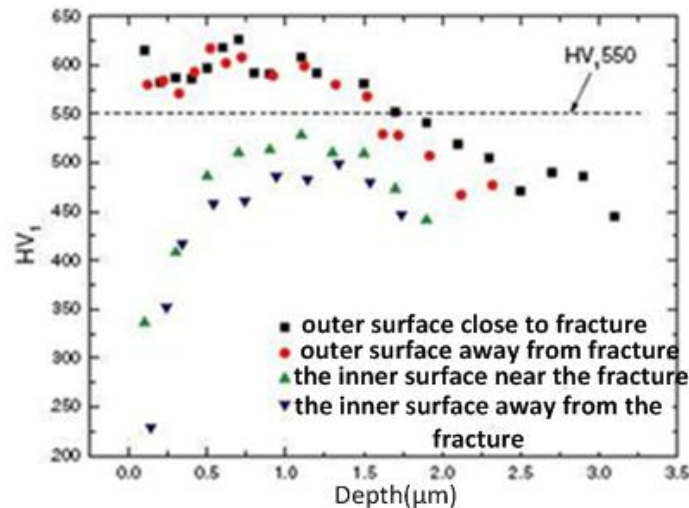
Figure 10. The profile of microdurality in different areas

In order to determine the depth of the hardened layer in the internal hole regions and the outer circle of the destroyed bolt, the hardness profiles at various surface-to-interior locations were performed (locations near and far from the fracture were selected), as observed in Figure 10. The results show that the depth of the hardened layer in the outer circle region is 0.5-0.8 mm, being higher than the specified upper limit (0.8 - 1.2 mm), despite the hardness of the lower layer.

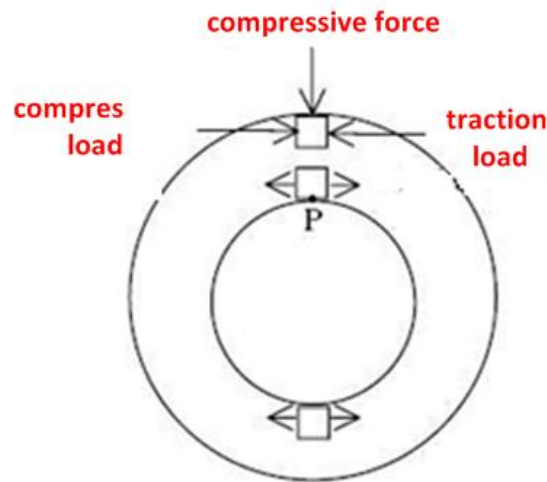
The bolt tension scheme, when the external surface of the bolt presses a compressive force, is shown in Figure 11. In the Diesel engine operating state, there are compressive stresses under the outer surface of the bolt. The compressive force reaches the maximum when self-ignition occurs. At the same time, under the surface of the hole there are maximum tensions as shown in Figure 11, point.

When the piston moves in the reverse direction, the voltage in P decreases. In conclusion, in the area around P, under the surface of the hole there are variable loads throughout the engine running. The presence of the deformed layer in the area of the hole surface makes the fatigue strength to decrease intensively, so the fatigue cracks can easily be initiated here.

The contact between the leg leg and the bolt may be considered to be approximately linear. Cracks have been initiated at different positions with the same axial orientation on the surface of the hole (G, B, E and D, A, F). These cracks could easily propagate under traction actions and thus converge into longitudinal cracks.

Figure 11. Tensions that occur when the bolt is pressed
