Analysis and management of a variation to a fluvial transport vessel caused by collision

Abstract. In general, the body of the ship is a welded metal structure made up of the shell and bone. The paper aims to analyze and present the solution for the collision damage to a river transport vessel. The problem is treated as in the case of a typical failure of welded constructions. In this regard, the fault will be described, after which the stages of the fault remedy will be presented.

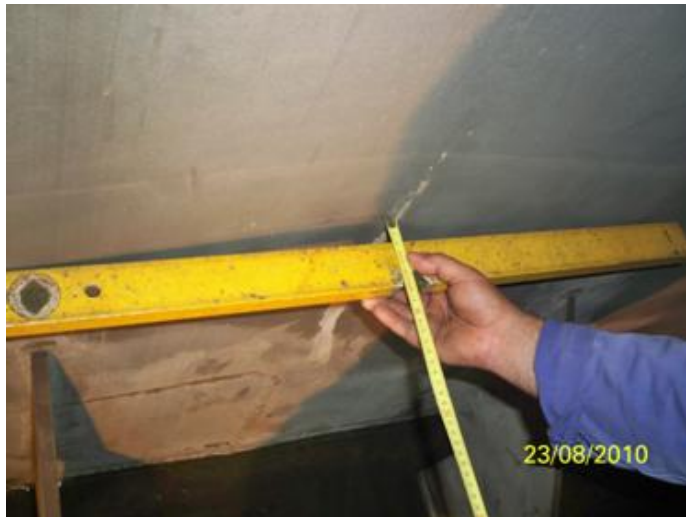
The damage consists of the visible plastic deformations with the naked eye of both the sheathing, the shell and the blade in the area of the shell and the bottom of the ship, as shown in Figure 2 and Figure 3. As a result of the research, it has been found that the two categories of deformations, both of the sheathing and of the ship's blade, in that area, lead to the weakening of the ship's longitudinal resistance, which can have disastrous effects in the future operation of the ship.

The weakening of the longitudinal resistance, by deformation of the blade, affects the body of the ship, considered a beam on the elastic medium (water). This weakening of the longitudinal resistance can cause the body to break in two loading and transport conditions.

Also, due to the researches carried out, there was also a loss of local resistance, by damaging the welding seams between the sheets of the shell, which leads to the non-sealing of the body's ship, without ensuring the conditions of immovability.

Figure 2. Movement of the bed sheets by 30mm over a length of 1m

- Cutting and removing the sides of the panel over a length of approx. 2m means four intercostal distances. The board is replaced with a thickness of 8 mm and is 1.5 m high.

- Taking and removing the gourmet plates over a length of approx. 2m, means 4 intercostal distance. The table of the gourd, replaced, is thick. 12 mm and has a width of 1m.

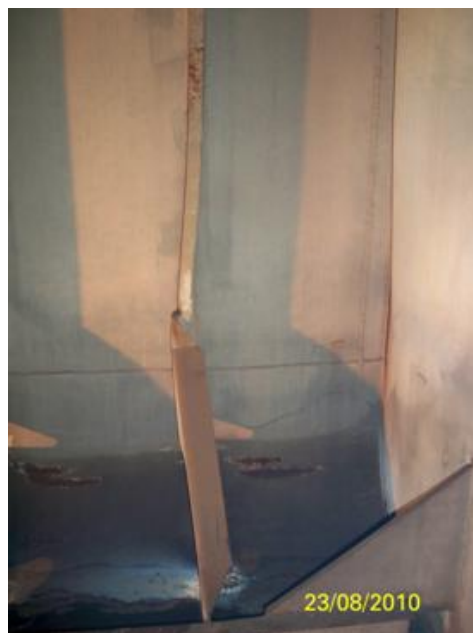
The deformation of the blade in the area of the shell and the bottom of the vessel can be seen in Figure 3.

Figure 3. Deformation of the blade in the shell and bottom of the ship

- Transition and removal of the transverse blade in the area of the shell, on 4 ribs. The blade in the area is made up of the HP 120x8 profile. Replace the profile at a height of 1.75m.

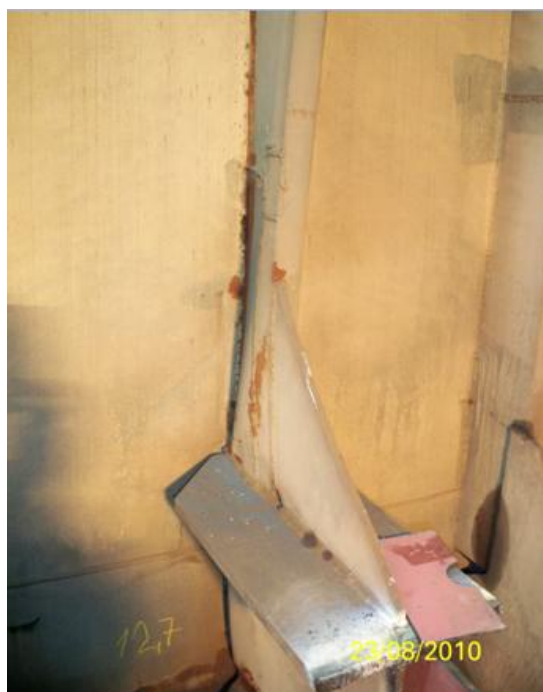
Figure 4. Cutting and removing the portions damaged in a varanga - heart and payment

- Ting and removing a portion of the reinforced blade from the bottom and the gourd: for four varges the heart is cut, the thick sheet. 8, on an area. of 1250 x 600 mm and cut out the 120x10 payload on a 1400 mm vario length, as shown in Figure 4.

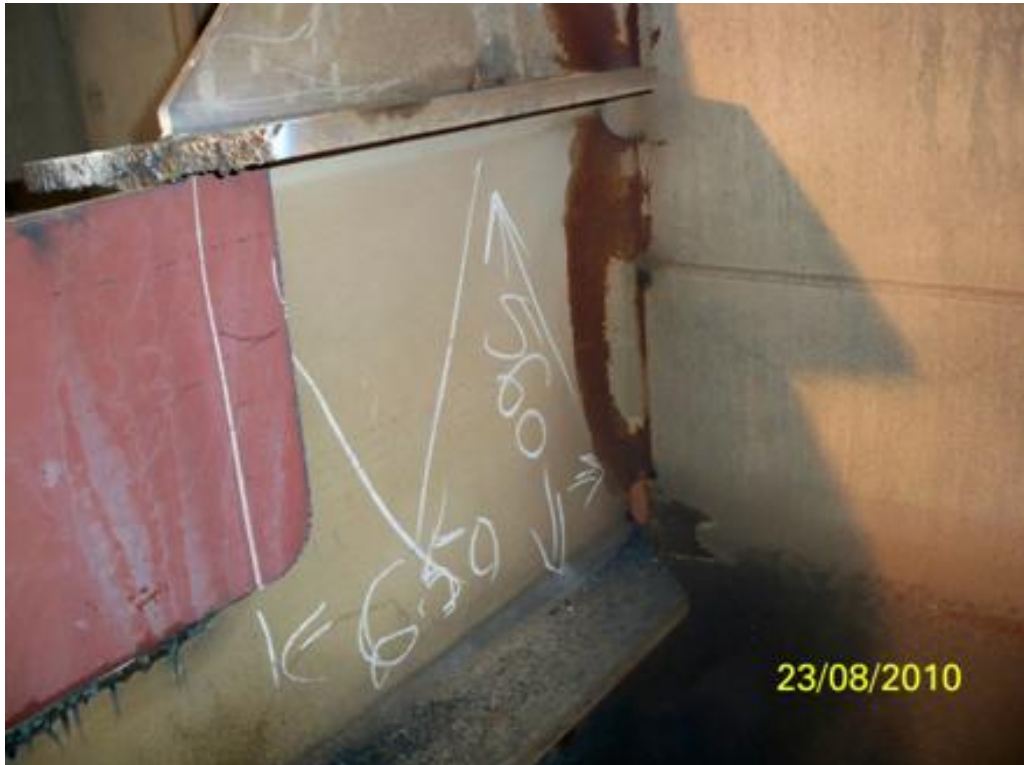
Figure 6 shows an insertion of blackboard in the heart.

Figure 6. Sheet insertion in the heart - the heart plate
