SECTION 8. Architecture and construction.

PECULIARITIES OF THE CORROSIVE STATE OF THE IRON COLUMN IRON PILLAR IN DELHI, INDIA

***Abstract:** The paper considers the iron column Iron pillar located in the archaeological complex Qutub in Delhi city (India), which has not corroded for 16 centuries. The mechanism of atmospheric corrosion in this column has been reviewed. The hypothesis about the nonappearance of corrosion processes on the surface of the column for a long period of time has been suggested.*

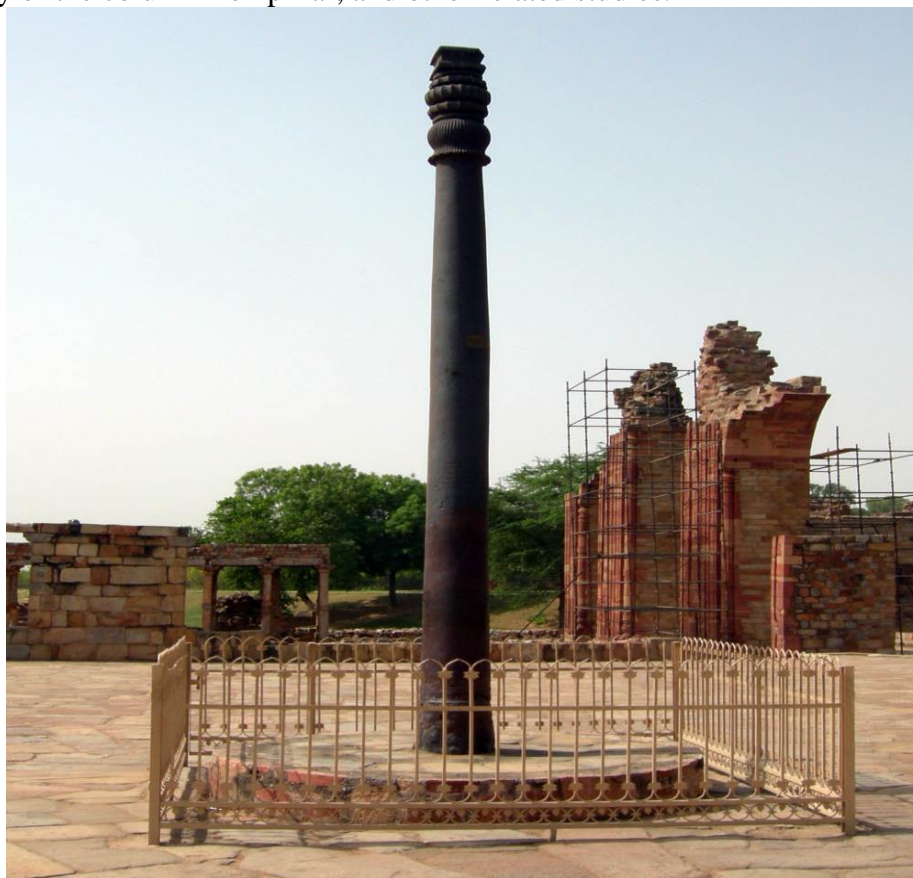
In this regard, the iron column Iron pillar (Fig. 1) in the archeological complex Qutub in Delhi city (India) is of great interest, which hasn't corroded for more than 16 centuries. Many scientists all over the world have studied this column, but haven't guessed the riddle – why hasn't this column corroded for so long? We have also visually studied this column, and made a conclusion on the corrosion mechanism of this construction. First, we will give some information about the history of the column Iron pillar, and other related studies.

Fig.1 - The iron column Iron pillar in Delhi city

The column was set in the 5th century at about 20 km away from the modern Delhi. It resembles a truncated cone. The column weighs about 6 tons [4].

One can not see the familiar traces of rust on the surface of the column. The first one and a half meter of the column has been polished with the hands of numerous pilgrims. Further the column is black, and the top of the column is bluish or even brown due to the oxide layer. Several hypotheses explain that the corrosion-resistance of the overground part of the column is due to the dry ambient air in Delhi [11]. The Swedish metallographer Y. Wranglen conducted experiments, in which cut pieces of the column were taken to the seashore and the industrial district of Sweden (marine and industrial media are the most dangerous for steel), where the pieces completely corroded. The underground part of the column, which has also been studied by Y. Wranglen, is covered with 1 cm thick rust. There are also 10 cm thick corrosion pits.

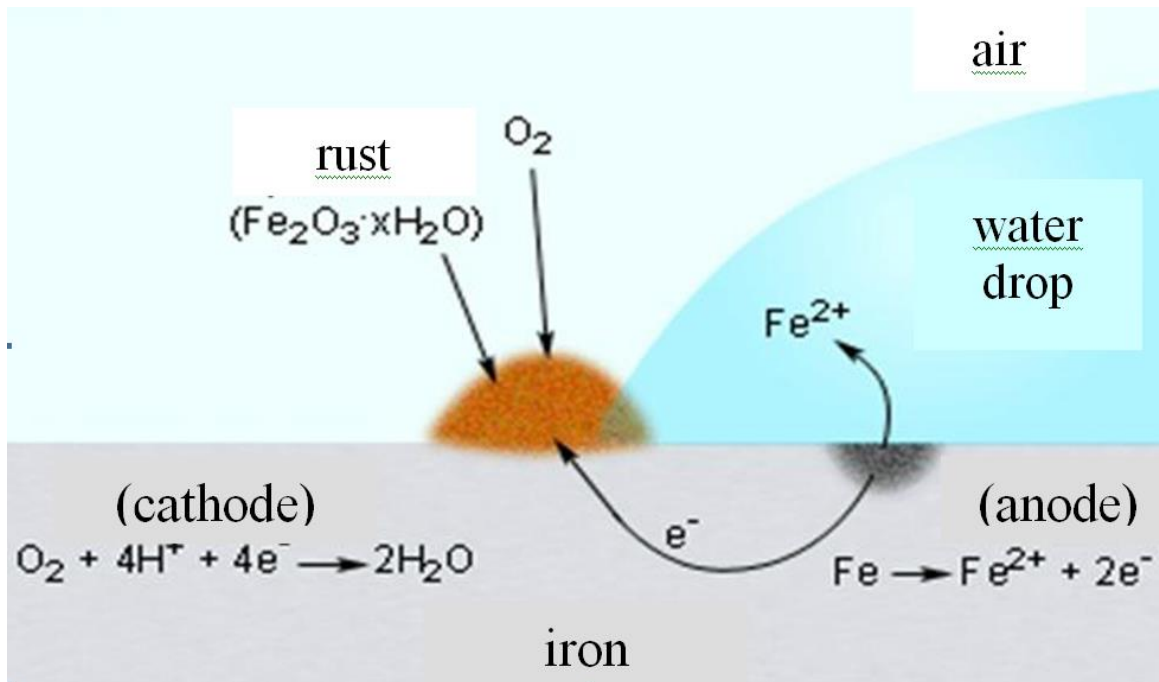
The process of atmospheric corrosion takes place and propagates only in case on the surface of the metal there is a water film of certain thickness, which takes on the properties of an electrolyte (Fig. 2) [20]. The duration of the propagation of the corrosive process and the quality of metal, which has turned into corrosive products, depend on the length of the presence of the electrolyte film on the surface of the metal. The longer the film on the surface dries up, or the more often it renovates, the longer the corrosive process is, therefore, the more corroded the metal

Fig. 2 - The mechanism of electrochemical corrosion

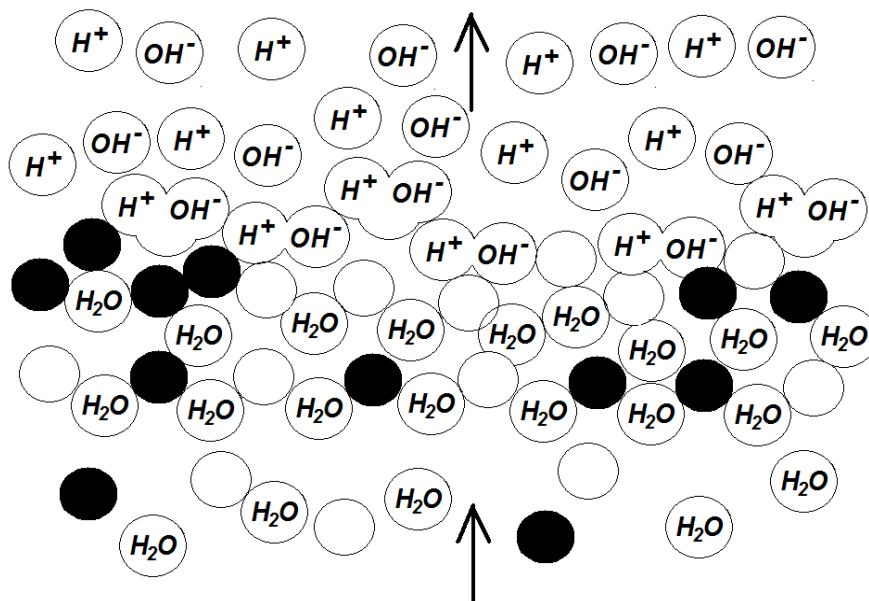
We suppose that while the molecule of the water vapour is moving up the place of evaporation, it is exposed to dissociation and is divided into ions H^+ and OH^- (Fig. 3) due to friction and blow onto the atmospheric gas mixtures, in which the liquid and solid materials are in a suspended state. Further, most ions join the water film on the elements of steel constructions, which cover the disrupted areas of their domain pattern by means of the mechanism presented by us [21, 22].

Fig. 3 - Dissociation of the molecules of the water vapour due to friction and blow onto the atmospheric gas mixtures
