Elena Ongaretto <sup>1</sup>  
Luca Pozza  
Marco Savoia

## WOOD-BASED SOLUTIONS TO IMPROVE QUALITY AND SAFETY AGAINST SEISMIC EVENTS IN CONSERVATION OF HISTORICAL BUILDINGS

**Abstract:** *Historical buildings can be highly vulnerable to earthquakes if in-plane strength and stiffness of floors and roofs are not sufficient to limit out-of-plane deformation of walls and to transmit the seismic forces among walls efficiently. In fact, floors and roofs in existing masonry buildings are normally realized with timber beams, purlins and a single layer of timber boards, and their in-plane stiffness can be limited when subjected to shear forces. Various retrofitting techniques are available, whose effectiveness can be very different and not easily predictable theoretically. In this paper, the behavior of different strengthening criteria for historical buildings, involving the use of wood and wood based products, is illustrated and critically discussed. Code provisions, design rules and calculation methods for strengthening interventions are described. In-plane behavior of floor and roof structures and their interaction and connection to the seismic resistant wall systems are considered. F

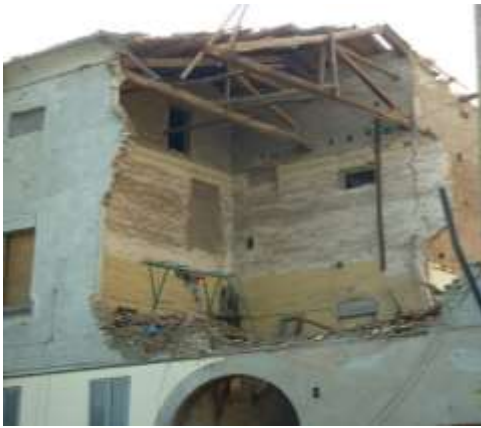
**Figure 1.** 2012 Emilia earthquake - Collapse of external slender walls due to the absence of the intermediate floor and insufficient stiffness at the roof level.

out its importance on the seismic overall resistance of the structure. Stiffness of wooden floors and roofs is fundamental to prevent excessive deformation in the floor plane and an insufficient transmission force mechanism. As an example, the wall collapse shown in Figure 1 is due to the insufficient stiffness at the roof level and the lack of the intermediate floor, necessary to prevent the out-of-plane collapse of the slender wall.

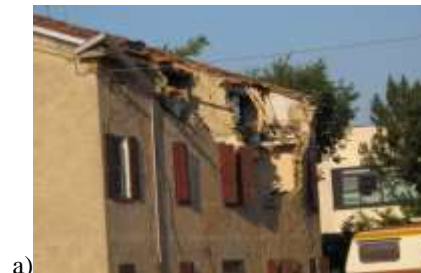
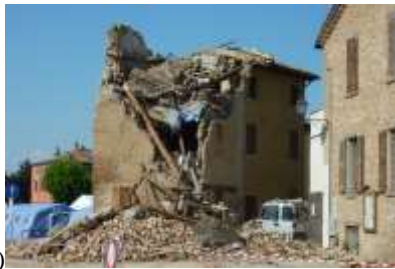
b) **Figure 2.** 2012 Emilia earthquake - a) collapse due to the absence of connections between floor/roof diaphragms and masonry walls; b) collapse due to the absence of efficient floor and roof diaphragms

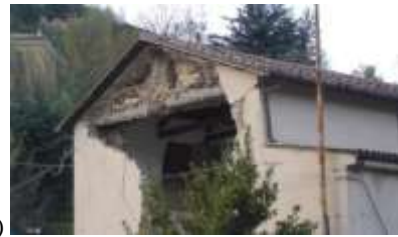
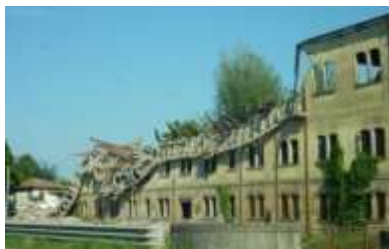
b) **Figure 4.** Collapses due to wrong interventions, with realization of heavy and rigid concrete curbs not efficiently connected with the roof structure or the masonry walls: a) 2012 Emilia earthquake; b) 2009 Aquila earthquake

Typically, inappropriate interventions involve the refurbishment of the roof structure without realizing efficient curbs suitable to confer a box-like behavior to the building (Figure 3). On the other hand, realization of rigid and heavy concrete curbs, not efficiently connected to the roof structure or the masonry walls, are inappropriate: it may increase the roof weight (and then the seismic action) without avoiding the out-of-plane failure of the walls (Figure 4).

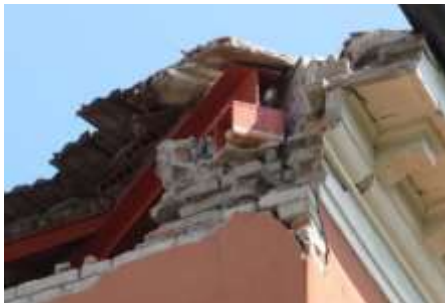
**Figure 3.** 2012 Emilia earthquake - Collapse due to a wrong intervention, without the realization of an upper curb on the masonry wall to distribute the horizontal forces transmitted by the new steel beams

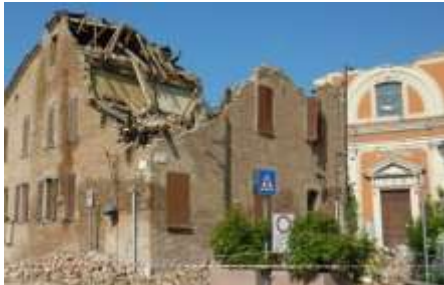
**Figure 5.** 2012 Emilia earthquake - collapse due to unbalanced horizontal thrusts of roof structures

In addition, at the roof level, the rafters may cause the presence of a horizontal thrust on the walls, even in the presence of vertical loads only. The effect becomes of course even worse and particularly critical in the presence of horizontal seismic loads and may cause very dramatic collapses (Figure 5). In fact, in the past timber roof structures were typically built to bear vertical loads only and without a formal design, with no provisions for responding to seismic actions.

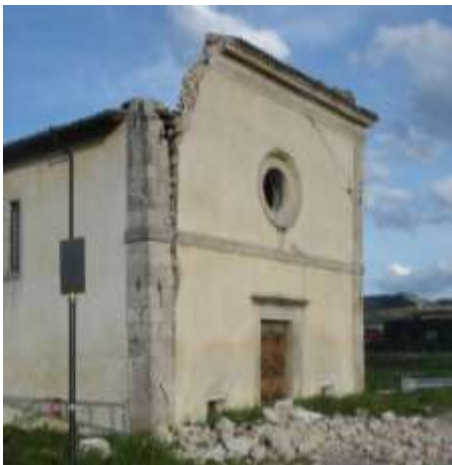
**Figure 6.** 2009 L'Aquila earthquake - wall detachment due to the absence of a roof structure capable of ensuring a box-like behavior of the church

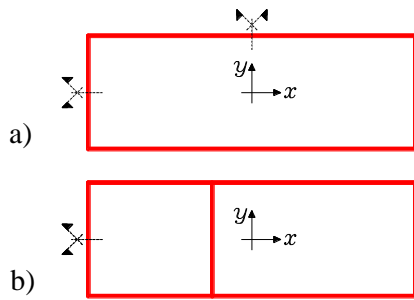
**Figure 7.** Examples of (a) isostatic and (b) hyperstatic WRS configurations in a masonry building

Two different WRS configurations can be typically identified: isostatic or hyperstatic scheme (Giuriani and Marini, 2008), see for instance Figure 7. The double symmetric floor diaphragm in Figure 7a can be schematized as an isostatic beam with lateral supports in both x- and y-direction. On the contrary, the floor diaphragm in Figure 7b requires a hyperstatic schematization in y-direction, due to the presence of three resisting walls supporting the floor diaphragm when subject to horizontal forces.

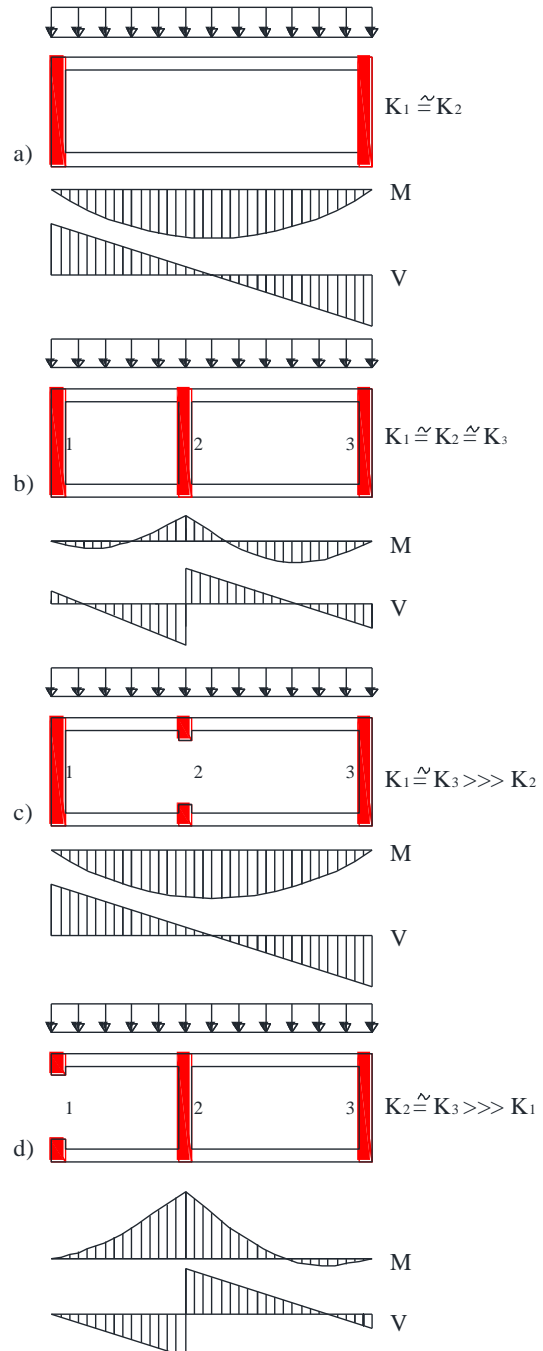
**Figure 8.** Examples of in-plane bending and shear diagrams for the floor diaphragm: (a) isostatic and (b-d) hyperstatic WRS configurations

If the walls are characterized by similar lateral stiffnesses, the horizontal floor beam is statically redundant, and the bending and shear distributions depend on the lateral wall stiffness as well as on the in-plane flexural and shear stiffnesses of the diaphragm (Figure 8b). On the contrary, in the presence of large openings, the wall stiffness is significantly reduced and sometimes can be neglected, giving rise to simpler isostatic schemes (see Figure 8 c, d).

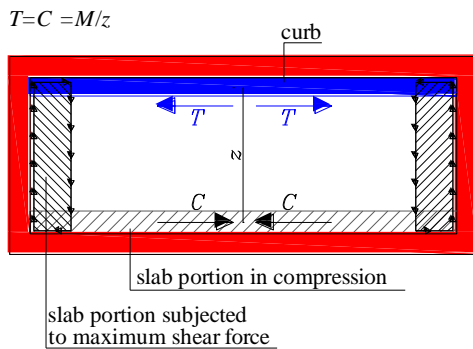
**Figure 9.** In-plane beam-like resisting system of a wood floor diaphragm. Design of floor/WRS connections.

The diaphragm resisting schemes and the consequent internal force distributions are based on the hypothesis of rigid connection between floor and masonry wall resisting system (WRS). Therefore, the design of floor/WRS connections is crucial, and the schemes in Figure 9 can be adopted to calculate the design forces to be sustained by them. Connection elements are finally sized considering an overstrength factor, in order to avoid any possible failure as well as to ensure the deformability of the floor/WRS connections be negligible with respect to that of the floor diaphragm itself (Giuriani and Marini, 2008).

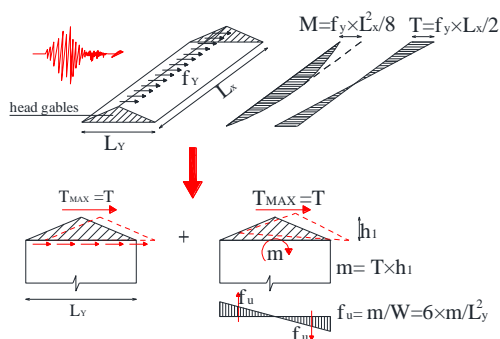
**Figure 10.** Roof subject to earthquake action in the transverse direction: scheme of forces acting on roof pitches and lateral gables.

Consider the transverse direction of the roof in Figure 10, where the pitches are strengthened and the seismic horizontal forces are transferred to the lateral resisting systems, typically two masonry gable walls. As reported in Figure 10, the masonry gables are subjected to both in-plane shear forces and overturning moment. The in-plane shear force induces a sliding effects on the gable with respect to the lower WRS, while the overturning moment may cause a rigid rotation of the gable with a consequent significant reduction of the vertical compression on one side and an increase of it on the opposite side. Such variation of the vertical loads could be dangerous for the structural stability of the upper part of the building under earthquake.

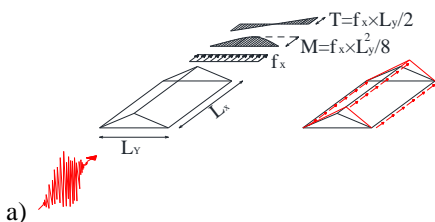
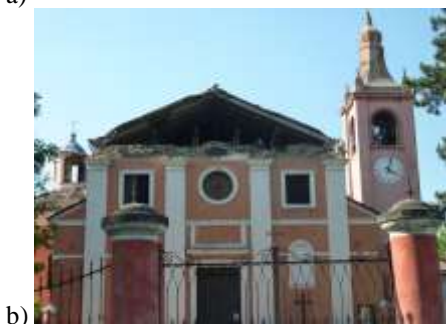
**Figure 11.** Roof subject to earthquake action in the longitudinal direction: a) scheme of roof forces acting on the pitches; b) collapse of the gable of a church

In the longitudinal direction, the roof structure behaves very differently. In this case, the pitches can be schematized as a beam simply-supported at the two extremities (see Figure 11a). Accordingly, the seismic longitudinal forces induce two relevant effects on the roof: a possible sliding of the entire coverage structure with respect to the WRS and a global in-plane deflection of the roof pitches with maximum displacement at the upper vertex of the gable. If the pitches are not sufficiently stiff in their planes, the large displacement of the roof top can cause the overturning of the masonry triangular gable (see Figure 11b).

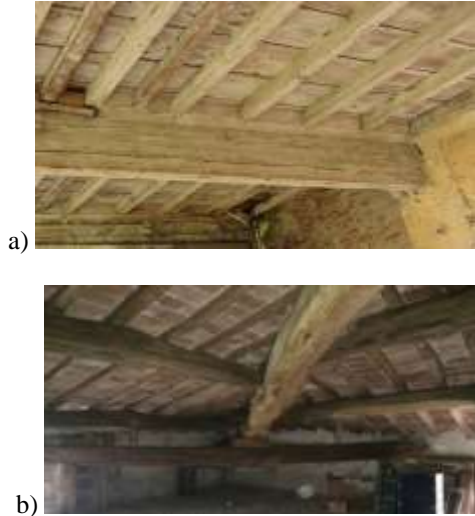
**Figure 12.** Common floor or pitch structural typologies: (a) wood planks nailed to the underlying rafters; (b) a layer of thin solid bricks resting on the rafters.

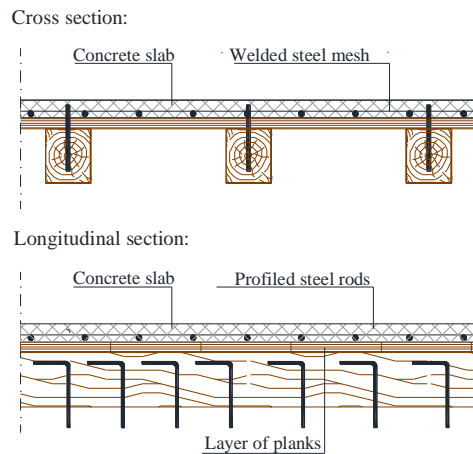
**Figure 13.** Transverse and longitudinal sections of a typical intervention of floor reinforcement with RC slab and steel connectors

This “wet” improving technique is more suitable for floors and not efficient for roof strengthening, due to the significant weight increase. Advantages of this strengthening system are: increase of the load-carrying capacity and stiffness of the floor, better distribution of vertical loads among wooden beams, reduction of deflection and vibration underfoot, increase of sound insulation.

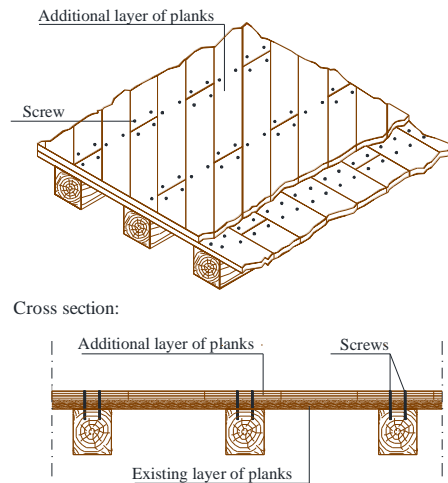
**Figure 14.** Floor reinforcement with additional layers of planks.

With a single layer, some improvement of the out-of-plane features can be attained only if planks are aligned and overlapped to the main beams and rigidly connected with them. In this case a “T” wood-to-wood composite cross-section is obtained, as shown in Figure 14.

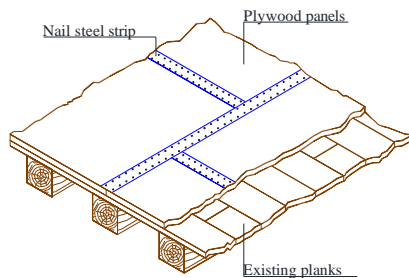
**Figure 15.** Floor reinforcement with multi-layered wood panels.

An improvement of the reinforcement technique with additional wooden planks consists in the use of multi-layered wood panels (i.e. Plywood panels, Oriented Strand Board Panels, etc...) fastened to the existing wooden structures (Giuriani *et al.*, 2005). This solution has some advantages: speed of laying in work, reduced structural weight, both in-plane and out-of-plane improvement and finally adaptability for both floors and roofs. Generally, plywood panels (thickness 15 ÷ 30 mm) are connected to each other by means of nailed steel plates and the whole pitch diaphragm is nailed to the perimeter steel chords and connected to the roof/floor rafters with screws or bolts (Figure 15).

This technique offers both reversibility and limited additional weight and guarantees that the reinforcement does not cause any significant damage to the existing wood structure.

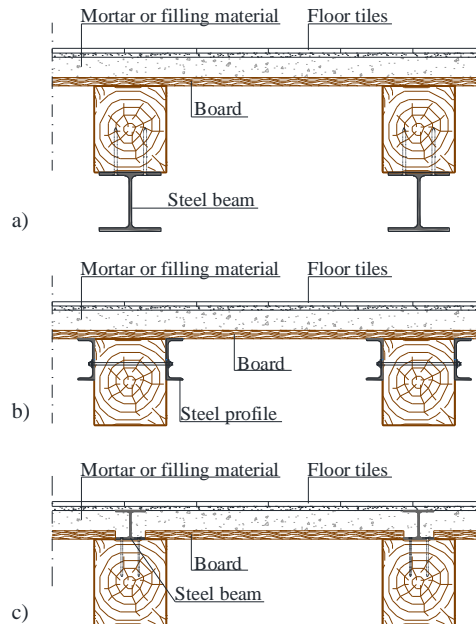
**Figure 16.** Steel profile reinforcements at a, b) intrados or c) extrados of wooden beams

Reinforcement of wooden beams by means of steel profiles (i.e., HE, IPE or UPN profiles) connected at its intrados or extrados (Figure 16) is adopted if the existing main floor elements are no able to carry the operational loads. Adoption of steel element at the intrados (Figure 16a) is the easiest intervention but quite invasive and sometimes unacceptable, especially in the presence of heritage constraints. Sometimes, steel profiles are placed on the sides of wooden beams (Figure 16b), being more acceptable and allowing to avoid clearance reduction of the lower floor. When possible, beam reinforcement at the extrados is preferred (Figure 16c), but requires removal of all or part of the existing superstructure (filling material, mortar under-paving, flooring, etc.). In this case, the steel profile is anchored to the wooden beam by metal connectors, realizing a composite steel-timber cross sections.

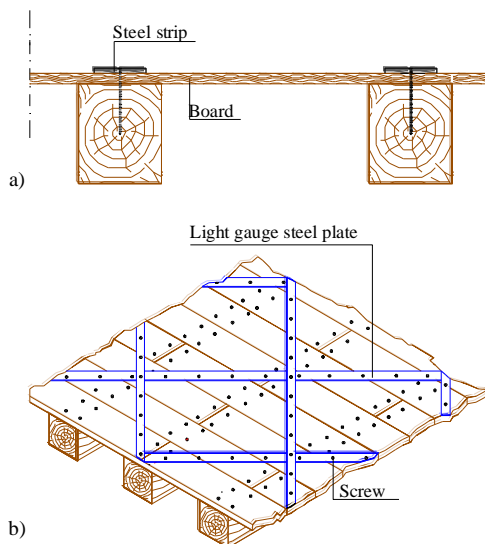
**Figure 17.** Schemes of wood-steel reinforcements suitable for (a) flexural – out-of-plane and (b) seismic – in-plane improvements.

An improvement of this strengthening technique was proposed in Gattesco *et al.* (2006), where the steel beam is replaced by metal steel plates connected to the beams through steel dowels (Figure 17a). In this case, connectors are forced with few hammer blows into bore holes, drilled in the timber member, and welded to the steel profile. The existing boarding partly contrasts the steel plate against buckling.

This technique may be considered “dry” because does not use any gluing material to bond the dowels to wood or any other material to be cast in place. Being simple, cheap, fully reversible and very low invasive, these interventions allow to considerably improve the wooden slabs by minimizing the additional load on the existing structures.

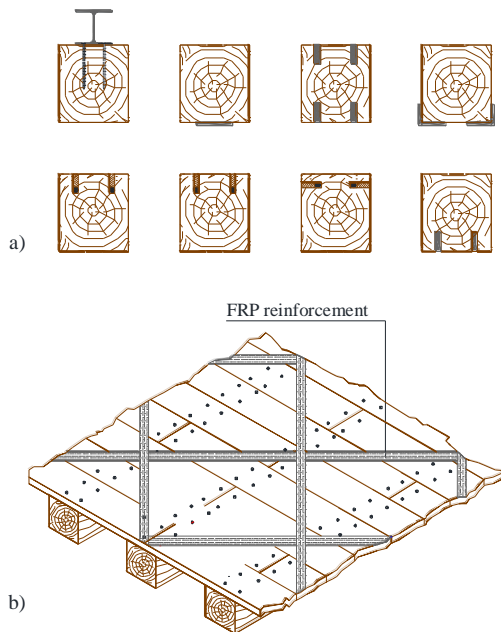
**Figure 18.** Schemes of typical (a) out-of-plane and (b) in-plane floor reinforcement with FRP

forces acting on walls. Of course, fiber sheets will carry the traction forces of the ideal truss system of resisting elements in the floor plane. Compression forces will be adsorbed by the existing wooden layer of planks that, if necessary, can be integrated by an additional layer.

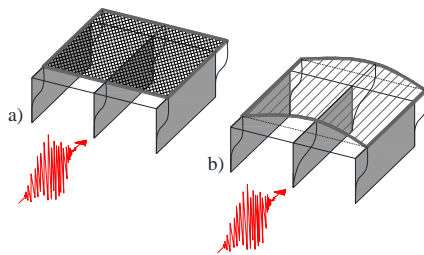
**Figure 19.** (a) Hyperstatic and (b) isostatic force redistribution among WRS, depending on the diaphragm stiffness

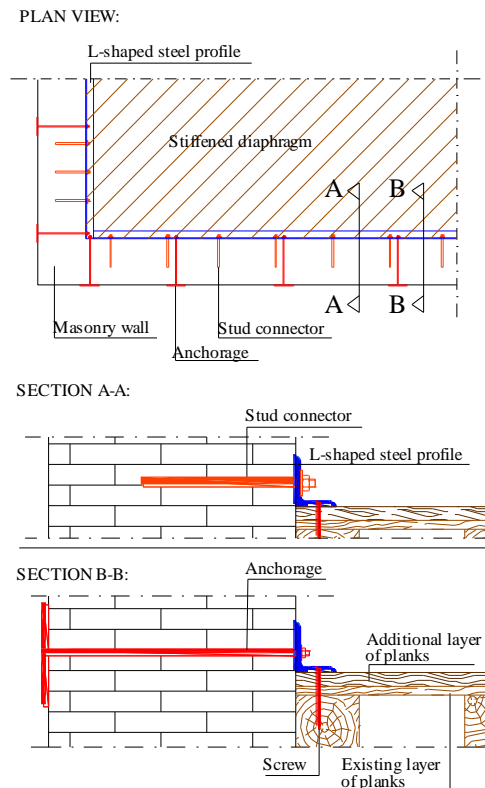
**Figure 20.** Examples of perimetral steel profiles with stud or anchorage connections

In the past, concrete curbs were realized in the wall thickness by partially demolishing the masonry wall, an intervention now considered too invasive and often negative, because a localized weakness in the masonry wall is introduced due to the partial demolition at the floor level. A less invasive but still not suggested intervention consider the realization of dovetail reinforced concrete joints of the floor in the wall thickness.

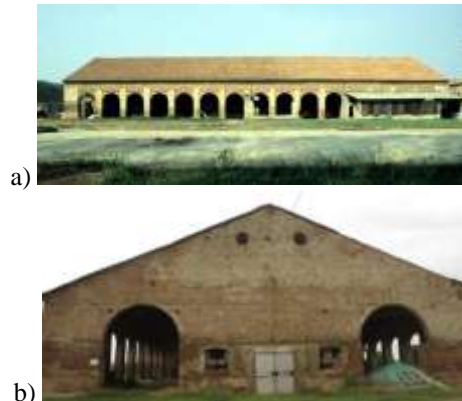
**Figure 21.** Bugno Martino (MN) old barn: (a) north elevation, (b) west elevation

The barn, located in San Benedetto Po (MN), Italy and belonging to the historic court of “Bugno Martino” (Figure 21), was built in XVIII century. It has a rectangular plan with dimensions 25.69× 59.78 m. The bearing structure is constituted of walls and pillars in solid bricks, timber gable roof and masonry strip foundations. Typical wall thickness is 50 cm, and pillar section is 90×60 cm.

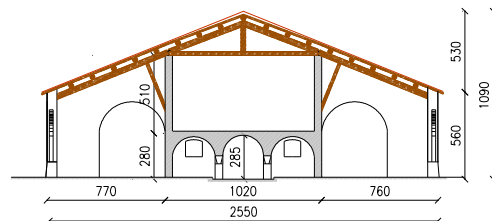
**Figure 22.** Typical cross-section of the barn with indication of the main wooden structure

The building has three longitudinal aisles, with two levels for the central one and one for the lateral aisles (Figure 22). The first floor of the central aisle has 17 masonry vaults supported by two rows of round masonry columns.

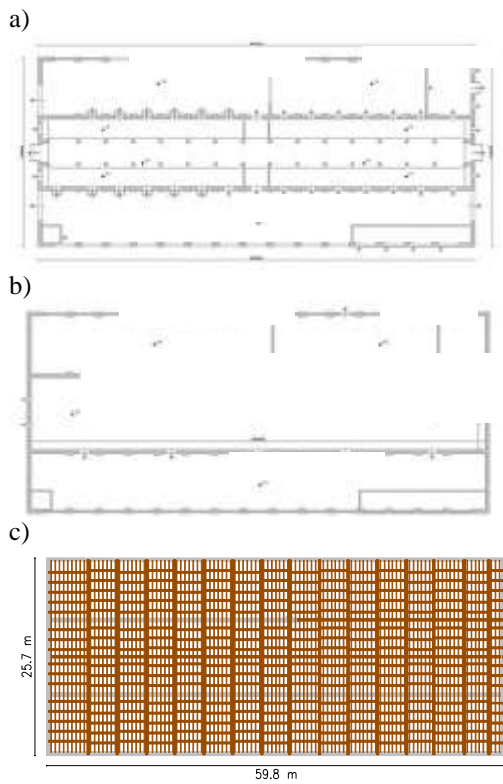
**Figure 23.** a) ground floor plan, b) first floor plan, c) arrangement of timber roof beams and rafters

The roof structure is constituted of simple timber trusses in the central aisle, supporting a secondary framework of round rafters, 24 cm diameter. The secondary framework is a grid of wooden joists supporting roof tiles (Figure 24). The secondary timber framework of lateral aisles is analogous, but the principal structure is constituted of wood poles, 30 cm of diameter, with diagonal struts acting as an intermediate supports (Figure 25a). The wooden roof is very deformable and unable to act as a diaphragm, as required to assure a box-like behavior to the masonry structure (Figure 26).

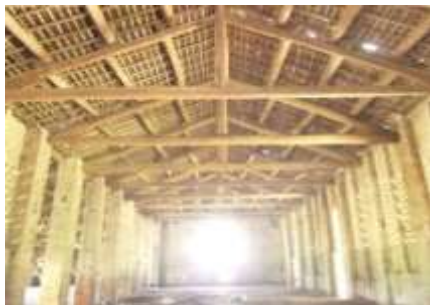
**Figure 24.** First floor of the central aisle

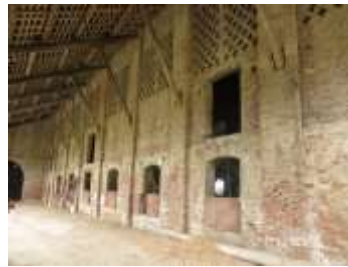
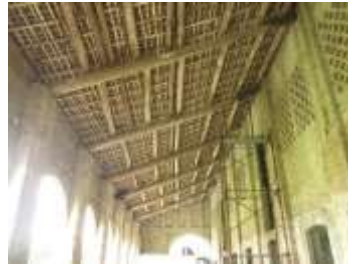
**Figure 25.** Lateral aisles: a) masonry wall, b) the wooden roof structure.

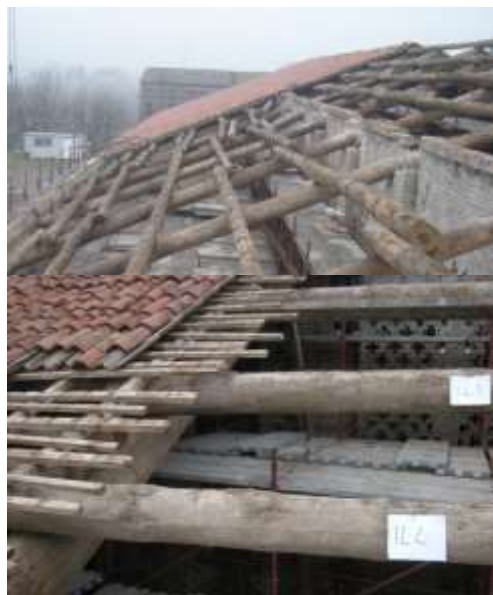
**Figure 26.** Flexible timber roof of the barn.

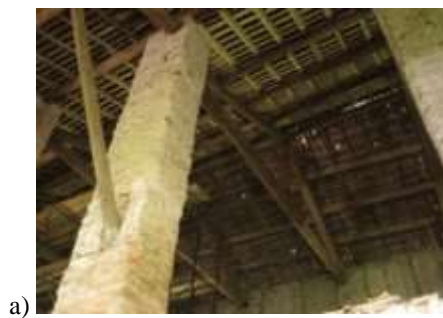
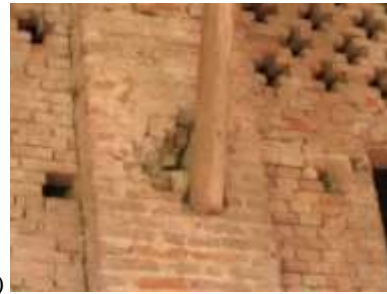
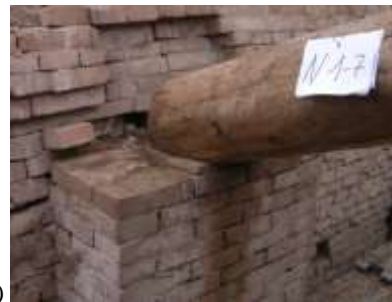
**Figure 27.** a,b) Relative displacements of diagonal struts of the lateral aisles with respect to masonry support; c) overturning of a masonry wall portion.

It was evident that damages were mainly due to the significant slenderness of masonry walls and pillars, as well as to the inefficiency of the wooden roof to prevent relative movements due to its high deformability.

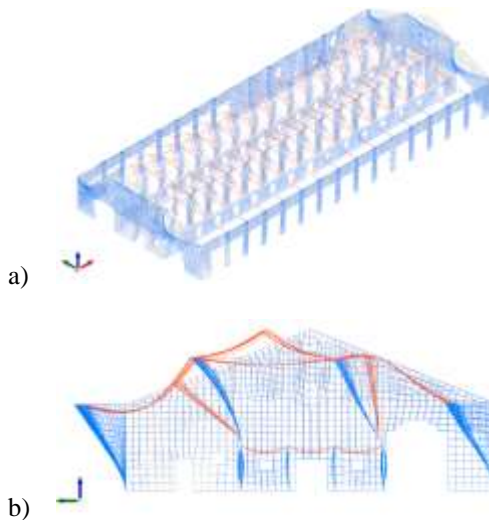
**Figure 28.** FEM modelling of the barn before retrofit - Displacements for earthquake action in the transverse direction: a) global view and b) lateral displacements in a transverse section gable far from the two masonry gable walls.

In order to estimate the seismic vulnerability of the existing building, to calculate seismic actions and to design the retrofit interventions, FEM modelling of the barn structure was performed using Sismicad 12.5 software (see Figure 28). Isotropic shell elements for masonry walls and isotropic beam elements for timber beams were adopted. The pitch rafters-to-wall, as well as the rafters-to-rafter supports along the roof ridge, were modeled as hinges.

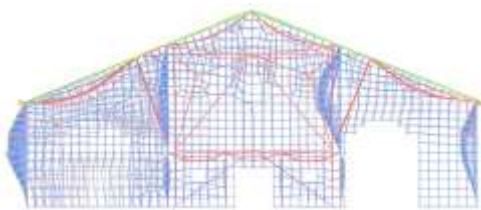
**Figure 29.** FEM modelling of the barn after retrofit - lateral displacements in a transverse section far from the two masonry gable walls.

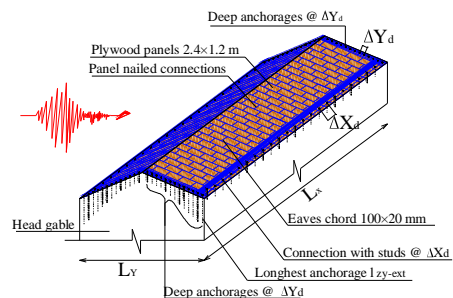
**Figure 30.** Reinforcement of the barn roof with multi-layered wood panels. Ora Lx sono grandi

Wood panels, with 2.4×1.2 m dimensions, are connected to each other through steel plates 2×80 mm connected through steel nails ( $\phi 4 @ 80$  mm). The multi-layered wood panels are connected to the extrados of the roof rafters and beams, by means of 8-10 mm screws at 600 mm spacing, approximately. Moreover, the secondary frameworks were connected to the main beams with the same kind of screws.

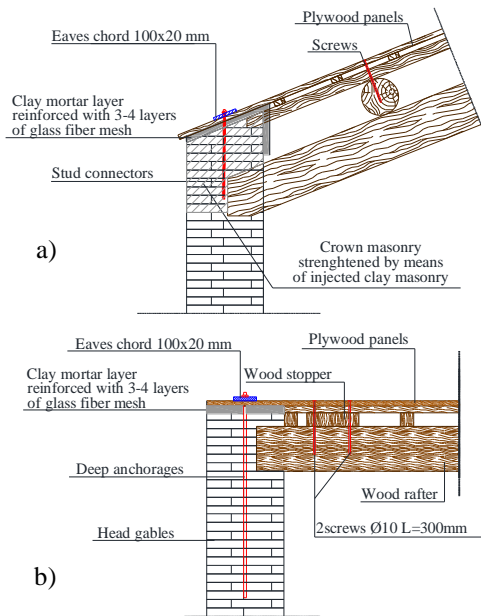
**Figure 31.** Wood diaphragm – masonry connection: a) transverse section on longitudinal masonry wall, b) transverse section on head gables

- 3) Along the wall crown, clay injections are performed for consolidation, and a clay mortar layer, reinforced with 3-4 layers of glass fiber mesh, is realized.

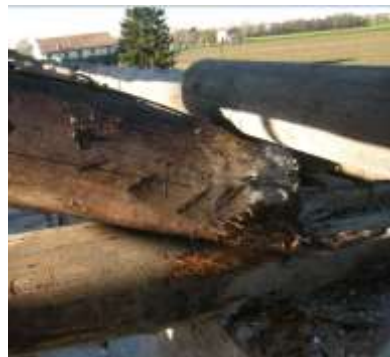
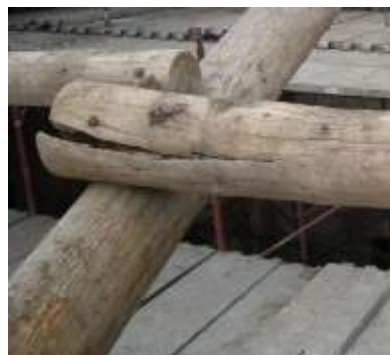
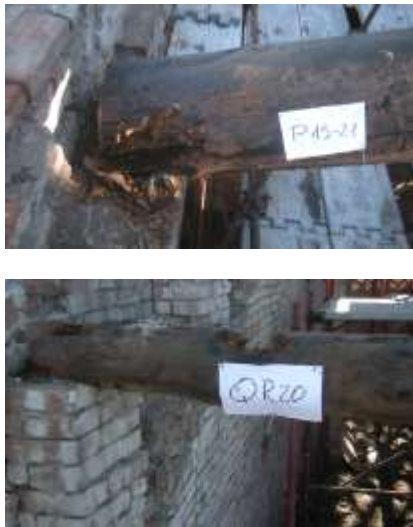
**Figure 32.** Local damages and deterioration on supports of timber elements.

often present at the beam extremities, where the shear force is maximum and the beam, constrained in the masonry wall and suffering limited air circulation, is subject to a moisture contents above 20% and, as a consequence, is vulnerable to biotic attacks. Some damages observed in the case study are reported in Figure 32.

The damaged parts must be eliminated and replaced with new material, which can be wood or other materials such as fiber glass composites, provided the collaboration between the new and the original part of the beam is ensured. Other possible solutions consist in creating a new support for the beams, with the insertion of shelves (wood, stones, iron) under the beams. These types of interventions, very common in the past, are nowadays almost unchanged except for the use of new materials.

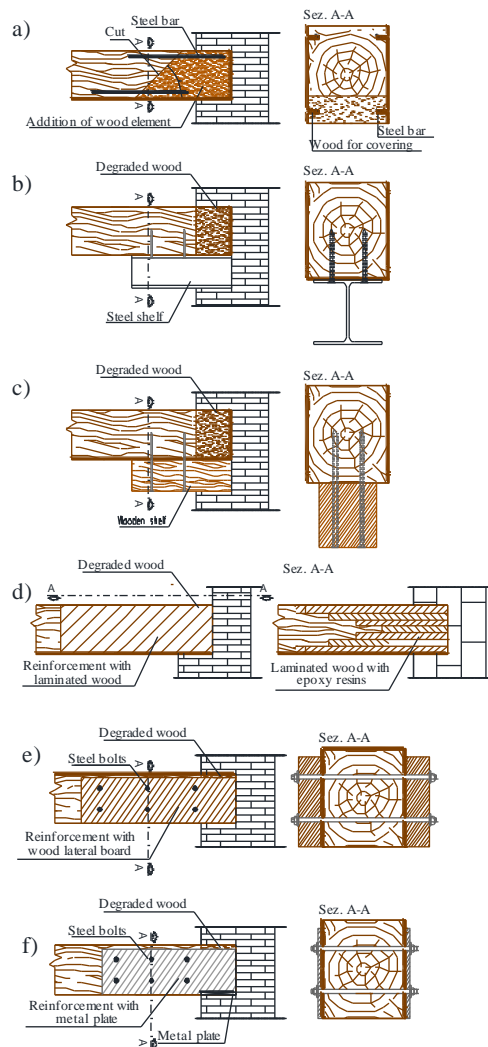
**Figure 33.** Typical interventions in the case of damaged extremities of timber beams

Some examples of typical intervention methods are reported in Figure 33: (a) use of a wooden prosthesis connected with rebars to the existing wood beam; (b, c) reinforcement with steel or wooden shelf; (d) wood substitution by plating with other wooden elements; (e, f) external reinforcement with wooden lateral boards or steel plates. Applicability of these methods depends on the peculiarity and architectural features of the historic building. However, the described interventions are scarcely reversible and may modify significantly the interaction between the wooden structure and the masonry walls. In the present case study, the solutions corresponding to letters a) and f) in Figure 34 were adopted in the preliminary design. Nevertheless, after a careful inspection, many elements showed a deep biotic attack and, consequently, replacement of many supporting beams and purlins was necessary. Connection of wood structural elements and joints is another important issue. Ancient floor and roof structures are generally realized by assembling wooden members by means of carpentry joints fastened with metal nails, bolts and steel plates. The role of fastening devices is crucial for the structural

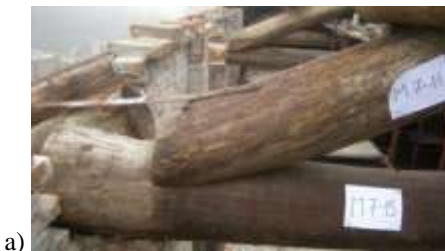
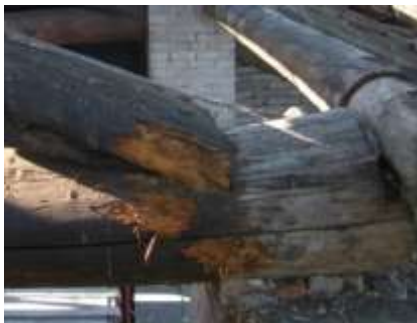
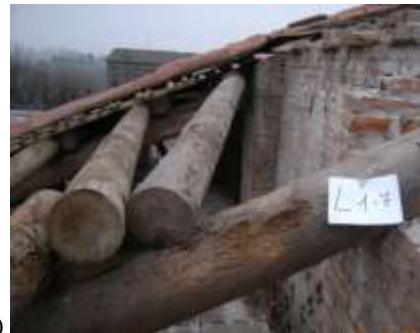
**Figure 34.** a, b) Damages in joints of the wooden truss; c) absence of connectors between wood rafters and secondary beams

stability of the wooden assemblies. However, during the years, such fastening systems can deteriorate due to wood damage or steel corrosion, and structural efficiency of joints or wood assemblies can be fully compromised (Figure 34 a, b). Sometimes, connections between principal rafters and secondary beams are even fully absent (Figure 34c).

Experimental tests (Tomasi *et al.*, 2007) highlighted that wood roof trusses can be subject to brittle failure of wooden joints causing the full collapse of the structure, especially during seismic events. Very restrictive checks of these nodes are then prescribed by codes (D.M. 14.01.2008).

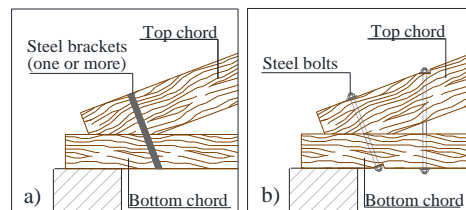
**Figure 35.** a), b) strengthening intervention of joints between wooden beams of the roof truss

The load bearing capacity of the joints of the wooden roof truss can be restored by means of additional connectors such as steel bars or plates. In the present case, external steel ties were used for the main joints (Figure 35a), in order to avoid to realize holes in the existing beams (Figure 35b), which can cause the onset of new biotic degradation in the future.

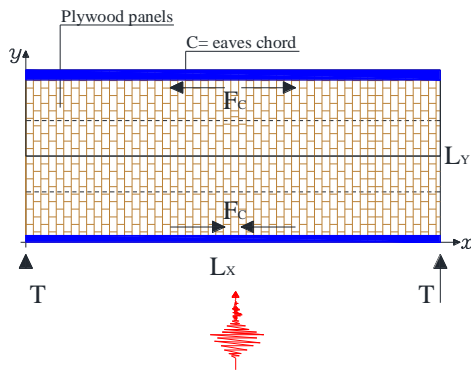
**Figure 36.** Roof subject to earthquake action in the transverse direction.

In this section, the preliminary design of the wooden roof as a part of an earthquake-resisting structure is described. The design, following the criteria illustrated in Section 3.3, considers the realization of a diaphragm at the roof level. For an earthquake action in the transverse direction (the most critical case), eaves chords and pitch panels withstand the global bending moment and shear on the roof plane induced by the seismic action (Figure 36). The pitch panels transfer the seismic action to the two head gable walls at the extremities of the barn, and then the action is transferred to the foundations.

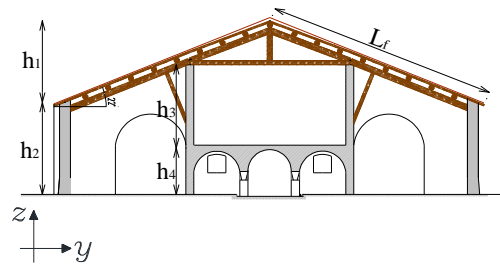
**Figure 37.** Transverse section of the barn structure with identification of main dimensions

Moreover, the thickness of the main walls is  $s_m = 48 \text{ cm}$ , and the weight per unit of volume of the masonry is assumed  $\gamma_m = 18 \text{ kN/m}^3$ .

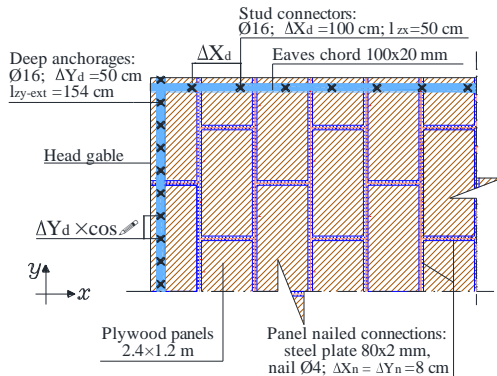
**Figure 38.** Reinforcement of the barn roof with multi-layered wood panels - Plan view of a portion of the roof

The length  $l_{zx}$  of stud connectors must be 20 times diameter at least, hence  $l_{zx} > 20 \times 1.6 = 32$  cm (50 cm was adopted).

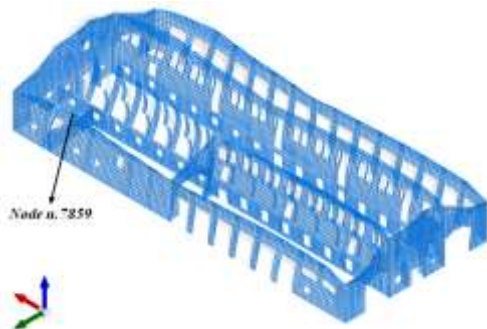
**Figure 39.** Maximum displacements in DLS load condition for the FEM model before the interventions

Finally, the displacements before and after the structural interventions, obtained from FEM modelling, are reported. The current code (D.M. 14.01.2008) requires the maximum interstory drift  $d_e$ , evaluated for the damage limit state (DLS), be less than 0.003. For the model before interventions, maximum displacement  $s$ , for DLS load condition, is equal to 4.15 cm for a node placed at the top of a wall 5.89 m height (Node 7859). Consequently, maximum drift  $d_e$  is greater than the admissible:

$$d_e = s/h = 4.15/589 = 0.007 > 0.003$$
