Shifting Courses of Ganga River, It Causes and Resultant Hazards of Manikchak Block, Malda District, West Bengal

Sriparna Mitra

Research Scholar, Department of Geography, University of North Bengal, India

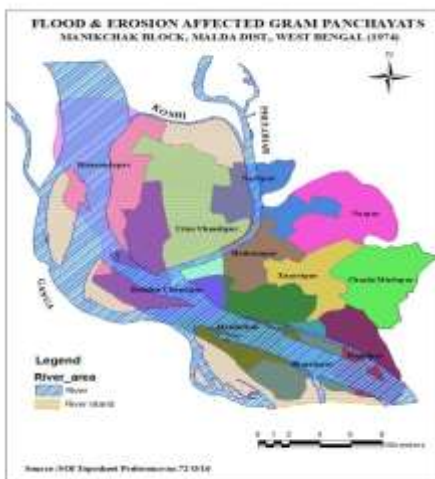
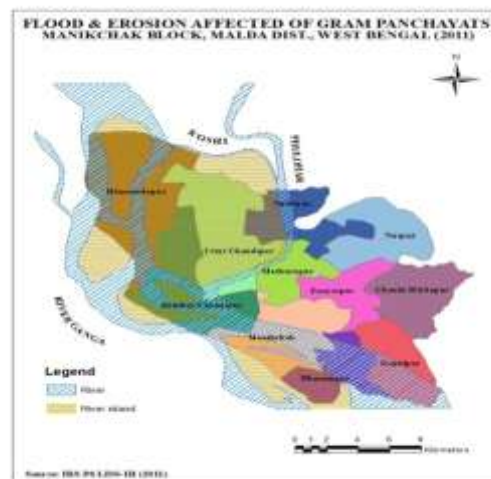
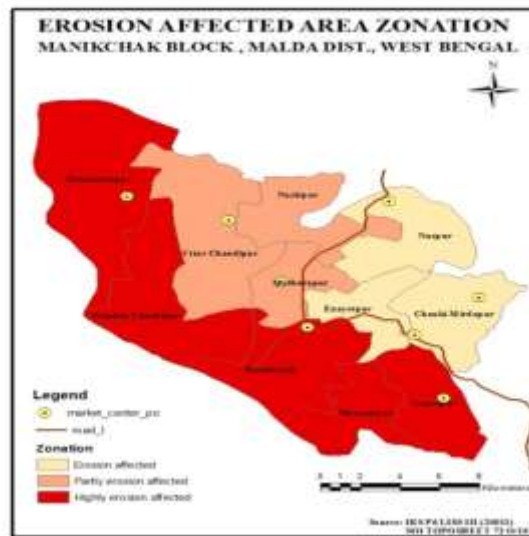
Soi Toposheet –Wise Details of the Shifting of the Ganga River in the Study Area

SL No.	Area Reference	Time Sequence	Remarks
1.	West of Baikunthatola	1.1974 to 1997 2.1997 to 1999 3.1999 to 2003	East ward shift of 1 km along left bank of river Ganga. Further east ward shift about 250m, damage circuite embankment. East ward shift by 500m.
2.	NW of Gobardhantola	1.1974 to 1997 2.1997 to 1999 3.1999 to 2003	East ward shift of 2.5km left bank of river Ganga. 200m eastward shift. 250m eastward shift.
3.	Dakshin Chandipur	1.1974 to 1997 2.1997 to 1999 3.1999 to 2003	Eastward shift of 750m along left bank of Ganga. Further eastward shift of about 200m engulfing abandoned meander scroll. It has eroded the northeastern part of Dakatia Char.
4.	Mathurapur	1.1974 to 1997 2.1997 to 1999 3.1999 to	Eastward shift of 250m along left bank of Kalindri river. Eastward shift by about 100m. Eastward shift by less than 50m.

2003	
5.	Janakiramtola	1.1974 to 1997 2.1997 to 1999 3.1999 to 2003	300m eastward shift along left bank of Ganga. 750m to 1km eastward shift. No significant change.
6.	Gopalpur	1.1974 to 1997 2.1997 to 1999 3.1999 to 2003	Eastward shift along left bank of Ganga by 1.75km. Eastward shift by about 300m. No significance change.
7.	Daulattola	1.1974 to 1997 2.1997 to 1999 3. 1999 to 2003	Eastward shift along left bank of Ganga by 900m. Eastward shift by about 1.4km. Eastward shift by about 350m.
