Bulletin of the Mineral Research and Exploration

AN APPROACH TO COAST EDGE LINE AT THE EASTERN ANTALYA MARGINAL-MARINE SEA SIDES

Research Article

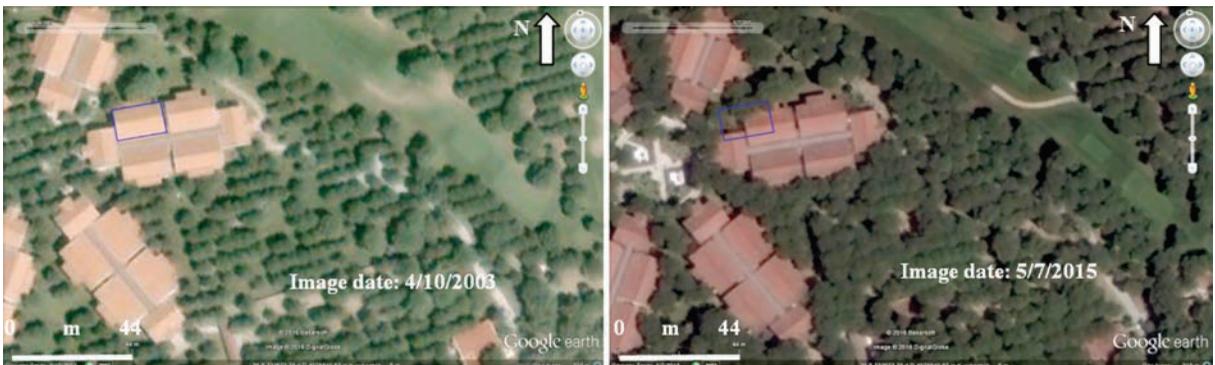
Figure 2- Google Earth satellite views showing illusion scale in meters in Recent and past views (it is clear that the same building is seen in different place in the 2015 satellite view, coordinates are shown in the figures).

Google Earth satellite data dated as 2003 and 2015 were evaluated. Some changes on the coasts are clearly seen within twelve years; even it is obvious within five years. However the views also have errors depending on pixel resolution. Figure 2 shows

vertical and horizontal differences, a few meters in distance. The reasons of that may be related to many factors such as beaming error, data difference, transformations of projection systems and corrections on the errors. Although these errors may be important, clear geomorphologic differences and changes on coastal edge line are clearer in the views. Figures 2-4 shows satellite views and changes in the studied coastal areas.

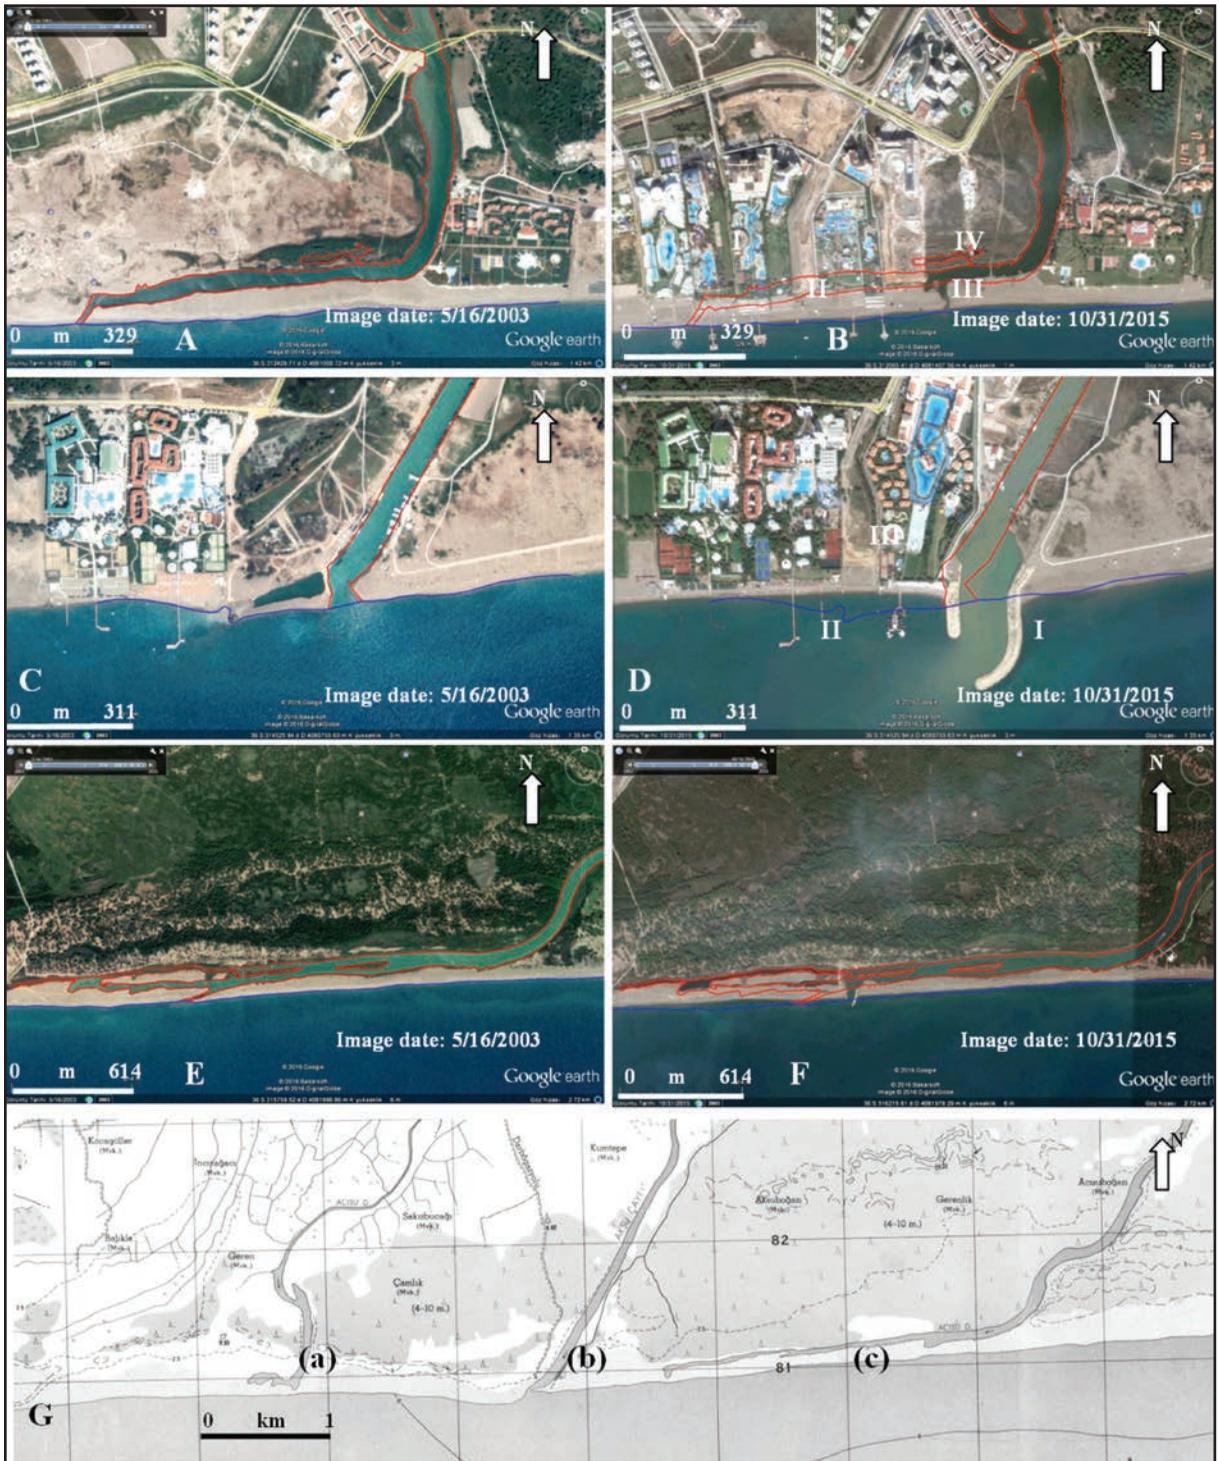
Figure 3- Google Earth satellite views of 2003 and 2015 for the following locations A-B. South of the Lara Main Road, C-D. exit of the Aksu Stream, E-F. exit of the Acisu Stream-2, G. topographical map of these three locations in 1962, (a) south of the Lara Main Road, (b) exit of the Aksu Stream, (c) Acisu Stream-2, numbers show changes in time.

The south of Lara Main Road: Touristic constructions and buildings on the sand dunes (I), flattened area around the exit of the one of the branch of the Aksu Stream (Acısu-1) filled by beach sediments (II), change of the exit of the stream (III) and changes in the size and locations of the swampy areas (IV) are seen as the main changes (Figures 3A- B). Longer beach or shore of the sea, and shorter stream angle are seen in the 1/25.000 scaled topographical map of the area dated on 1962 (Figure 3G).

Exit of the Aksu Stream: Mankind effects at the exit of the Aksu Stream (I), changes on the coast line (II) and buildings (III) are the important changes in the area (Figures 3C-D). Changes on the coastal edge line is seen clearly in 1962 topographic map, 1/25.000 in scale (Figure 3G).

Acısu Stream-2: Left side bending at the exit of the Aksu River is seen and called as Acısu Stream in the eastern part of the river (Figure 3E-F). Although some coastal changes are seen in the area, hollow of stream parallel to sandy dunes is more or less the same during the last fifty-sixty years. Widening sandy barrier (I), differences at the exit of the stream (II) are the main changes. Standard topographical map 1/25.000 in

scale and dated as 1962 show a natural water channel at the exit of the Acısu Stream in the land (Figure 3G).

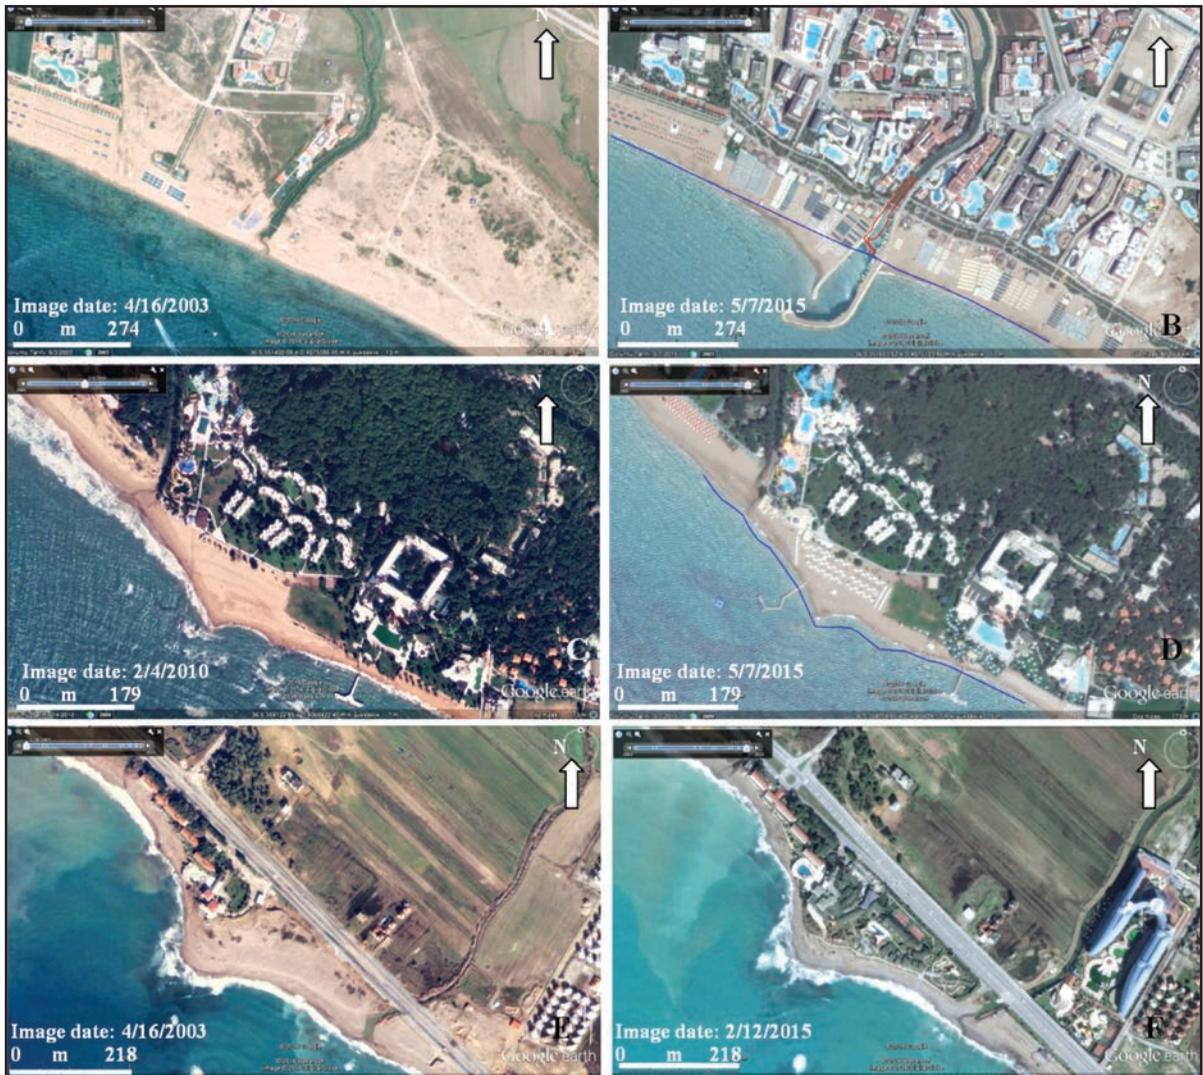
Figure 5- Comparative Google Earth satellite views of 2003 and 2015 for the south of the seashore at the south of Evrenseki, seashore at the east of Side and south of Kızılot.

Seaside at the southern Evrenseki: When comparing the views of 2003 and 2015 Google Earth satellite views, buildings or constructions and changes on the coastal edge line are seen clearly (Figures 5A-B).

Seaside of the eastern Side: During the last two decades, significant differences are not seen in the area when comparing the satellite views (Figures 5C-D).

Kızılot: Sheki occurred around the coast edge of the area during the last fifteen years is seen clearly in comparing of satellite views (Figures 5E-F).

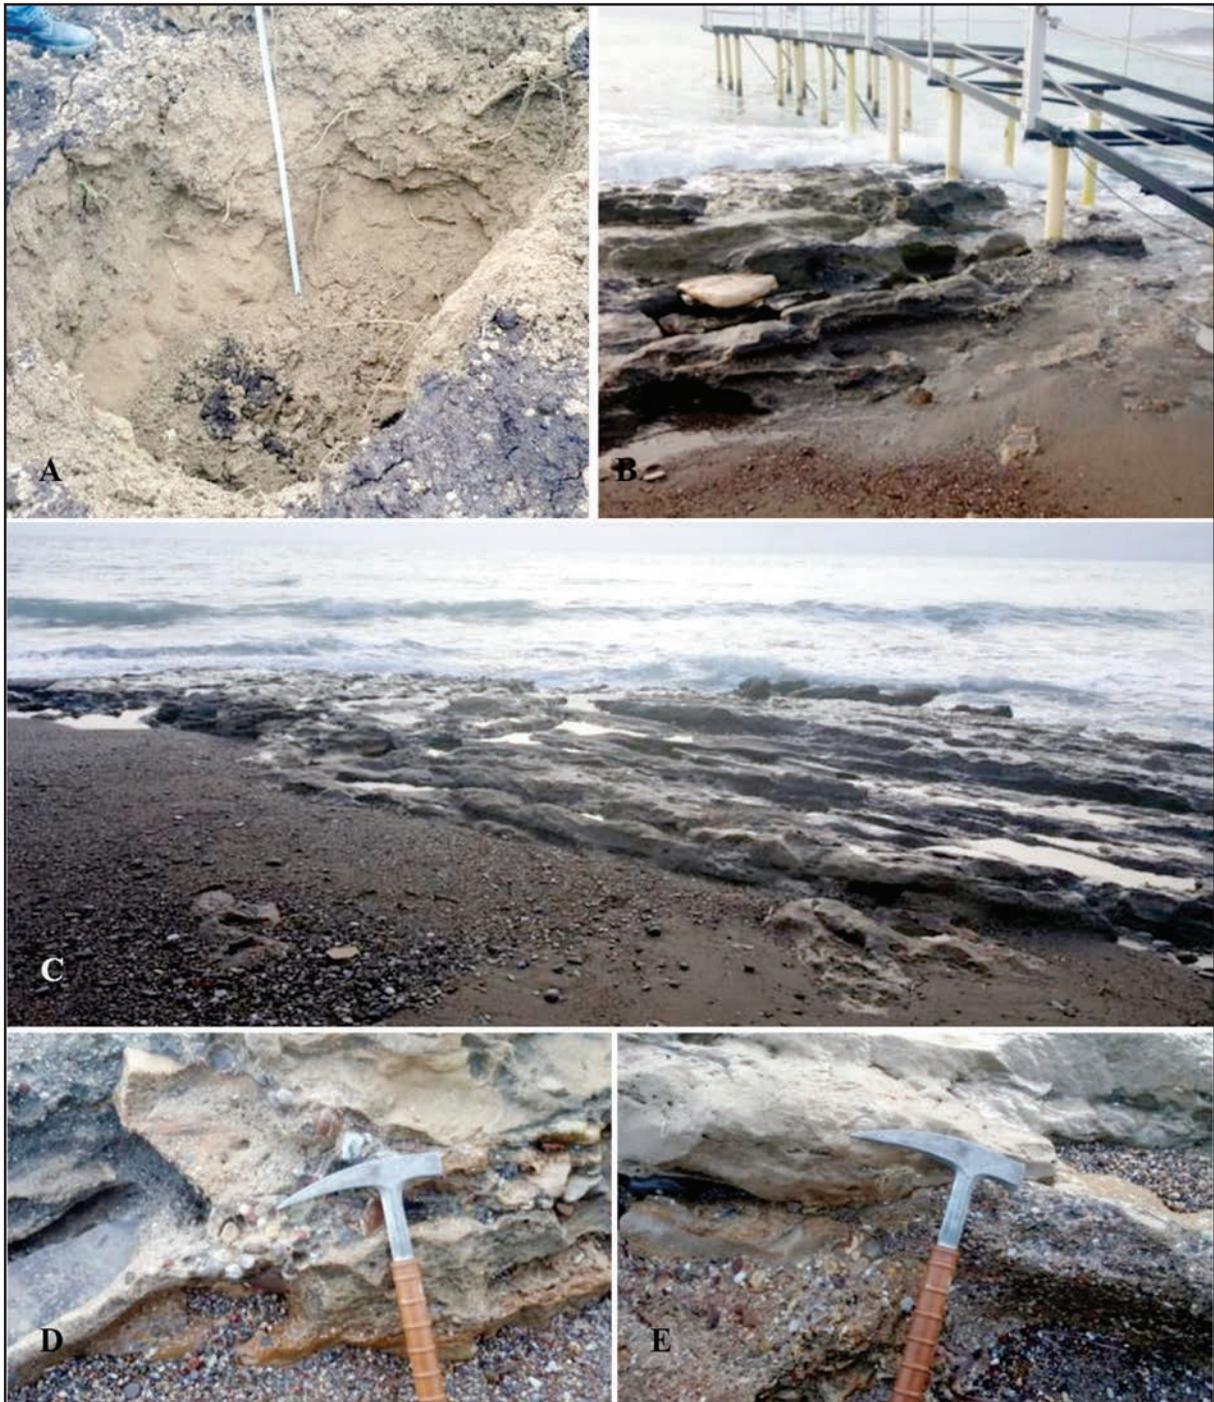
Figure 12- A general view from the beach area (A), observation hole at the north part of the beach area (B), a view from the Miocene aged (5-10 million years) conglomerate-sandstone, carbonate sandstone lithologies (C), closer views of the siliciclastics (D, E).
