# Comparison Between Conditions of Major Roads Within and Outside the Port of Durban

**Abstract**—Over the past years road traffic has increased at the Port of Durban. Due to the lack of maintenance, this has resulted in road deterioration. Roads are considered as the most important transport mode at the Port of Durban. It is an important mean for facilitating economic growth of local, regional and national industries. For the Port to maintain global competitiveness with the current trend of globalization, it has to be ensured that the roads are well maintained. The purpose of the paper is to provide an overview of road condition within and outside the Port. Verification and assessment of the condition of the existing eight major roads was conducted. Comparisons between the condition of the eight major roads within and outside the Port were highlighted. Conclusions and recommendations were also drawn based on the findings.

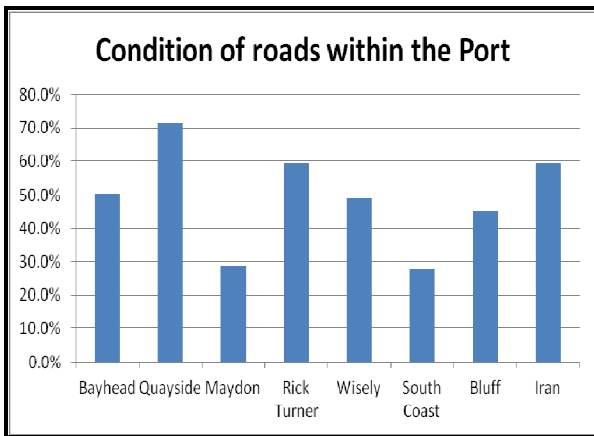
Fig. 2. Summary of major road condition within the Port

The results from the inspection reports conducted on the eight major roads within the Port are shown in Figure 2. Maydon and South Coast Roads are low rated roads which are in a poor condition. Quayside Road is highly rated and in a very good condition.

- Quayside Road (71.5%) falls under B (very good) category. It looks like new and minor maintenance work may be required at a later stage.
- Rick Turner (59.5%), Iran Road (59.5%) and Bayhead Road (50.5%) fall under C (good) category. It is moderate and maintenance work may be required within 12 months.
- Wisely Road (49%) and Bluff Road (45%) fall under D (fair) category. It is reasonable but maintenance work may be required within 6 months.
- Maydon Road (28.8%) and South Coast Road (28%) fall under E (poor) category. It is not safe and needs urgent attention.

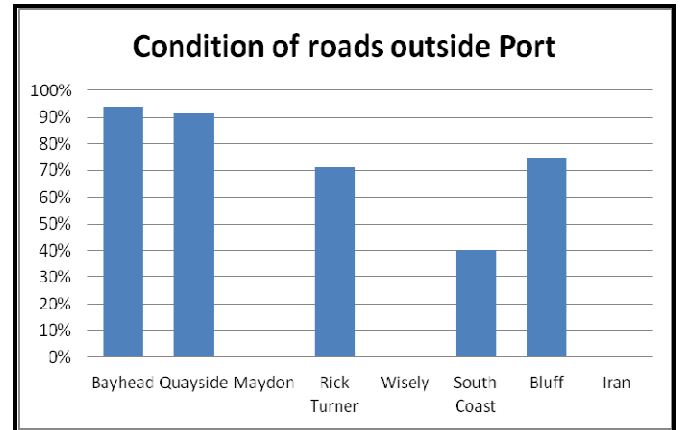
Fig. 4. Assessment of road condition outside of the Port.

The results from the inspection reports conducted at the five major roads that have sections which fall outside the Port are shown in Figure 4, namely Bayhead, Quayside, Rick Turner,

South Coast and Bluff Roads. The full length of Maydon, Wisely and Iran Road falls within the Port and hence cannot be assessed. South Coast Road is a low rated road which is in a fair condition and all other roads are rated above 70%.

- Bayhead (94%) and Quayside Road (91.5%) fall under A (excellent) category. It is new and perfect. No maintenance work required at this stage.
- Rick Turner (71%) and Bluff Road (75%) fall under B (very good) category. It looks like new and minor maintenance work may be required at the later stage.
- South Coast Road (40%) falls under D (fair) category. It is reasonable but maintenance work may be required within 6 months.

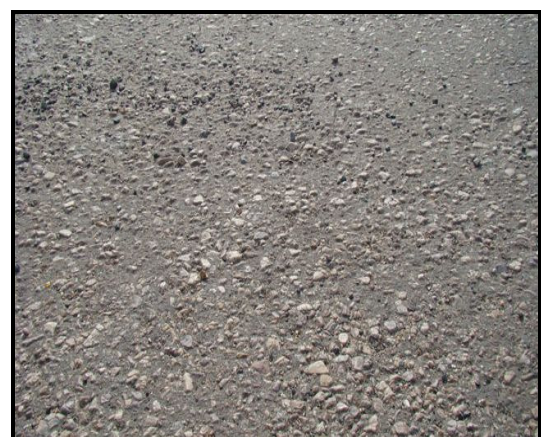
Figure 5 shows the typical defects found on sections of Rick Turner Road outside the Port near King Edward Hospital.

Fig. 5. Aggregates loss on Rick Turner Road.

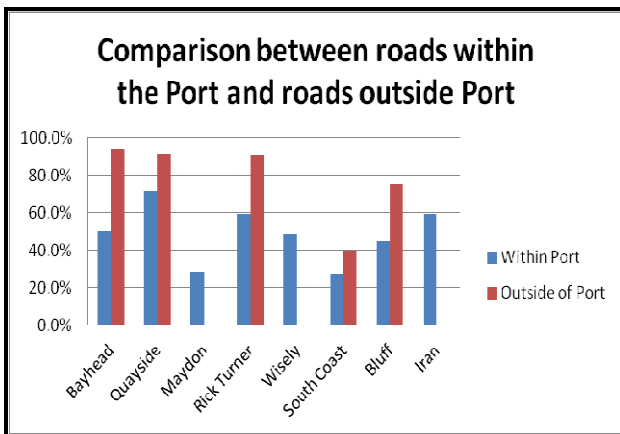
Fig. 6. Comparison between roads within and outside of the Port.

The section of roads which falls outside the Port are in a good condition compared to the section of roads within the Port as shown in Figure 6.

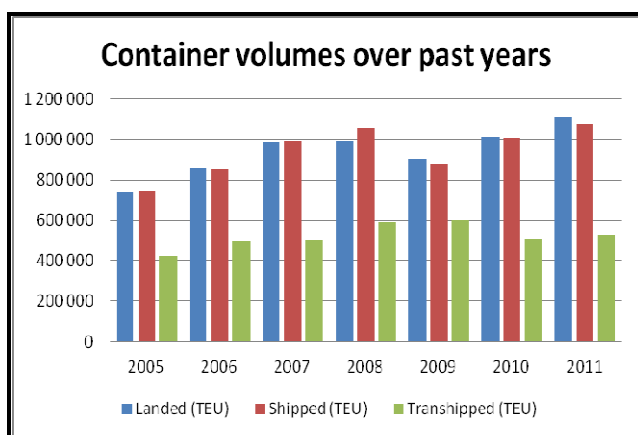
Fig. 7. Container volumes at the Port of Durban [4]

Figure 7 shows the container volumes handled at the Port of Durban over the years where it increased from 1,9 million TEU in year 2005 to 2,7 million TEU in year 2011. This has put

pressure on the roads within the Port and resulted in deterioration of the road condition [4].
