Geothermal System as the Cause of the 1979 Landslide Tsunami in Lembata Island, Indonesia

Yudhicara, Bani, P., and Darmawan, A., 2015. Geothermal System as the Cause of the 1979 Landslide Tsunami in Lembata Island, Indonesia. *Indonesian Journal on Geoscience*, 2 (2) p.91-99. DOI:10.17014/ijog.2.2.91-99

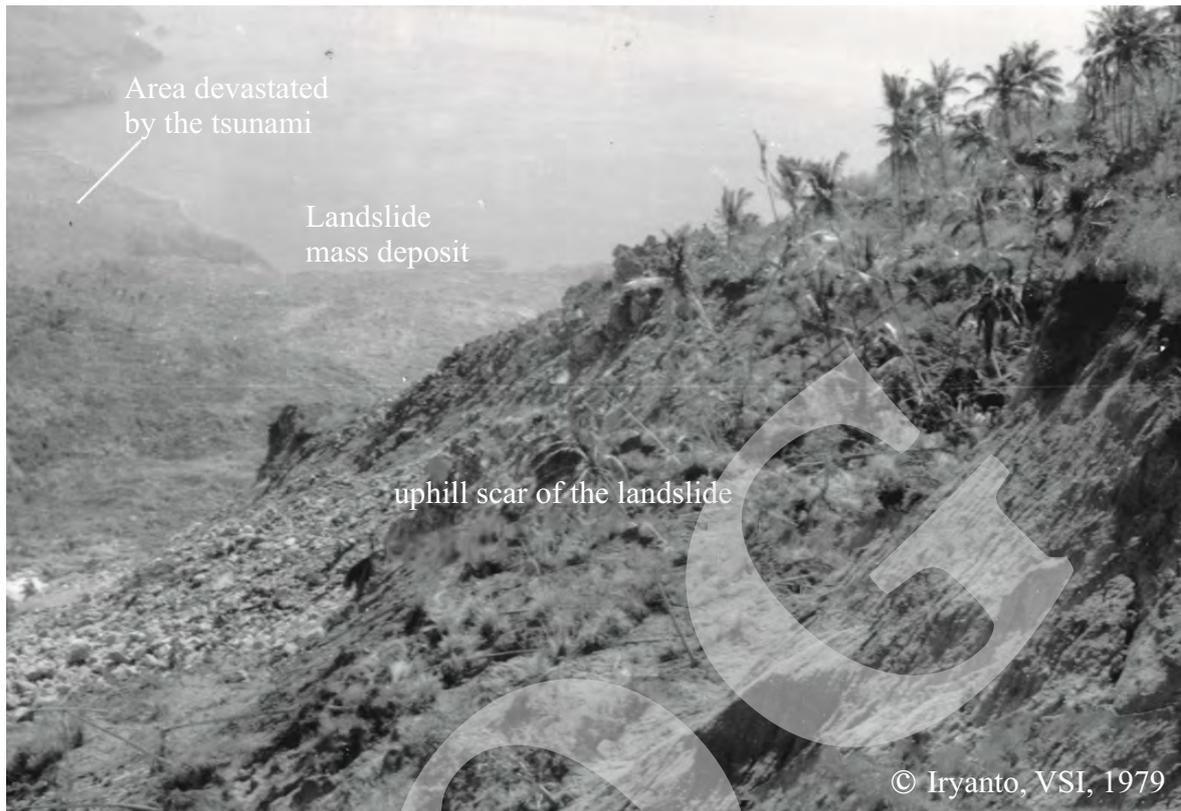
Figure 4. Location of landslide and tsunami impacted areas (taken from Iryanto, 1980).

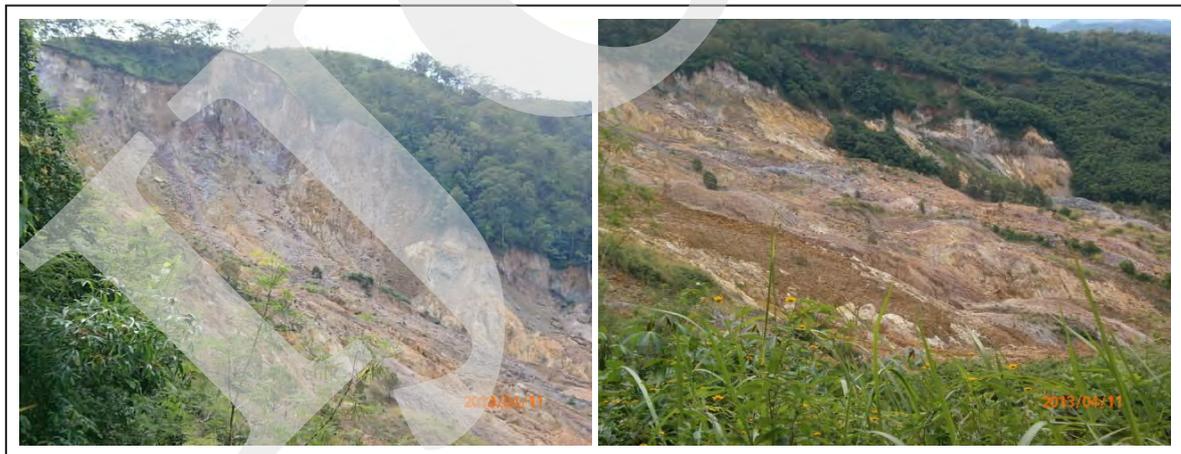
The landslide area is located at an old crater of Iliwerung complex. The crown of landslide is found at Atakore Village, named Bauraja Hill (Figure 5). The Bauraja Hill forms a cliff that is

Figure 5. Evidences of the 1979 landslide taken on April 2013, the crown (left) and the landslide body (right) (Yudhicara *et al.*, 2013).

unstable and prone to landslide, particularly after a heavy rain. The study area is about 1.2 square km. It has many volcanic cones around and close to the landslide site, active faults cutting across it and is often subjected to a heavy rainfall. The study area has a hilly morphology with a very steep slope and is covered by dense forest and

trees, however the landslide scar is still barren and not been revegetated.

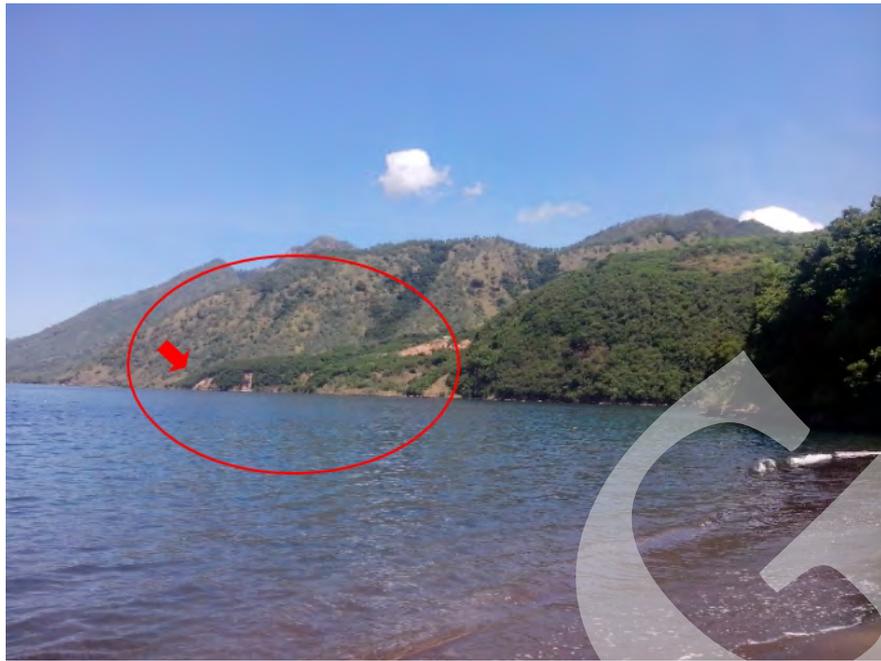
Figure 6. The landslide product protrudes into the sea (red circle); location of water sample is shown by red arrow (Yudhicara *et al.*, 2013).

material was taken nearby the sea (Figure 6), which has finer grain volcanic ashes, yellow to white colour, very soft, clayey, loose, slippery and easy to move.

Some hot springs were found around the landslide site indicating a fumarole system. A water sample was taken from a hot spring at the foot hill of the landslide material at position of 08°28'44"S - 123°33'34.3"E (Figure 6), which coincides with a fault line. The mixing of water
