ENVIRONMENTAL EFFECT OF LIFT IRRIGATION SCHEME-A CASE STUDY

ABSTRACT

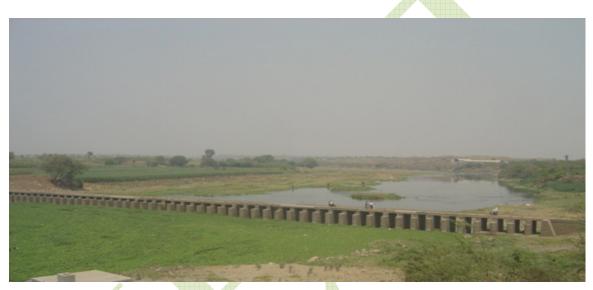
Fig.1.Eutrophication near the K.T. Wier, Koregaon Mul

A few months a year, the river is completely filled with water hyacinth. Again this indicates pollution to a large extent and the presence of metals like phosphorous, etc. Water hyacinth does not allow the atmospheric oxygen to dissolve in the water, thereby destroying the natural river flora and fauna.

Discussion: The BOD and COD levels were abnormally high. The water surface had undergone extensive eutrophication which portrayed the necessity of treatment.
