Effect of Surface Texture on Bond Strength of GFRP Rebar in Concrete

RIAZ AHMAD GORAYA*, KAMAL AHMED**, AND MUHAMMAD AKRAM TAHIR***

ABSTRACT

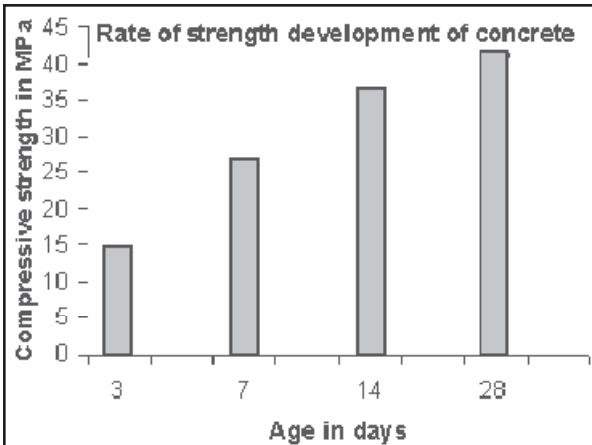
FIG. 2. COMPRESSIVE STRENGTHS OF CONCRETE

Concrete of compressive strength about 40 MPa was used in the experimentation. The results of compressive strength tests are shown in Table 1 and Fig. 2. Plain and sand coated GFRP rebars having diameters 9.5, 13, 19 and 22mm having yield strength of 415 MPa were used in pull-out tests as shown in Fig. 3. The concrete cylinders 150mmØ diameter and 300mm height were used in pullout tests. In order to achieve the desired bonded lengths, PVC pipes were used. These smooth surface pipes broke the bond between GFRP rebars and concrete.

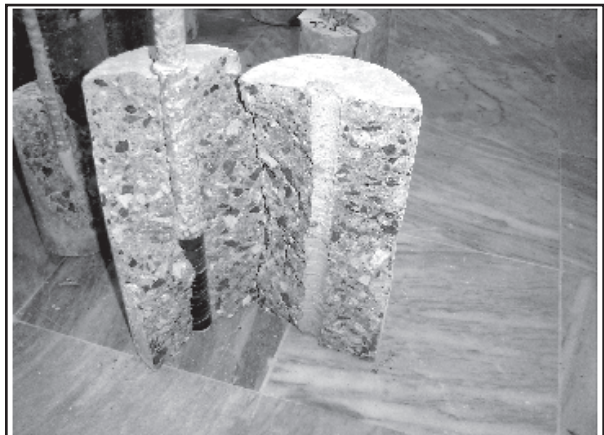
FIG. 8. CONCRETE KEY OF GFRP REBARS AFTER PULLOUT TESTS

was formed between plain/low rib height GFRP rebar and the concrete as shown in Fig. 8.
