# Effect of Axial Pre-Compression on Lateral Performance of Masonry Under Cyclic Loading

SYED HASSAN FAROOQ\*, MUHAMMAD ILYAS\*\*, AND ASADULLAH QAZI\*\*\*

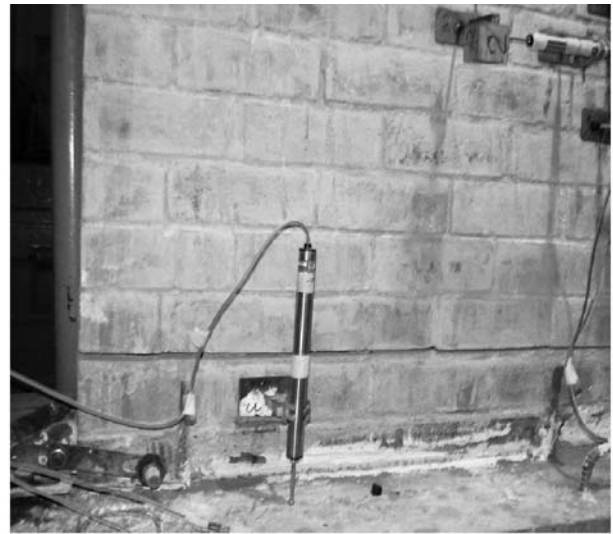
FIG. 6. WALL 6 AT FAILURE (A) BASE UPLIFT AT POSITIVE SIDE (B) BASE UPLIFT AT POSITIVE SIDE

displacement was recorded. The wall exhibited rocking failure and started to rock between last and 2nd last coarse at very early stages of loading that is during 2nd cycle. No cracking or toe crushing was observed during cyclic test due to zero pre-compression. The lateral force and displacement at yield and peak was almost same. At peak stage very less drift ratio of 0.09% was recorded which increased to 0.58% at ultimate stage. The lateral load and displacement at ultimate stage was 11.3kN. The wall experienced rocking failure mode as shown in Fig. 6(a-b).

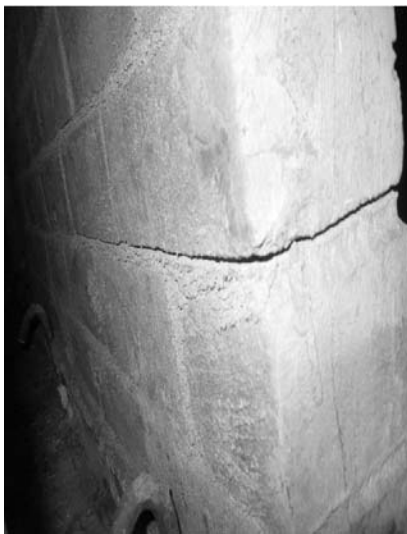
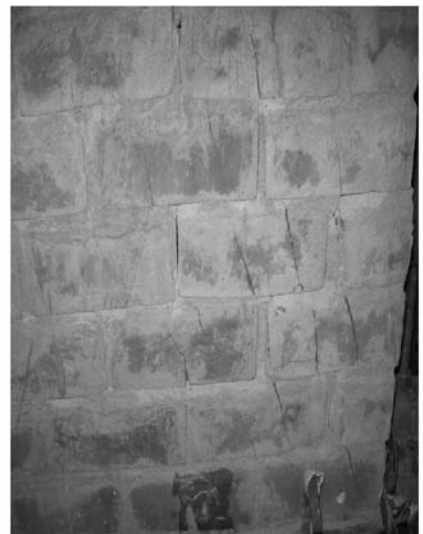
FIG. 7. WALL 9 AT FAILURE (A) UPLIFT AT POSITIVE SIDE (B) CRACKS PASSING THROUGH BRICKS (C) CRACKING AT TOE

The wall 9 was tested at 1MPa. The peak load recorded was 170.5kN with ultimate displacement of 8.6mm. The wall experienced brittle shear failure due to heavy pre-compression cracks mostly passed through the bricks. The first crack appeared in second last coarse towards positive direction during 9th cycle. Later new cracks passing through bricks appeared at middle top and towards negative direction. Yielding force and displacement was 155kN and 2.1mm. Slight sliding and rocking was also observed at later stages as shown in Fig. 7(a-c) causing higher ultimate displacement. On further cycling, some cracking at wall bottom on both directions were observed

with widening of existing cracks. Very few cracks passed through the mortar. At ultimate that is 80% degradation, the test was stopped and the lateral load was 137kN.

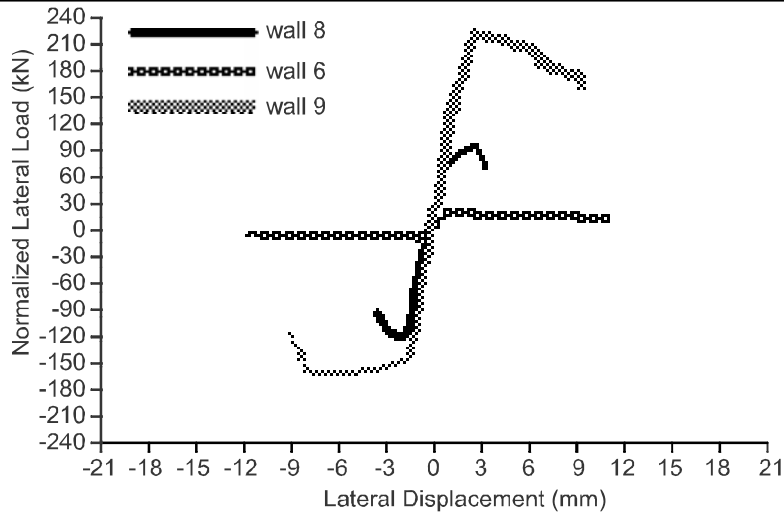
FIG. 8. BACKBONE CURVE ON BOTH SIDES

Fig. 8 shows the backbone curve of all the walls in both the directions and Fig. 9 shows the critical backbone curves. It is very clear that Wall 9 as expected showed

very steep rise in strength and then sudden reduction in strength at the end. Wall 9 with 1Mpa pre-compression has showed maximum strength increase of 92% as expected and least lateral strength is observed in case of Wall 6, which is just 16% of the reference wall 8. The ultimate lateral displacement of URM wall was just 3.31mm and lateral displacement for Wall 9 and Wall 6 were increased by a factor of 2.6 and 1.93 respectively as shown in Figs. 10-11. For Wall 9 the lateral displacement at yield and peak was 1.39 and 2.43 times higher than the reference specimen whereas, the lateral displacement was just 0.6 and 0.35 times of reference wall displacement in case of Wall 6. The yielding and peak lateral force and displacement of Wall 6 was almost same. The higher value of lateral resistance for Wall 9 is primarily due to high pre-compression and higher displacement is due to extensive cracking of bricks.

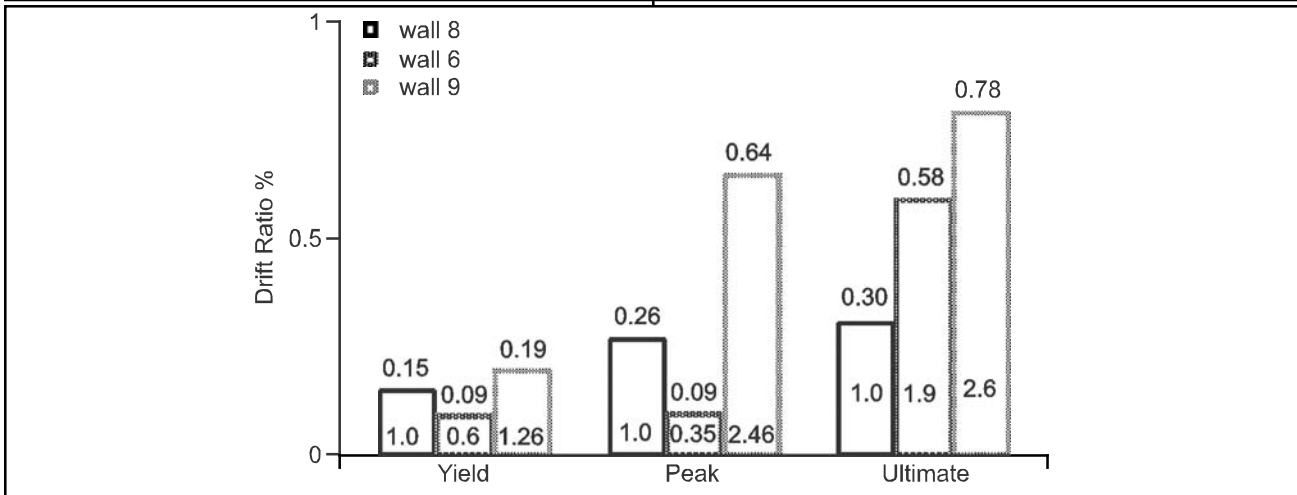
FIG. 12. COMPARISON OF DRIFT RATIO AT DIFFERENT STAGES

Very less drift ratio of 0.097% was achieved for Wall 6 at yielding stage as shown in Fig. 12. However, at ultimate stage, the drift ratio increased to 1.9 and 2.6 times as compared to reference wall.

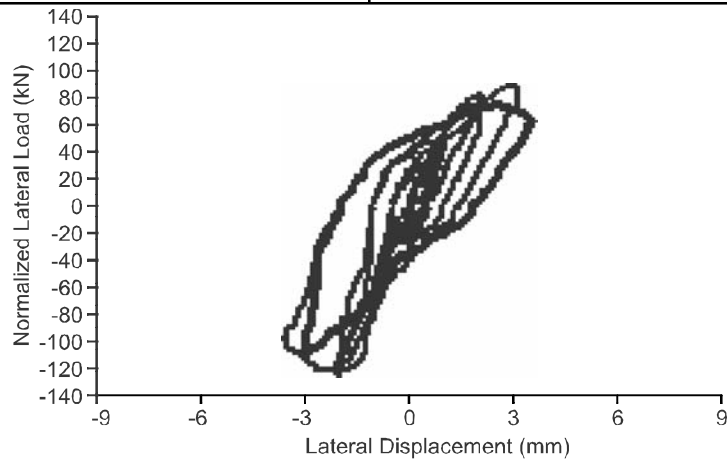
FIG. 13. HYSTERETIC RESPONSE OF WALL 8

The hysteretic behavior of all the three walls is shown in Figs. 13-15. The nonlinear elastic response of Wall 8 is quite evident but the inelastic response is very poor due to sudden fall in strength. The wall reached its peak load and then there is a sudden drop in lateral strength showing typical brittle behavior. The narrow hysteretic loop is due to lower residual displacement prior to cracking whereas, it get quite high after initiation of cracking. Uptill elastic

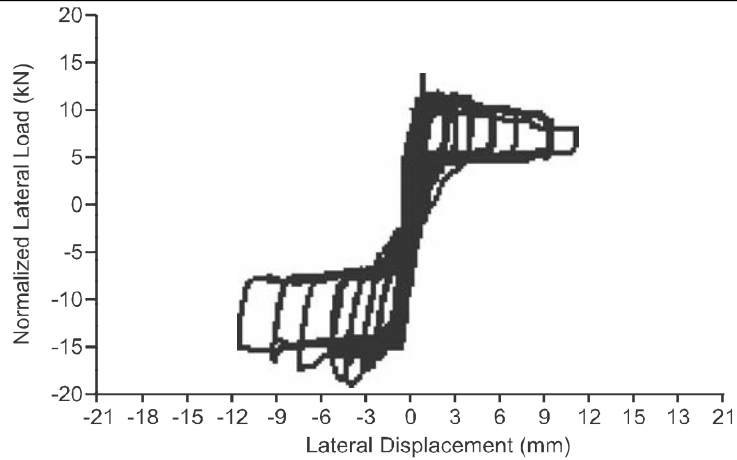
FIG. 14. HYSTERETIC RESPONSE OF WALL 6

The hysteretic loop of Wall 6 is quite interesting. Yielding and peak stage occurred at the end due to excessive rocking. The peak load lateral load achieved was quite low due to start of rocking at very early stages of cycling. After start of rocking the wall maintained the force and dissipated the energy through displacement increase. The loop is fanned out at the top but narrowing at bottom. However, the width of hysteretic loops for all the three walls was narrow with less energy dissipation, a peculiar characteristic of URM wall. The residual displacement after each cycle is shown in Fig. 16.

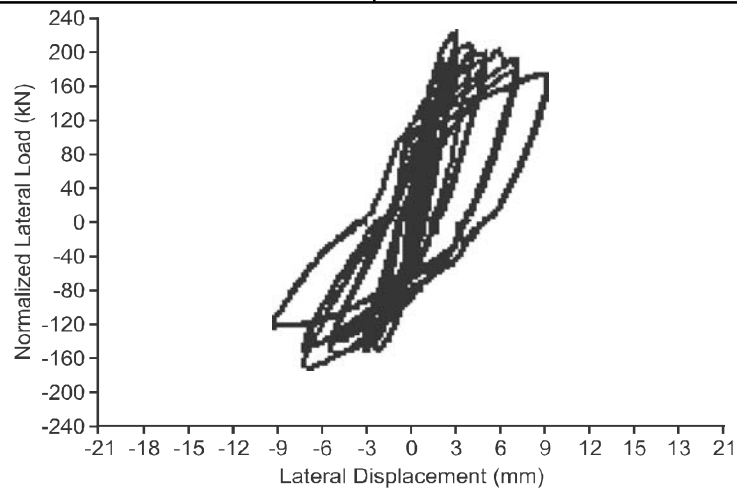
FIG. 15. HYSTERETIC RESPONSE OF WALL 9

stage the behaviour of Wall-9 is quite similar to reference wall with higher lateral strength but after yielding, the hysteretic loops are quite widened due to slight rocking/

sliding. After the peak the wall experienced sudden drop in strength, a typical characteristic of URM wall. The residual displacement was also higher.

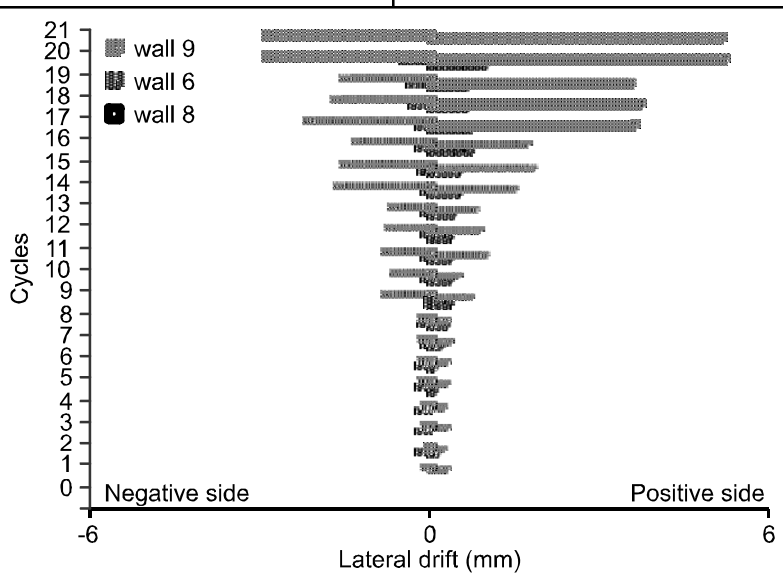
FIG. 16. COMPARISON OF RESIDUAL DISPLACEMENT/CYCLE

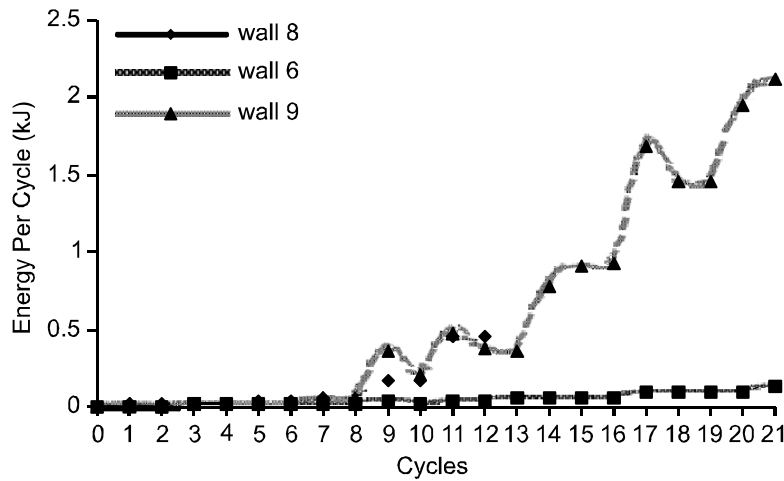
FIG. 17. COMPARISON OF ENERGY ABSORBED PER CYCLE

Figs. 17-18 show the energy dissipated during each cycle and cumulative energy absorbed in all the cycles. The energy dissipated during cyclic loading mainly depends upon the friction along joints; widening/new cracks formation, crushing of bricks; rocking and toe crushing.

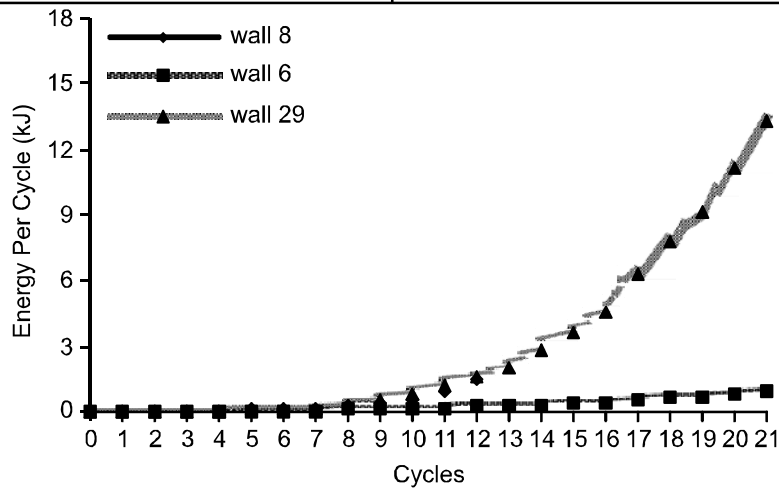
FIG. 18. CUMULATIVE ENERGY DISSIPATION IN ALL CYCLES

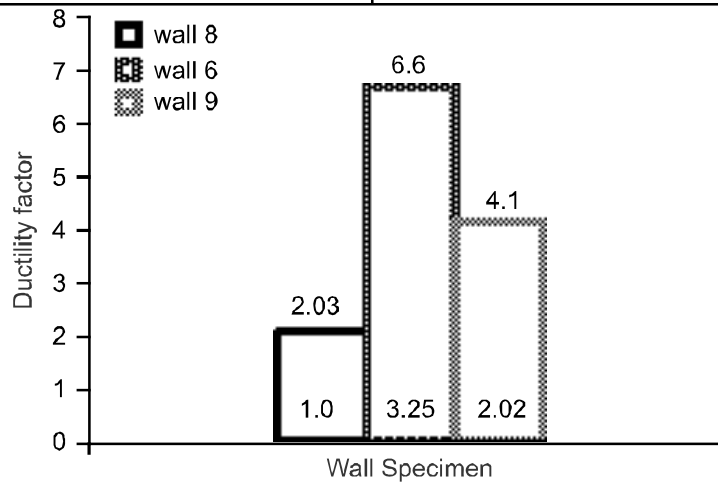
FIG. 19. DUCTILITY FACTOR FOR ALL SPECIMENS

Ductility is the most important factor of performance of any structural system in the seismic prone area. The displacements at yielding, peak and ultimate stages were calculated by using a method proposed by Mugruma [21]. Using these displacement values the displacement ductility was calculated for all the specimens. Ductility of the test specimens is compared in Fig. 19. The failure mode also affects the ductility. In rocking failure the specimen tends to return to its origin and the peak stage is delayed. Higher ductility factor in order of 3.25 and 2.02 times were recorded in case of Wall 6 and 9 respectively. The higher ductility factor in case of Wall 9 was due to extended inelastic

branch as the wall went into rocking and sliding after yielding. In case of Wall 6 higher ductility factor is attributed because the yielding occurred very soon at just 0.97mm of displacement and ultimate displacement was 64mm.

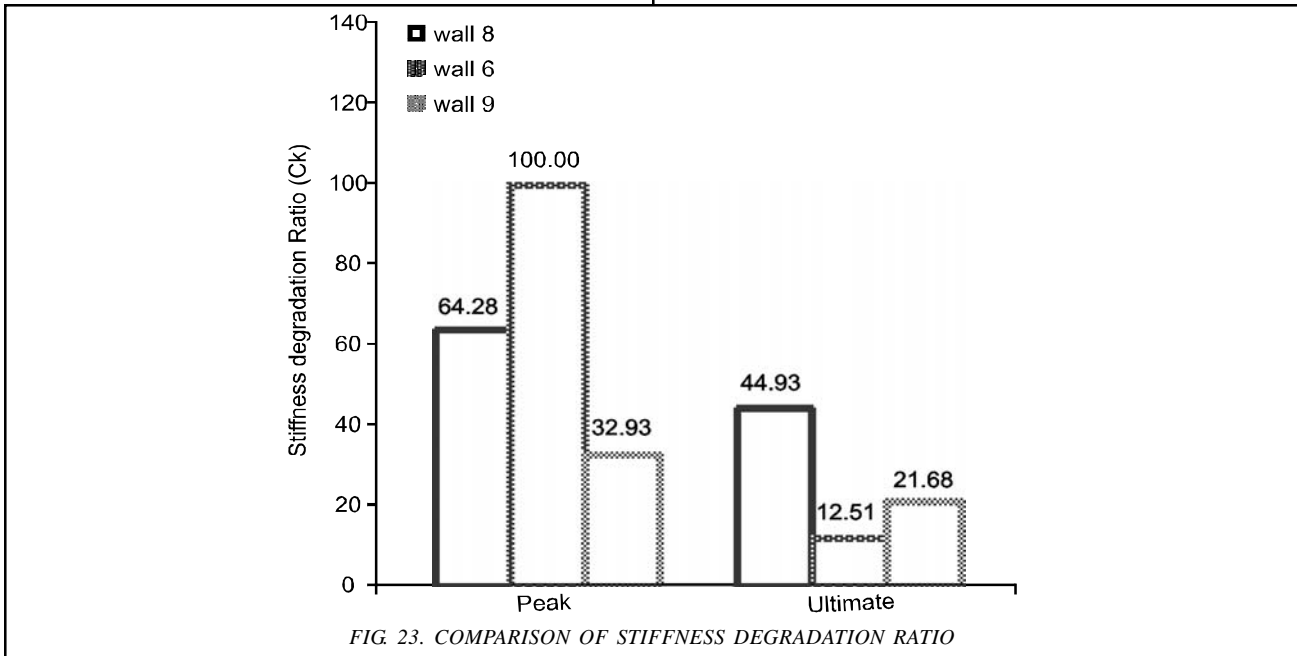
FIG. 23. COMPARISON OF STIFFNESS DEGRADATION RATIO

Fig. 23. In case of Wall 6 the stiffness degradation was 100 and 33% for wall 9. At ultimate stage the stiffness degradation of Wall 6 and 9 was quite less than the reference wall.
