Pashkevich, A., Nowak, M. Road safety risk assessment at pedestrian crossings: a case study from Sułkowice. *Scientific Journal of Silesian University of Technology. Series Transport*. 2017, **95**, 159-170. ISSN: 0209-3324. DOI: <https://doi.org/10.20858/sjsutst.2017.95.15>.

**ROAD SAFETY RISK ASSESSMENT AT PEDESTRIAN CROSSINGS:
A CASE STUDY FROM SUŁKOWICE**

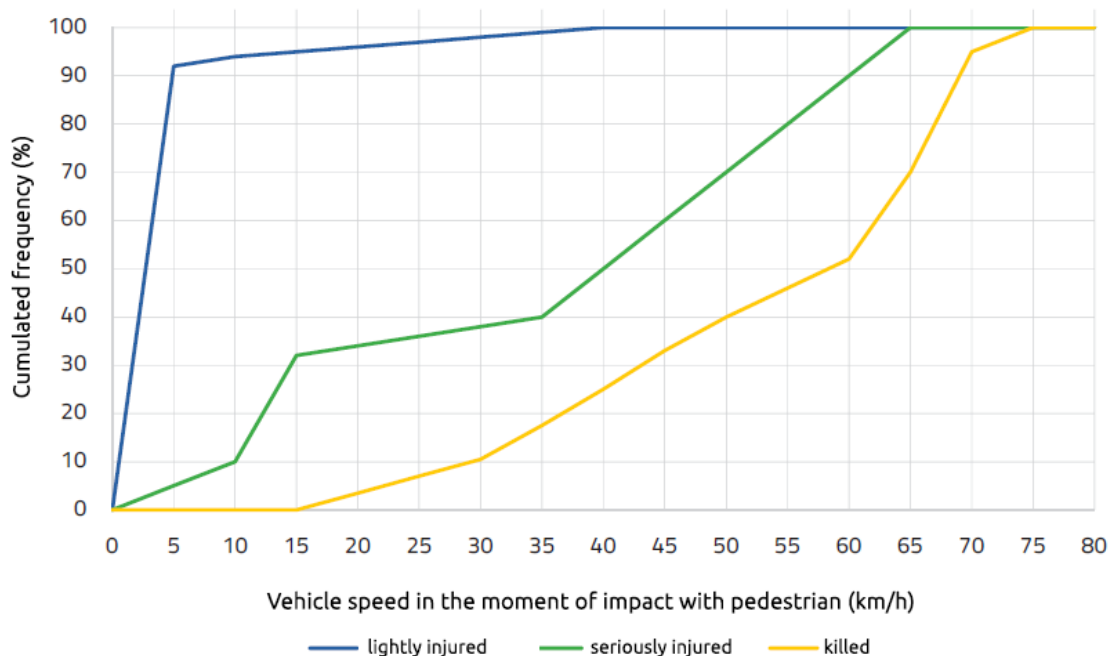
Fig. 1. Results of vehicle-pedestrian collision at various speeds: cumulative amounts (in percentages) of lightly wounded (blue), severely wounded (green) and killed (yellow) are shown [Błąd! Nie zdefiniowano zakłádki.]

Previously, it was found that the “safe” collision speed was only about 30 km/h [2]. As presented in Fig. 1, the risk to pedestrians does not increase linearly, but with some “kinks”, which may be attributed to the evolutionary development of human beings. Jamroz and colleagues [3] have recently presented the correlation between vehicle speed and the risk of injury to pedestrians, as shown in Fig. 1.

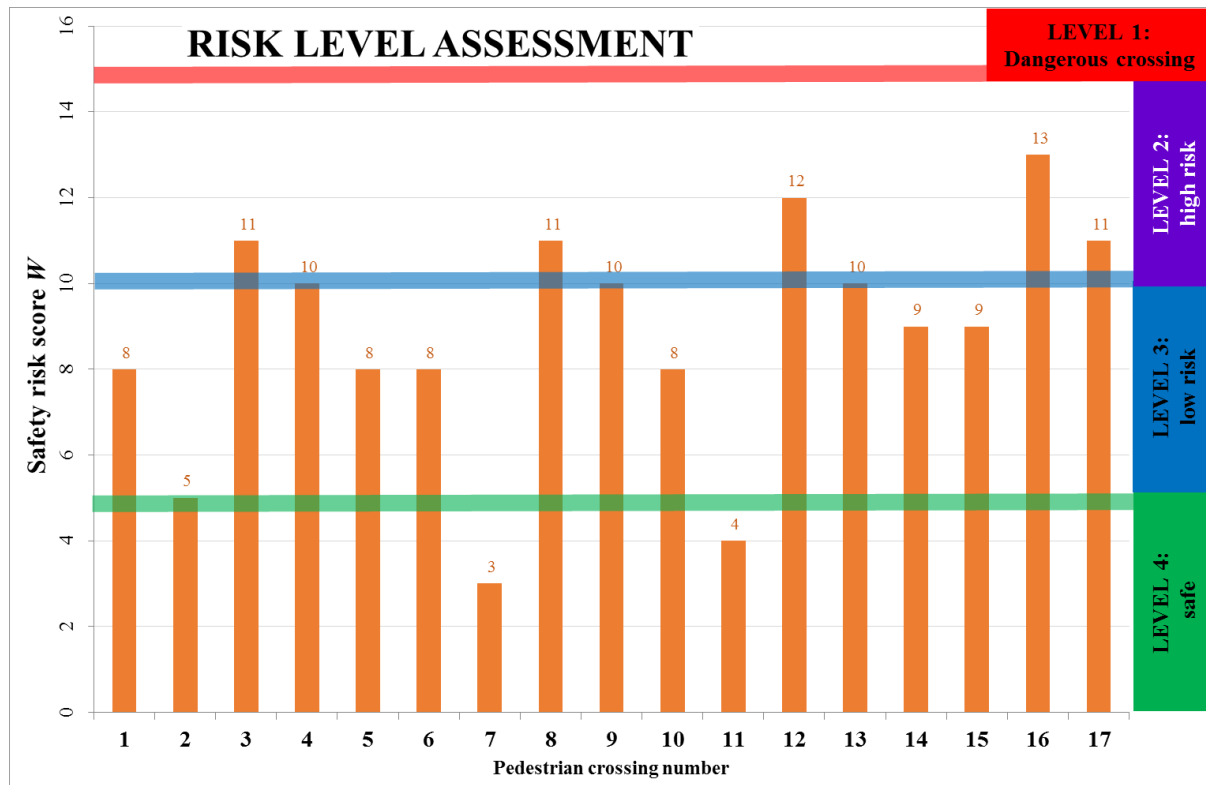
Fig. 3. Safety risk assessment of pedestrian crossings in Sulkowice; safety risk score W

Each of the evaluated 17 pedestrian crossings was assessed based on the 26 parameters described above. The safety risk is presented in Table 3 and charted in

Fig. 3.

Only two crossings can be considered as safe, based on the utilized method, due to the presence of additional engineering features and very good marking conditions. Five crossings were found to be unsafe, mostly because of high speed and the lack of engineered traffic calming measures. The crossing labelled '12' is of particular concern because it is located near a preschool and, somewhat surprisingly, located too far from any street lighting. Other crossings were scored in the low risk range, but it must be noted that, in the case of two of them, even one additional negative factor could result in a high-risk score.

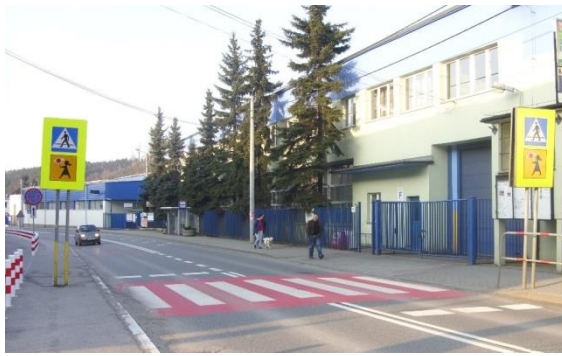
Fig. 4. A pedestrian crossing (labelled '7' on the map in Fig. 2) is an example of a safe crossing due to enhanced horizontal and vertical markings

The photographs shown in Fig. 4 and Fig. 5 demonstrate examples of safe and unsafe pedestrian crossings, respectively. The low-risk score (fourth safety level) of the crossing labelled '7' (Fig. 4) can be attributed to additional horizontal and vertical markings. The use of a red background is likely to catch drivers' attention and increase their vigilance [10]. Contrariwise, the crossing labelled '16' (Fig. 5) has one of the highest risk scores; due to its poor design, it ends up at an island separating a bus stop from the road (thus, pedestrians are forced to break traffic laws). The absence of additional warnings increased the risk score.

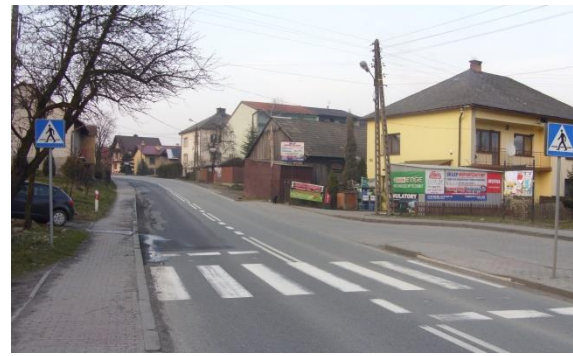
Fig. 5. A pedestrian crossing (labelled '16' on the map in Fig. 2) is an example of an unsafe crossing, as it leads to a bus stop separation island, without any additional safety features
