## First Attempt in Retrofitting Design for the 4-Story Existing Damaged Stone School Building By Combination of Base Isolation with Reinforced Concrete Jackets

Mikayel Melkumyan

Center of New Construction Technologies” at Arm project OJSC, Yerevan, Armenia

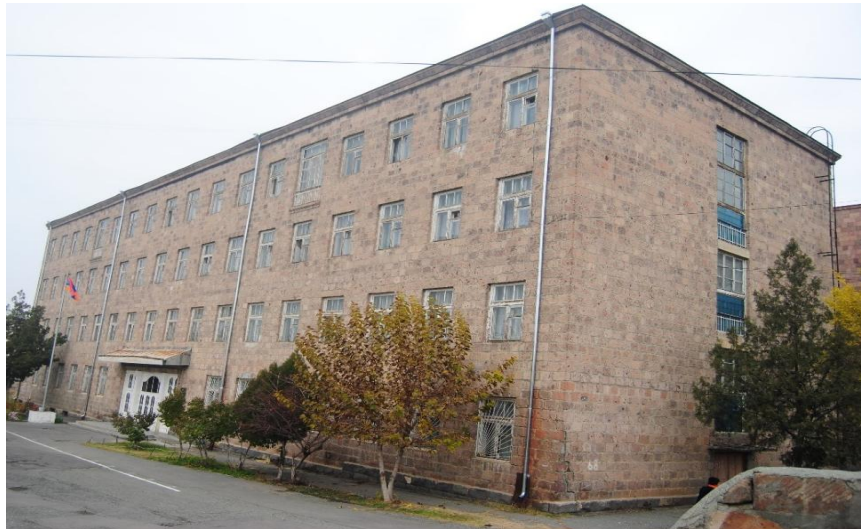
a.

Figure 1: General view of the 4-story old damaged stone building of the school #68 to be retrofitted by base isolation and strengthened by the R/C jackets (a) and fragments of its damaged parts within the limits of the first (b) and upper floors (c)

School #68 after M. Mkhoyan consists of four buildings and the oldest one among them was constructed in 1959 (Fig. 1a). This building has damages concentrated mainly within the limits of the first floor (Fig. 1b) and also there are damages in the form of incline cracks (Fig. 1c) in the walls of the upper floors. Retrofitting design of the mentioned old building was developed in accordance with the contract between the “Save the Yerevan Schools from Earthquakes (SYSE)” Foundation (Client) and the “Armproject” OJSC (Design Institution) in 2015. The structural concept of retrofitting using base isolation technology together with strengthening by R/C jackets of the damaged load-bearing walls and results of earthquake response analysis of the considered building are described below.

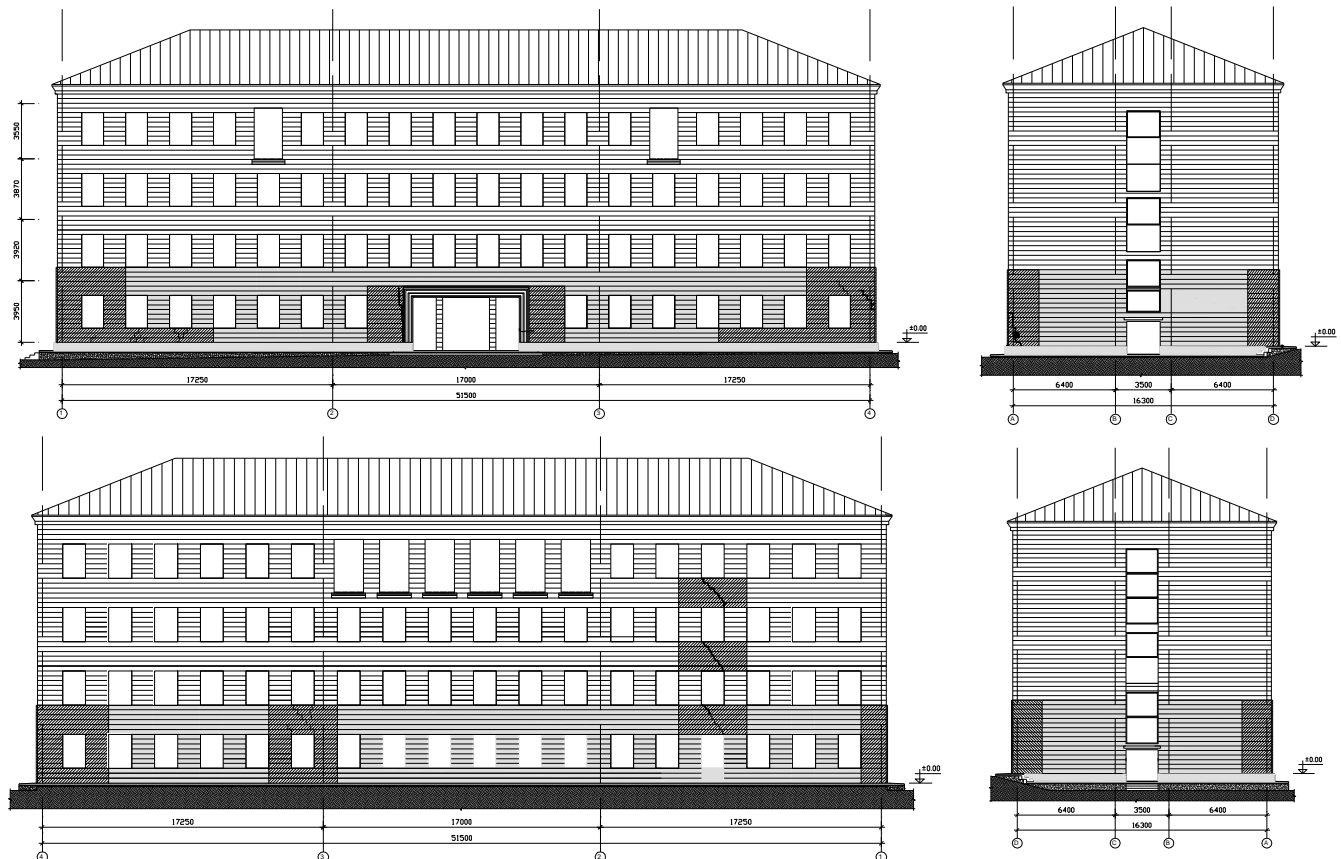
Figure 2: Main, side, and back façades of the 4-story old damaged stone building of the school #68 indicating damages and the designed R/C jackets

Those jackets which are designed to cover the damaged parts of the walls (such R/C jackets are shown by the inclined hatching) have the thickness of 80 mm and will be constructed from both sides of the load-bearing walls. Reinforcement in these jackets consists of 200×200 mm steel meshes with horizontal reinforcing bars having a diameter of 14 mm and vertical reinforcing bars with diameter of 12 mm. The vertical bars are anchored in the upper beams to be constructed above the seismic isolation plane. The jackets from both sides of the load-bearing walls are connected to each other by the reinforcing bars of diameter 8 mm which are placed in the holes of diameter 10 mm drilled with the spacing of 600 mm in the load-bearing walls. In order to provide reliable connection of the mentioned reinforcing bars with the tuff stones design requires the use of the epoxy glue. The both sides of these bars have to be reliably connected to the steel meshes of the R/C jackets. Before constructing the mentioned jackets the cement injection in the walls' cracks must be performed.

Based on the carried out analysis and on the technical condition of the walls within the limits of the first floor it was also decided to cover/strengthen the rest surface of these walls by the other type of the R/C jackets. These jackets (shown by hatching of shading type) will be constructed only from the exterior sides of the load-bearing

walls and have the thickness of 40 mm. Their reinforcement consists of 200×200 mm steel meshes with horizontal and vertical reinforcing bars of diameter 6 mm. Such type of jackets connected to the load-bearing walls by the reinforcing bars of diameter also 6 mm which are placed using epoxy glue in the holes of diameter 8 mm and the deepness of 200 mm drilled with the spacing of 600 mm in the load-bearing walls. However, design envisages construction of the same type 40 mm thick jackets also for two interior transverse load-bearing walls again within the limits of the first floor. In this case the R/C jackets will be constructed from both sides of the mentioned walls.

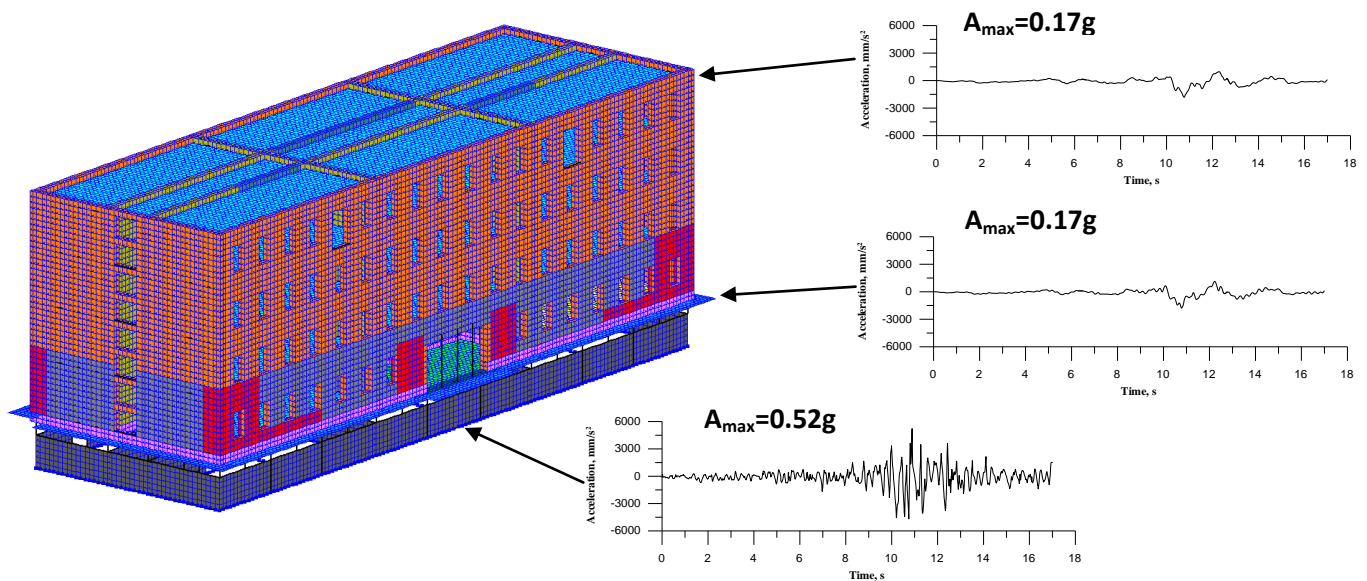
Figure 7: Design model (front view) of base isolated 4-story old damaged building of school #68 and comparison of the response accelerations at the levels of the top of isolators and the top of the building by the analysis in longitudinal direction using the 7.12.1988 Spitak Earthquake accelerogram

From these results it follows that maximum acceleration along the height of superstructure is equal to 0.18g, meaning that thanks to application of base isolation the input PGA of 0.52g decreases by about 2.9 times. Also it was obtained that in none of the isolators the vertical force exceeds 1500 kN. Superstructure is moving in horizontal direction as an almost rigid body without any overturning and consequently the obtained results prove the high effectiveness of the created base isolation system. This will ensure high reliability of the building, which will suffer no damage under seismic impacts, since the structural elements below and above the seismic isolation plane will work only in the elastic phase. Indeed, according to the RABC II-6.02-2006, the permissible inter-story drift for this type of the stone structure is equal to 1/550 of the floor height. The obtained results show that the maximum drift comprises 7.0 mm and occurs in transverse direction at the level of the first
