## **Natural and anthropogenic threats to the cultural tourism potential of Kıyıköy**

## Natural and anthropogenic threats to the cultural tourism potential of Kiyıköy

### Abstract

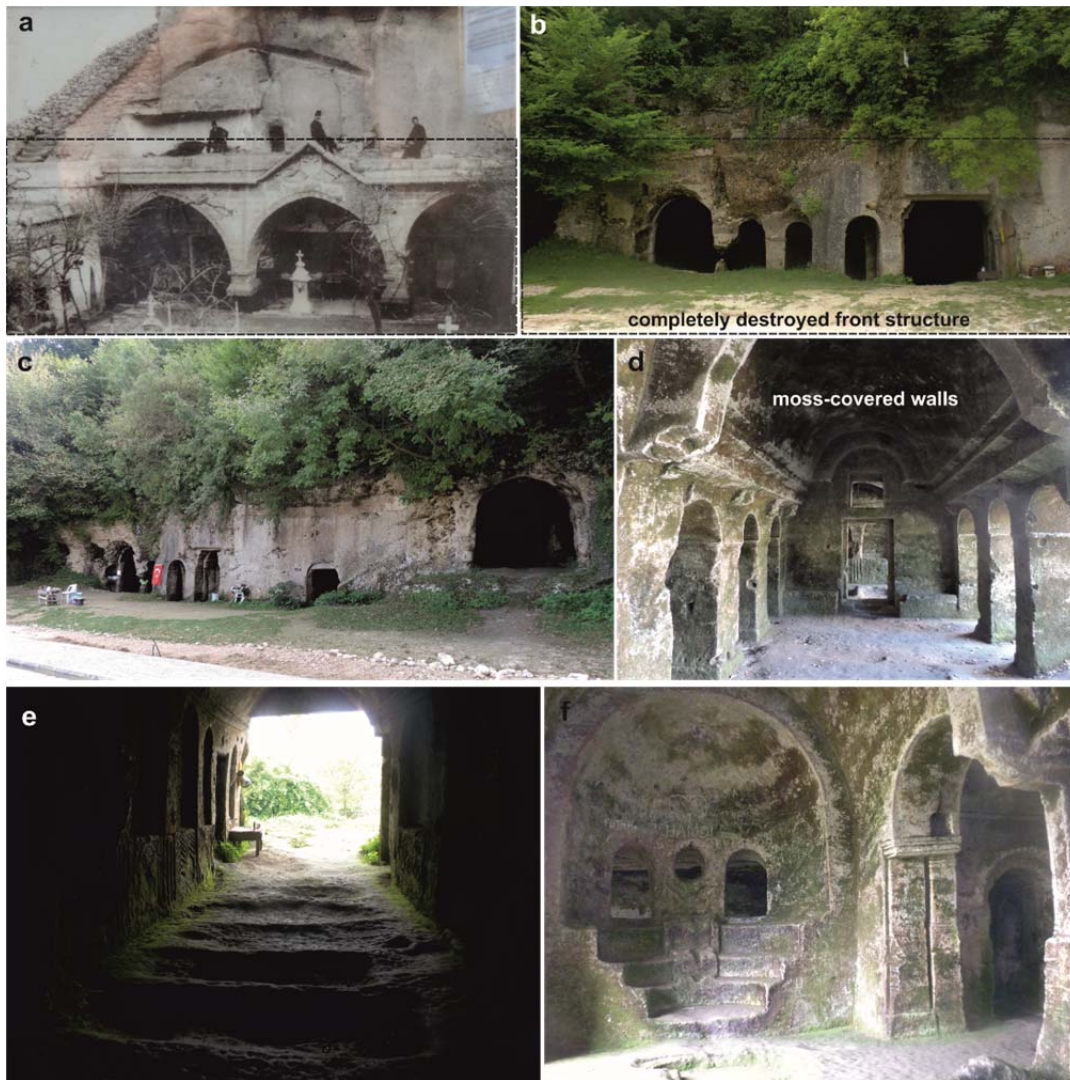
Fig. 2. Views of Aya Nicholas Monastery. (a) Front of the rock-cut monastery during pre-Republican period, (b,c) intense destruction and biologically-induced deterioration in front of the heavily-destroyed monastery walls, (d) moss-covered walls, (e) ruins of tombs, and (f) abscissa section near entrance to the monastery.

The entrance to the building, seriously damaged and covered with weeds at present, is through two consecutive doors carved into the main rock (in the north) (Fig. 2b,c). The door legs have been left in the form of a massive rock in one direction and a corner column in the other direction. The brick and mortar parts of the

The holy spring is several meters below the entrance; access to the basin is provided by stairs from the north side. Although it is under protection, it cannot be said that it is properly protected. Even though one of the local residents of Kıyıköy volunteered to look after the monastery, all the decorations and interior designs have been Kıyıköy destroyed; and the statue of Aya Nicholas, one of the most important elements of the monastery, is missing. It is understood that the tombs at the monastery's entrance were completely destroyed by treasure hunters (Fig. 2e). Likewise, in the abscissa section near the entrance, the monastery walls have been greatly damaged by visitors. The walls of the monastery are covered with moss and visually spoiled at present (Fig. 2d). There is an information plate in Turkish and English at the entrance of the monastery. .

Out of the known rock-cut monasteries and churches in Turkey, such as Gümüşler Monastery (Gümüşler, Niğde), Gölören Rock Church (Aşkale, Erzurum), Sümela Monastery (Maçka, Trabzon) and Mor Barsavmo monastery (Midyat, Mardin), the Aya Nicholas Monastery is perhaps in the most ruinous state. The most evident indicator of the destruction of the monastery as a loss of cultural heritage is the completely disappearance of the magnificent marble facade on the front. As seen in Figure 2a, there was a splendid architectural structure in front of the rock-cut monastery during the pre-Republican period. Besides this, a wooden entrance in front of the rock gallery was built by the Greeks in the 19th century, but this section was later demolished (Kırlareli Governorship, 2000).

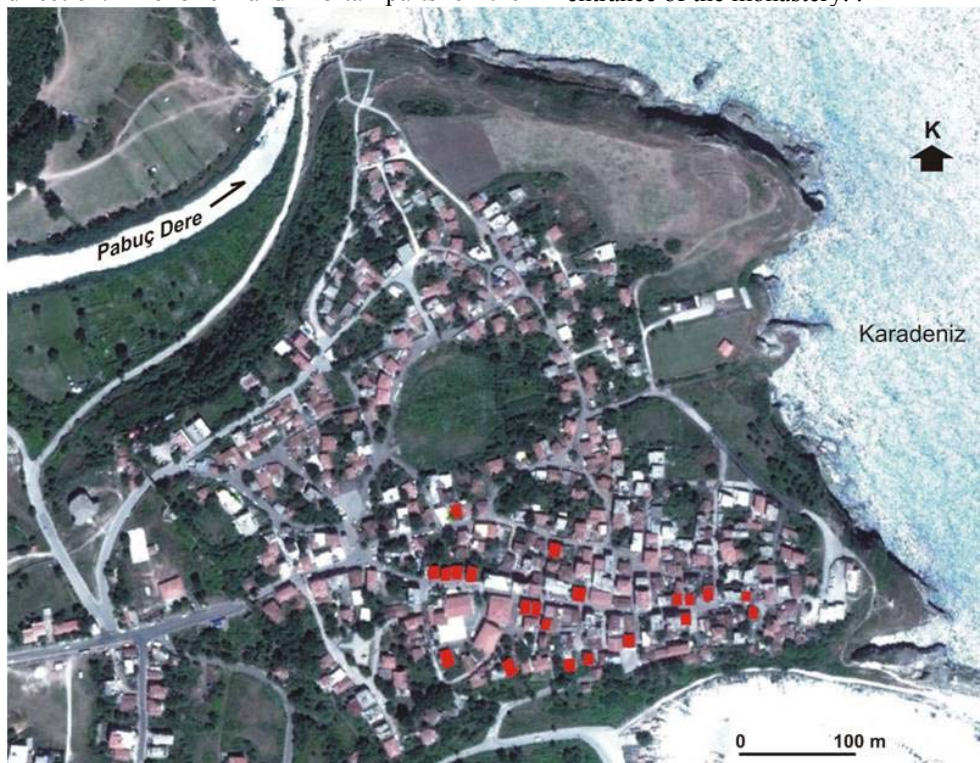
Fig. 3. Location of Kıyıköy houses on Google Earth satellite image (image date: 22.07.2011; last accessed: 04.01.2013).

neighborhoods (Apak 2009; Fig. 3). In interviews with the Mayor of Kıyıköy, it was stated that the necessary application had been made to the Ministry of Culture proposing 10 of these houses for restoration. The historical houses belonging to the Early Republican period also carry traces of Greek and Armenian architecture besides Turkish architecture. Almost all of the houses are 2-storey; the upper floors are used for accommodation and the lower floors are used as a storeroom or shop.

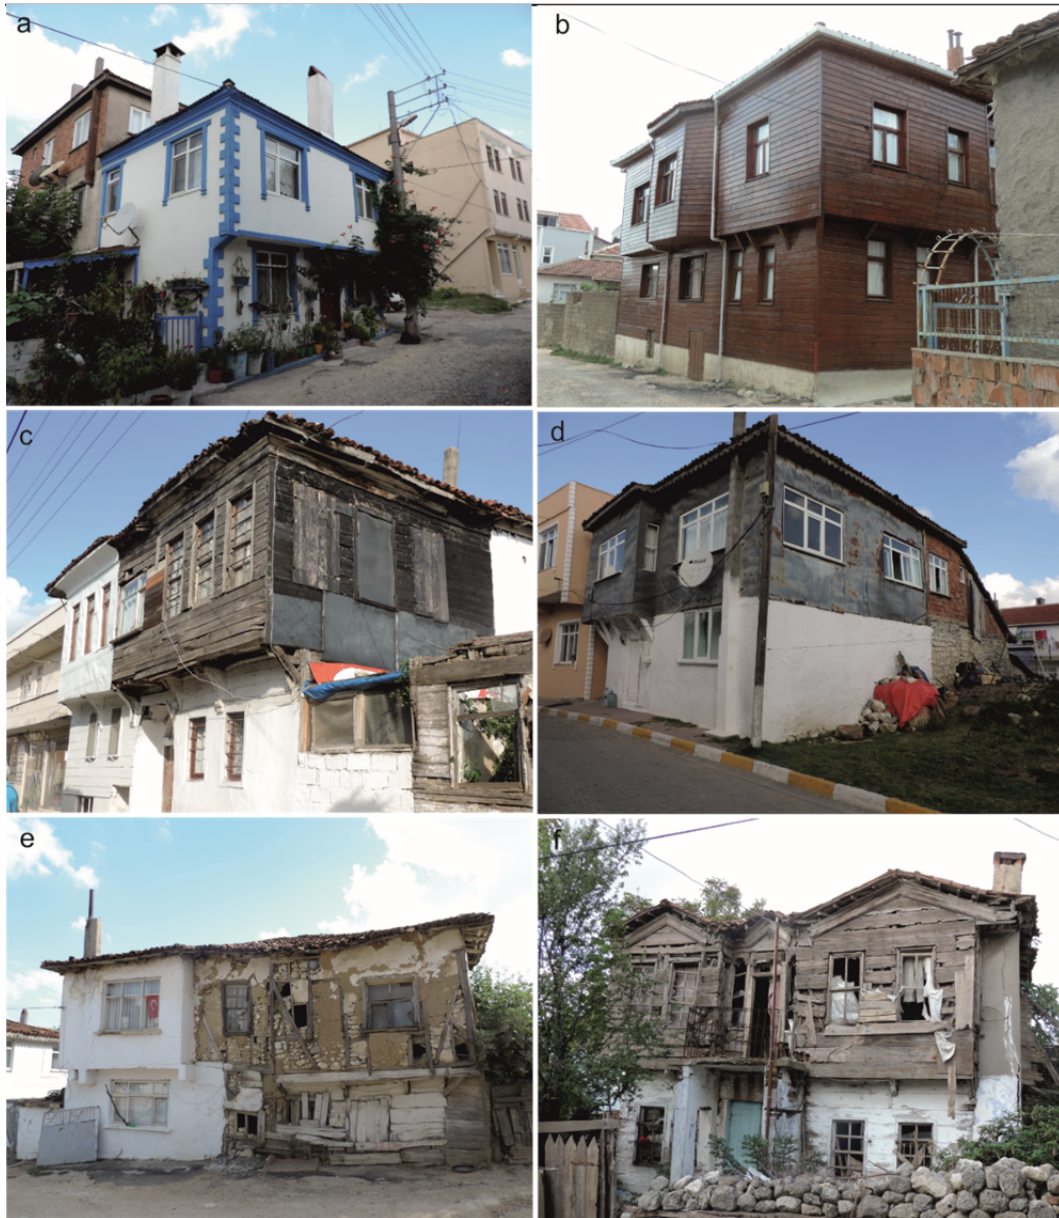
Fig. 4. Views of Kıyıköy Houses used for residential purposes at present and those that have been largely destroyed. (a,b) completely-restored houses, (c,d), incompatible interventions on the original architectural texture of building facades, and (e,f) completely ruined houses.

Figure 4 shows some Kıyıköy houses. As clearly seen in Figure 4, many of the Kıyıköy houses are still lived in and used for accommodation. However, the original appearance of the structures has been changed because of subsequent painting of the garden walls and lower floors with lime. This is one of the most important and common forms of damage to these examples of civil architecture. In addition, asymmetry is quite apparent on the exterior facades of these buildings and in the supporting columns. This indicates that the architectural structure has been severely degraded

Realistically, most of the Kıyıköy houses are too damaged to be utilized (Fig. 4). In addition to the bending and warping of the wooden columns of the upper floors of houses which are in a more deteriorated condition, there are examples where the wooden front facade is totally broken so the brick fill is exposed and the windows and glass are completely broken. In addition, the entire wooden facade on the top floor of one building is covered with sheet metal. Another example is the lower floor of a house used as a workplace; for which purpose the original texture of the house was totally obliterated by being painted over with white lime. A further example is where the restoration on the upper floor of the building is

To sum up, these examples of civil architecture in Kıyıköy were built in the style of wooden houses because the township is located in a wooded area. Climatic conditions, topography and natural vegetation are influential on the type of material used in the construction of houses and residential architecture. However, the restoration style of the Kıyıköy houses, the manner in which they are used today, and the large-scale despoilment of unused structures all negatively affect their touristic potential.
