Comparative Evaluation of Dentinal Defects Caused by Different Rotary Ni-ti Instruments: A In Vitro Study

Dr. Smita Sahni¹, Dr. Anil K. Tomer², Dr. Shobhit Kumar Pyasi³

PG Student^{1,3}, Professor & HOD², Department of Conservative & Endodontics, DJ College of Dental Science, Modinagar, Ghaziabad

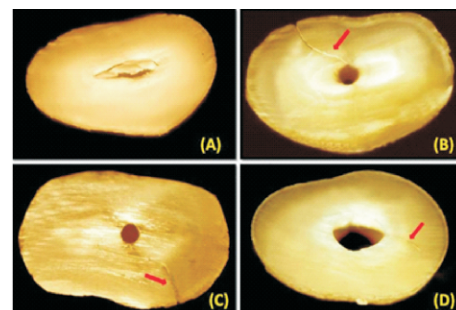
Fig -1 Various Dentinal Defects

- "No defect" was observed as root dentine devoid of any lines or cracks where both the external surface of the root and the internal root canal wall had no defects.
- "Fracture" was observed as a line extending from the root canal space to the outer surface

- "Craze line" line extending from the outer surface into the dentine that did not reach the canal lumen
- "Partial crack" line extending from the canal wall into the dentine without reaching the outer surface of the root.

Roots were classified as "defected" if at least one of the three sections showed either a craze line, partial crack or a fracture. Results were expressed as the number and percentage of defected roots in each group.

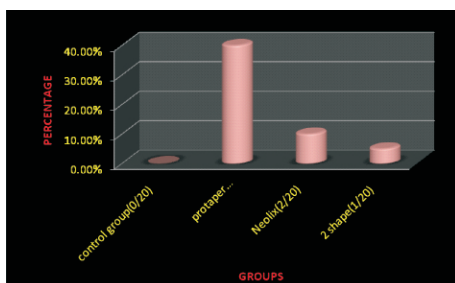
Fig-2 Bar Chart
Representing Percentage of Root Defects

Figure 2 is a bar chart representing the number of root defects in each group.

The teeth in the control group showed no defects. The maximum percentage of defect was seen in the teeth instrumented using Protaper universal file system (8/20) (40%). The percentage of defects seen in the other two groups are neolix (2/20) (10%), and 2 shape (1/20) (5%). Statistical significant difference was seen between protaper universal and the other two rotary groups. No significant difference was found between the neolix and 2 shape group ($P > 0.05$). All experimental groups demonstrated significantly more defects at the 3 mm level when compared with the unprepared group.

ProTaper had 40% of dentinal defects as compared to other rotary systems which was significantly different. ProTaper rotary files are with progressive taper design which increases stiffness and facilitates active cutting motion and removes relatively more dentin coronally compared with other systems. ProTaper file F2 has a large taper of 0.08 which could explain the higher incidence of damage than other tapered rotary files. Bier et al. observed cracks in the horizontal sections of 16% of the roots instrumented with the ProTaper system and reported that ProTaper rotary files created more dentin damage than other rotary instruments¹⁵.

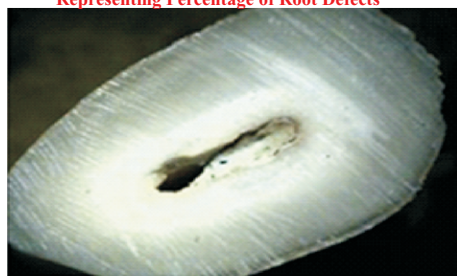
Fig-3 Stereo microscopic
Images Showing Dentinal Defects

Group II (protaper universal)

Group III (Neolix) Group IV (2 shape)

Neolix (Neolix, châtres-la-Forêt, France) and 2 shape both groups showed presence of dentinal defects in form of partial or complete cracks. Neolix has a non-homothetic rectangular section along the blade enabling a progressive flexibility to better negotiate the curves and respect the canal anatomy. It is a single file system which has an inbuilt abrasive property of the flutes and edges associate a grater and cutting action, avoiding smear layer risk. Its ability to conform to the root anatomy and greater flexibility may be the reason for less number of dentinal defects seen in his group.

2 shape file system produced the least number of defects. It has a triple helix cross-section with two main cutting edges and one secondary cutting edge for debris removal. The asymmetrical cross section allows for increased efficacy of the circumferential brushing movements for efficient selective cleaning thus reducing the incidence of dentinal defects created during cleaning and shaping of root canal¹⁶.
