Dynamic identification of historical Molla Siyah mosque before and after restoration

Calik I, Bayraktar A, Türker T, Ayan AO. Dynamic identification of historical Molla Siyah mosque before and after restoration. *Res. Eng. Struct. Mat.*, 2017; 3(3): 164-175.

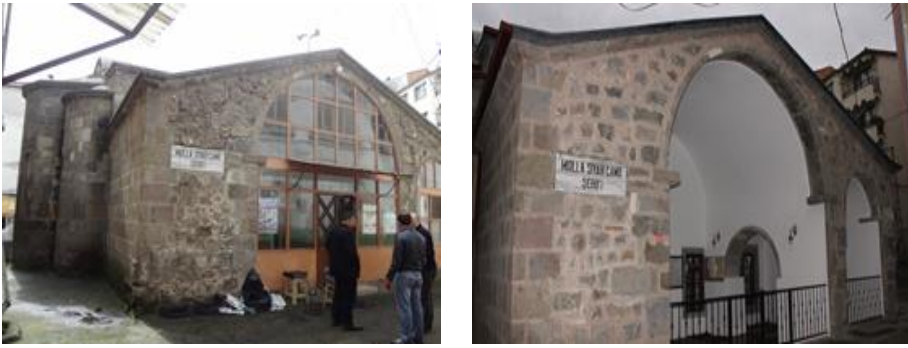
Fig. 2. Images of Trabzon MollaSiyah Mosque before and after the restoration

The structure of the mosque was built as a church in the XI Century initially. It was converted into a mosque before the 1557 [21]. The owner of the structure is Foundation of Fatih Sultan Mehmet, the administration and the representation is carried out by the General Directorate of Foundations. The mosque was restored and strengthened by the Trabzon Regional Directorate of Foundations in 2015. The photographs of the mosque before and after restoration are presented in Fig. 2.

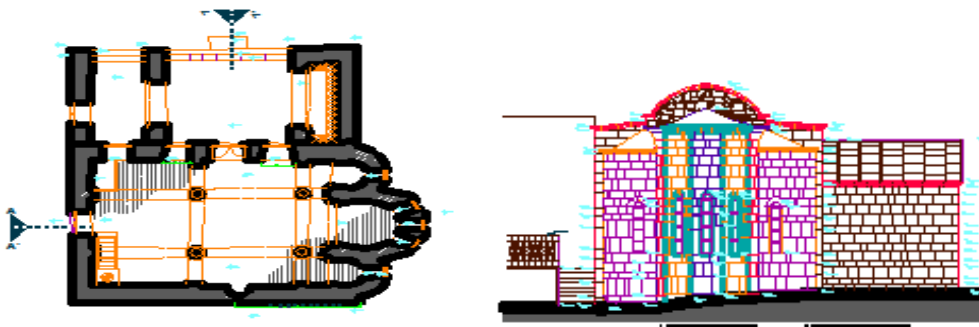
Fig. 4. Layout, inside and outside of the restoration project of Molla Siyah Mosque [23]

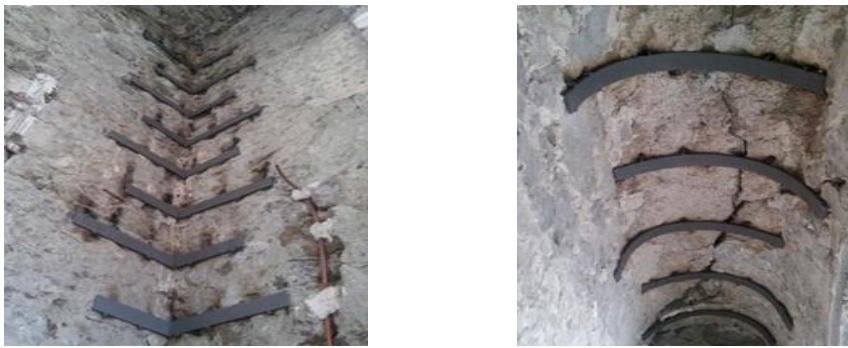
- The stone altar was cleaned of oil paint and the original stone elements were revealed.
- The mosques interior plaster has been renovated with Horosan mortar.
- After dismantling of interior plaster, it was seen that there are some deep cracks on the east and west vaults of the narthex which are in line of north to south. The injection of hydraulic lime mortar and steel sewing techniques were used to strengthening of these structural elements (Fig. 5). Also at the southwest corner of the mosque, a crack was detected from the top to the bottom. This crack is also strengthened with same techniques (Fig. 5).

Fig. 5. Strengthening applications

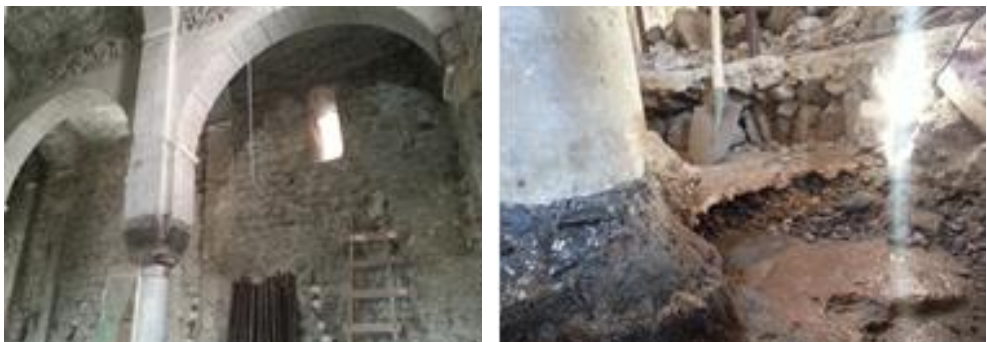
- After dismantling of interior plaster, it was observed that the beams connecting the walls and columns were made of reinforced concrete. Therefore, the beams were not converted to the masonry. They were renovated with Horosan mortar (Fig. 6). The filler on the ground were removed and it was covered with wooden slab (Fig. 6).

Fig. 6. Wall, arch and excavation applications

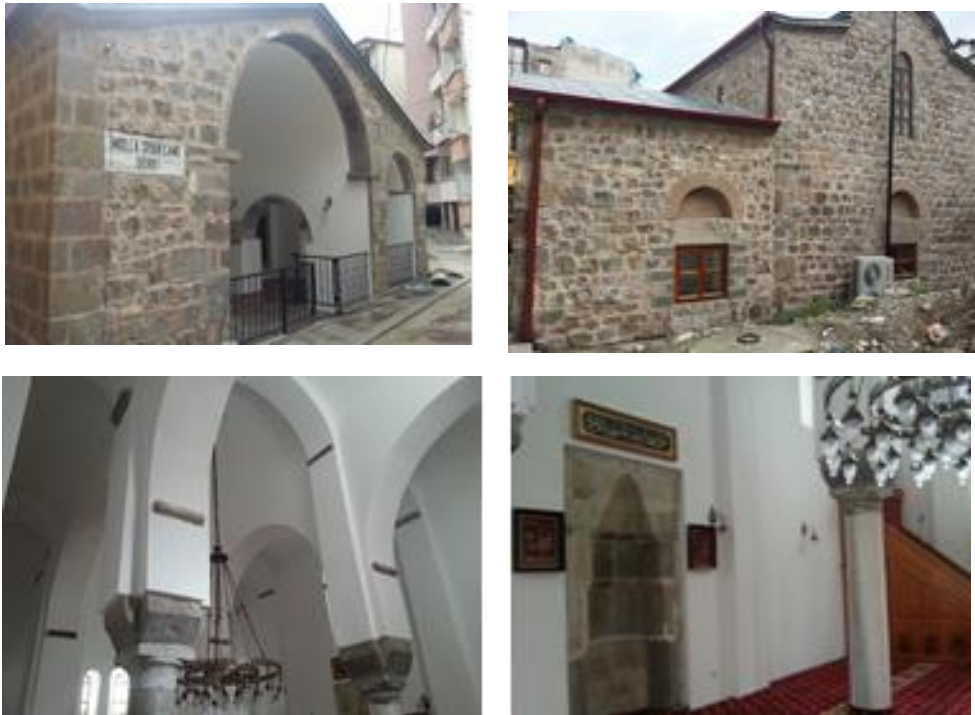
Fig. 7. The images of Molla Siyah Mosque after the restoration

The images of MollaSiyah Mosque after the restoration are given in Fig. 7.

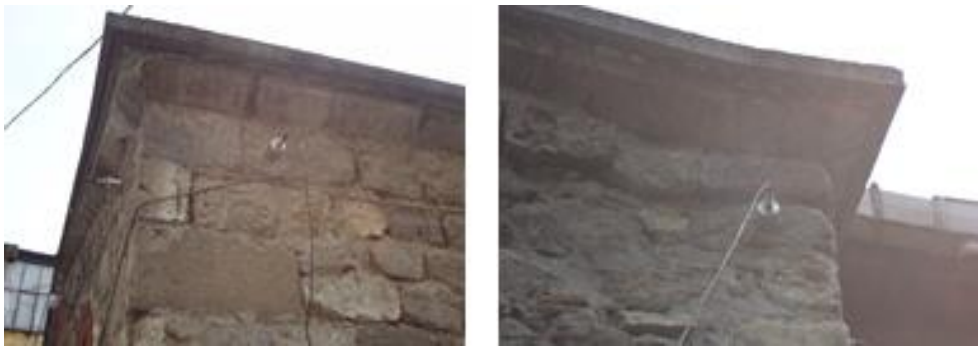
A total of 12 accelerometers were used in the measurements performed on the Molla Siyah Mosque before and after the restoration. The accelerometers were attached to the corner points of the mosque in the transverse and longitudinal directions. The used accelerometers have 10V/g sensitivity and 0.1–1500 Hz frequency range. the excitation was turned on. The frequency range for the base measurement was selected 0–12.5 Hz according to the pretest results to get the first three modes of the building model and 1024 number of sampling point was also used in these measurements. The measurement durations were selected as 60 min. Some images of the accelerometer placements and the data acquisition system are given in Fig. 8.

Fig. 8. The images of measurements of Molla Siyah Mosque before the restoration

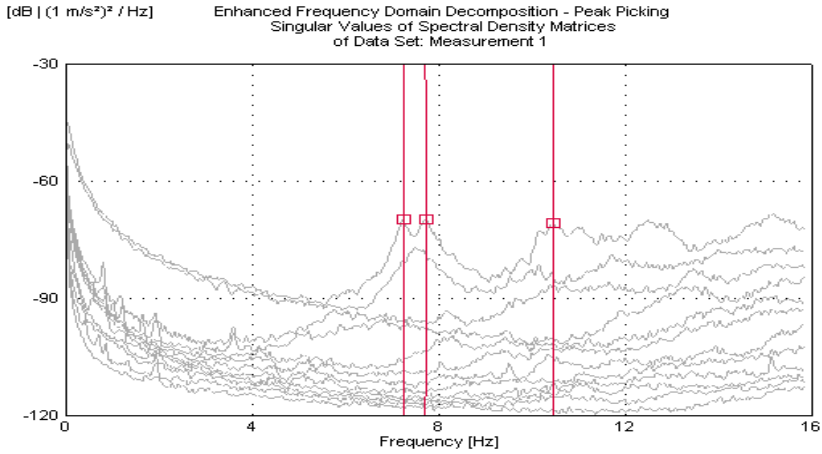
Measurements were taken from the outer body of the walls before the restoration for a period of 30 minutes and the resulting signals were analyzed using Enhanced Frequency

Domain Decomposition (EFDD) technique. The singular value plot obtained from the mosque before the restoration measurement as shown in Fig. 10.

Fig. 10. The frequency response function obtained from the mosque before the restoration measurement

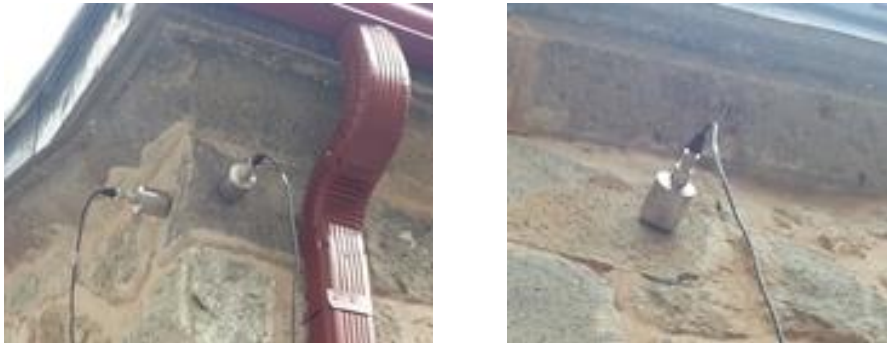
The same representative model of the accelerometer locations given in Fig.9 are used after the restoration. There are some images of the accelerometer placements and the data collection systems in Fig. 12.

Fig. 12. Some images of the measurements of Molla Siyah Mosque after the restoration

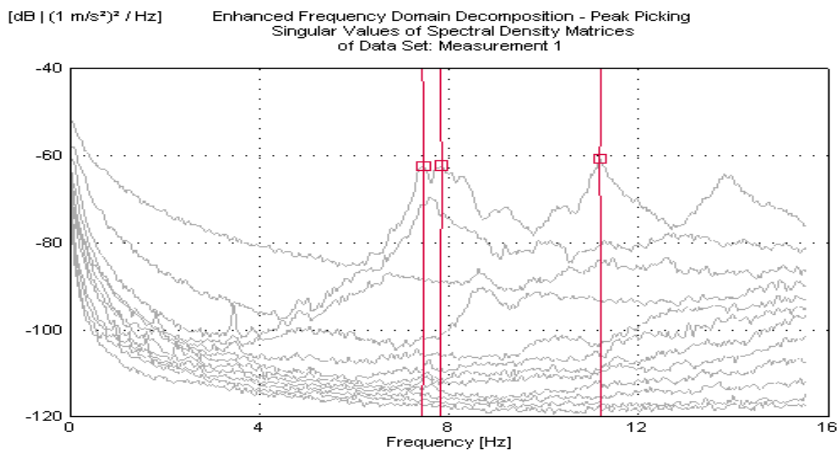
Measurements were taken from the outer body walls of the mosque after the restoration for a period of 30 minutes and the resulting signals were analyzed using the Enhanced Frequency Domain Decomposition (EFDD) technique. The singular value plot obtained from the mosque after the restoration measurement is given in Fig. 13.

Fig. 13. The frequency response function obtained from the mosque after the restoration measurement
