# Investigation and Quantification of Water Track Networks in Boreal Regions of Alaska

Mendbayar, Uyanga, Misra, Debasmita, Gupta, Tushar and Ghosh, Tathagata

Department of Mining and Geological Engineering, University of Alaska Fairbanks, Fairbanks, AK, United States

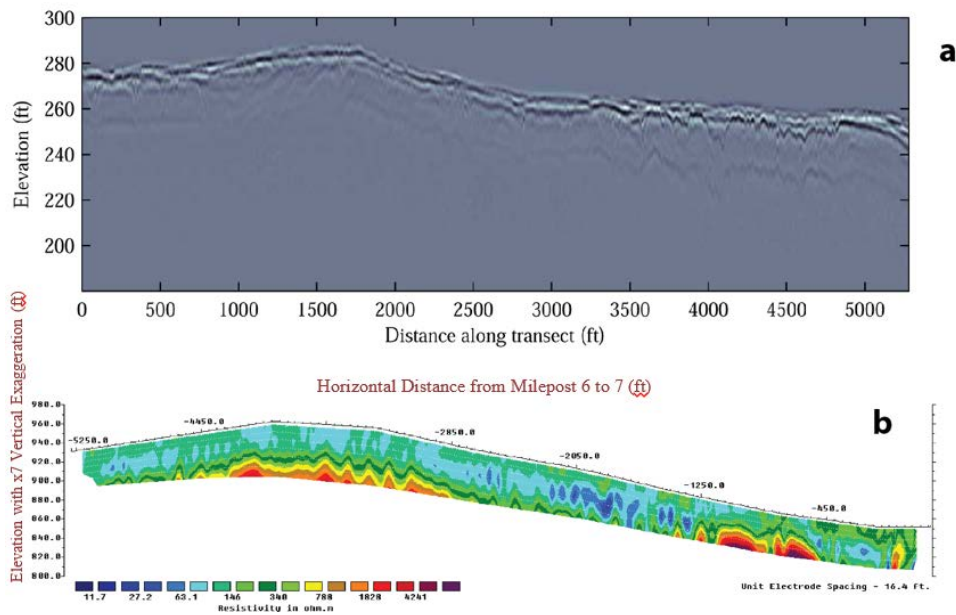
**Figure 2.** Goldstream Road geophysical results, Milepost 6-7. a) Topographically corrected GPR survey collected March 2011 b) CCR-ERT transect collected spring 2012 (courtesy of CRREL) on Goldstream Road mile 6 to 7 [7].

Goldstream Road experiences high amounts of damage resulting in a high maintenance cost. To investigate the road damages, the Alaska Department of Transportation (ADOT&PF) in conjunction with the U.S. Army Cold Region Research and Engineering Laboratory (CRREL) conducted a geophysical study in 2012. The geophysical study encompassed a seven-mile resistivity survey (i.e., Capacitive-Coupled Resistivity-Electrical Resistivity Tomography or CCR-ERT) and a two-mile Ground Penetrating Radar (GPR) survey. A sample visualization of the geophysical data is presented in Figure 2.

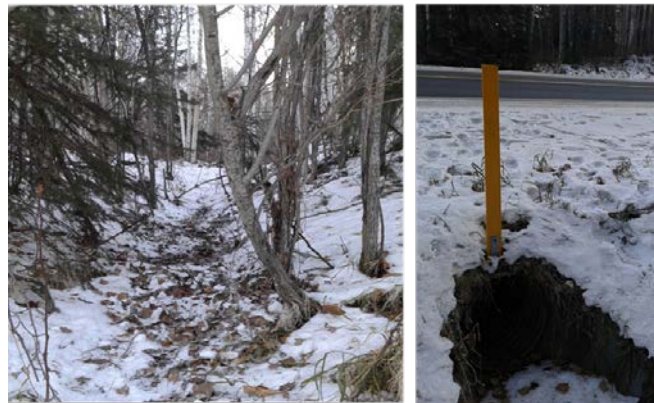
**Figure 3.** Prominent water track intercepting with the Goldstream Road. Water flow in the track has eroded the finer sediments over time so that the track resembles a rill.

One of the prominent water tracks (in Figure 3) bisecting the Goldstream Road around Mile 7 (see Figure 4 for location of the track on the road) was characterized. The track seems to have been there for a long time; a small depression is apparent along the track due to the removal of fine material by the water flow in the track. A culvert (Figure 3) was put at the location where the water track is crosscut by the road.

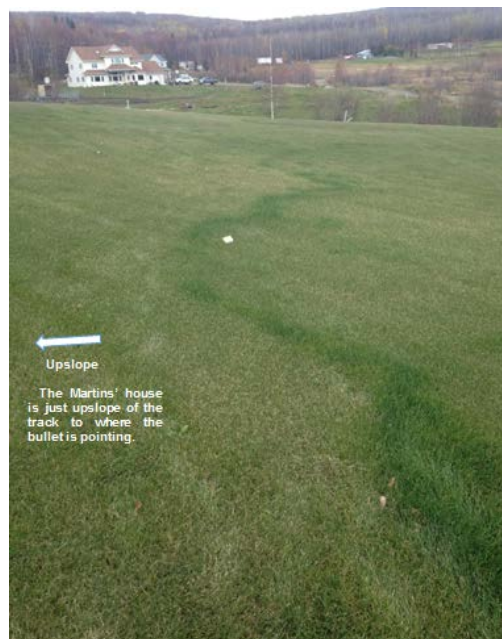
**Figure 6.** The location of Martin's property with respect to the City of Fairbanks

The second study area is located in a residential area, at the property of Bob and Mary Martin on Fabian Drive, northeast of Fairbanks, Alaska (Figure 5). A prominent water track (Figure 6) visible in summer of 2014 was characterized in November 2014.

Martin's property has been experiencing a significant amount of damage, which includes pervasive linear and curvilinear subsidence, (see Figure 7) in the recent years. The characterized track was prominently visible by its denser vegetation than the surrounding. It was located across the slope in front of Martin's house (Figure 6) in 2014 summer, but was no longer visible in 2015 summer. This track and its vicinity showed no sign of subsidence.

At the second characterized water track at Martin's property, measurements were taken in November 2014, when the ground was covered with snow, and the air and soil temperatures were below freezing. The water track in front of Martins' house, hidden by snow cover, was located by observing photographs taken in early fall of 2014 (Figure 6). A nine-meter length transect—set up perpendicular to, and across the track (Figure 9)—was shoveled clear of snow. Along this survey line, measurements of soil temperature, unfrozen water content, and intrinsic permeability were taken at ten centimeter (0.1 m) intervals using the same equipment as the characterization at the Goldstream Road (i.e., oven thermometer for soil temperature; Hydrosense II sensors for unfrozen moisture content; and Tiny Perm II permeameter for intrinsic permeability).

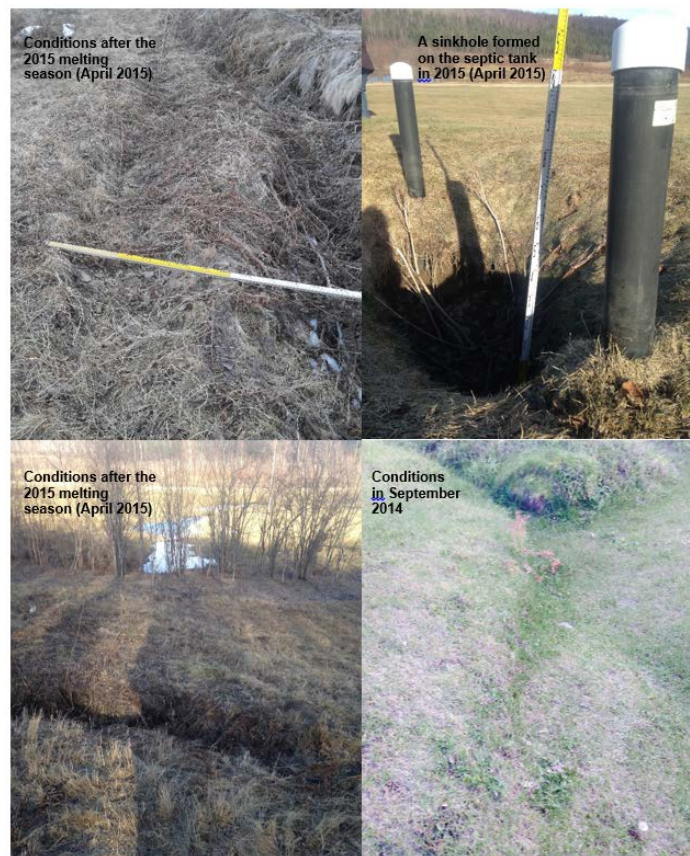
**Figure 7.** Subsidence and topographic changes observed at Bob and Mary Martin's property.

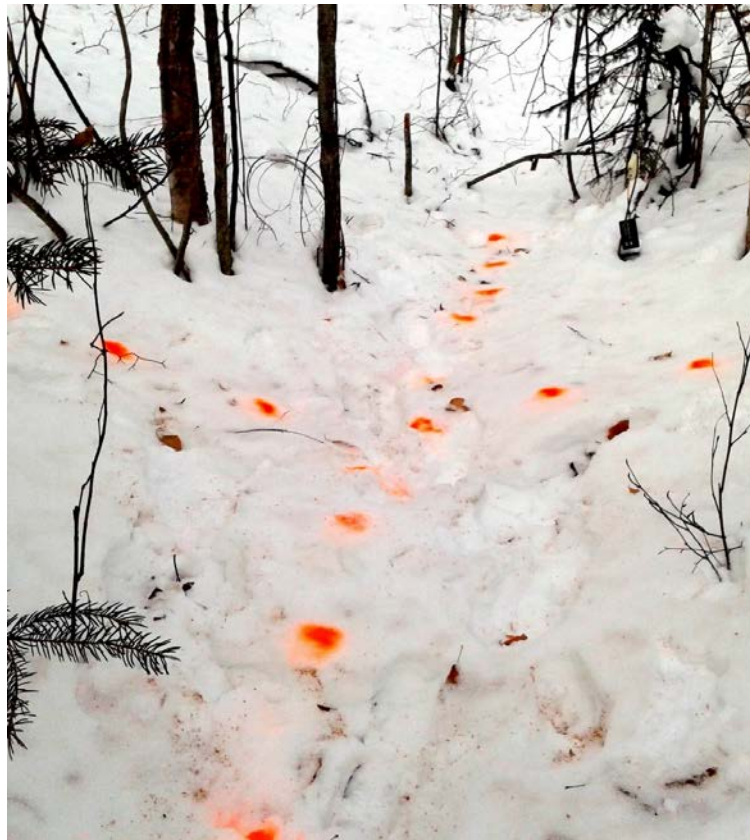
**Figure 8.** The water track sampling set-up near the Goldstream Road. N-S points on the downhill transect (referred as vertical transect) portray characteristics along the water track, and the E-W points on transect across the water track (referred as horizontal transect) characterize the water track surroundings.

At the water track on Goldstream Road, data was collected pre-winter (12/16/2014) and post-winter (03/20/2015) on a vertical (along the track) and a horizontal (across the track) transects to observe the changes between the physical properties of the two transects. Figure 8 shows the survey set-up at the field. The air temperatures on 12/16/2014 and 03/20/2015 were recorded as  $-12\text{ }^{\circ}\text{C}$  and  $+9\text{ }^{\circ}\text{C}$ , respectively.

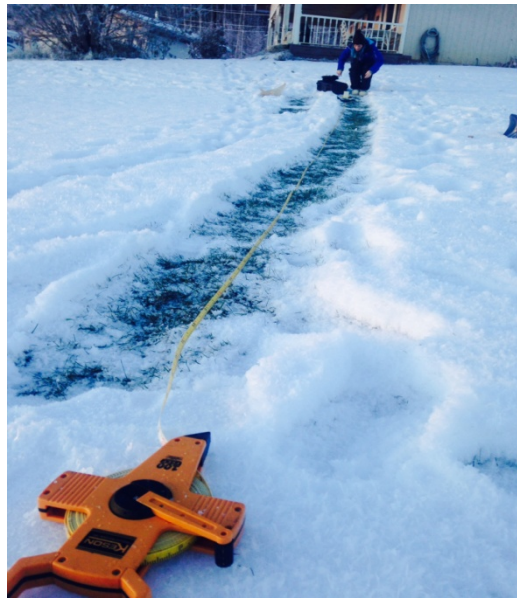
**Figure 9.** The transect across the water track at Martin's house being set up by Rebekah Tsigonis, former undergraduate student of Geological Engineering, University of Alaska Fairbanks (UAF) in fall 2014.

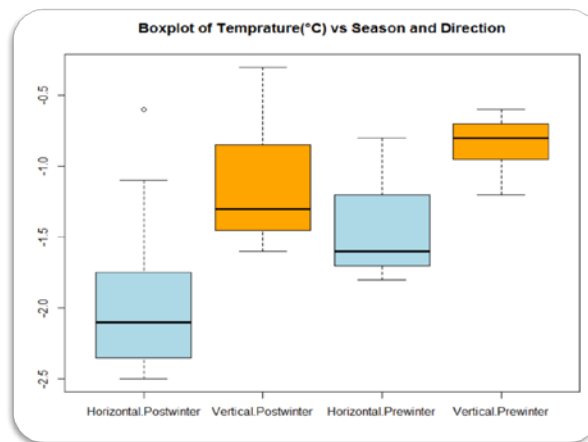
**Figure 10.** Boxplots of temperatures on- and off-track during pre- and post-winter seasons. Vertical transect (on-track) represents along the water track areas, and horizontal transect (off-track) traverses across the water track, characterizing its surroundings.

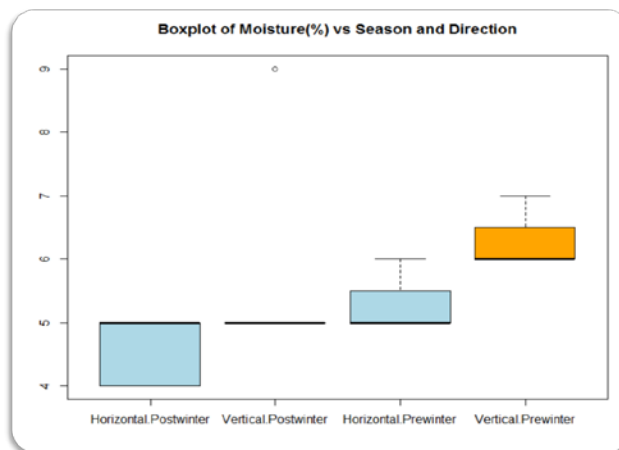
**Figure 11.** Boxplots of moisture content on- and off-track during pre- and post-winter seasons.

Figure 11 shows the difference in saturation between the water track and its surrounding ground in pre-

winter sampling. However, the limited difference is noted in post-winter sampling, suggesting that moisture redistribution was beginning to occur at that period of time. It may be noted from Figures 10 and 11 that in the post-winter data, significantly higher temperature and water saturation (e.g., the outlier in Figure 11) are measured at the bottom of the vertical transect—near the water track and road interception. This suggests that despite there being a culvert to route the water flow through the road fill, the runoff is possibly pooled in the subsurface at some point of the interception of water track and road fill. The F-test conducted on the difference of mean properties (temperature and water saturation) between the two transects show that these differences are statistically significant at 95% confidence level (Table 1).

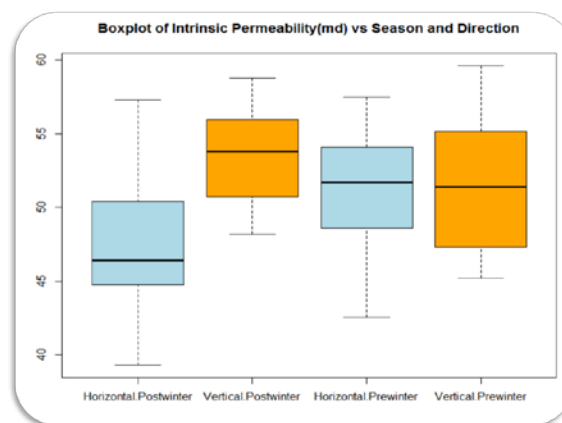
**Figure 12.** Boxplots of intrinsic permeability on- and off-track during pre- and post-winter seasons.

Although Figure 12 data was not used in the testing of our hypothesis, it reveals that significant anomalies in intrinsic permeability along the track and its surroundings could be used effectively to identify water tracks. More researches are necessary to determine the use of intrinsic permeability as a parameter to characterize water tracks.

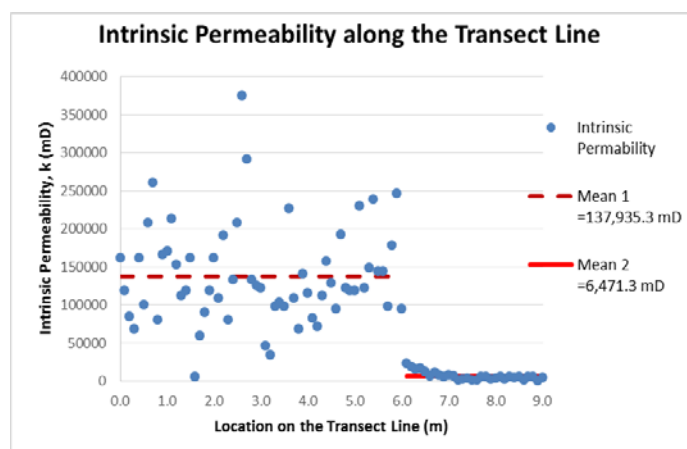
**Figure 13.** Obtained intrinsic permeability along the survey line, which increases from 0 to 9 m down the slope.

When the raw permeability data was plotted against the horizontal distance along the nine-meter transect (see Figure 13), it is observed that the permeability measurements of the first six meters of the transect line are significantly higher than those of the last three meters. The mean intrinsic permeability was calculated to be 137,935 mD ( $1.36\text{E-}06 \text{ cm}^2$ ) from 0 to 6 meters and 6,471 mD ( $6.39\text{E-}08 \text{ cm}^2$ ) from 6 to 9 meters. The mean permeability of the first section (0-6 m on the survey line) is over 21 times larger than that of the second section (6-9 m on survey line). This abrupt change in permeability implies the presence of zonal anisotropy, suggesting that there are possibly two geologic units along the survey line. The permeability profiles of each section (geologic unit) are presented in Figures 14 and 15.

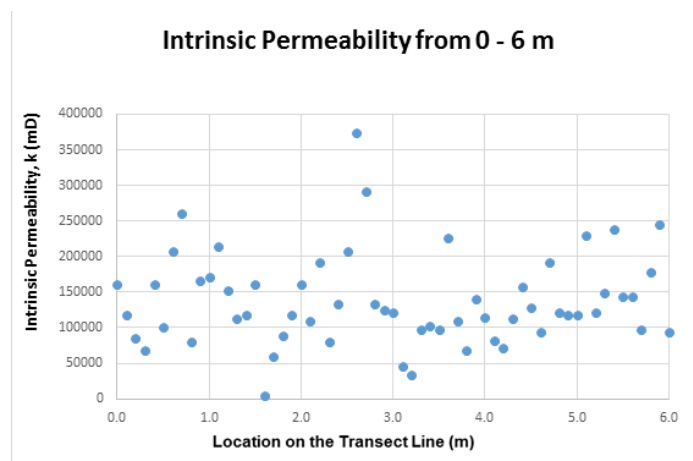
**Figure 14.** The intrinsic permeability of the first section of the survey line (0 m to 6 m)

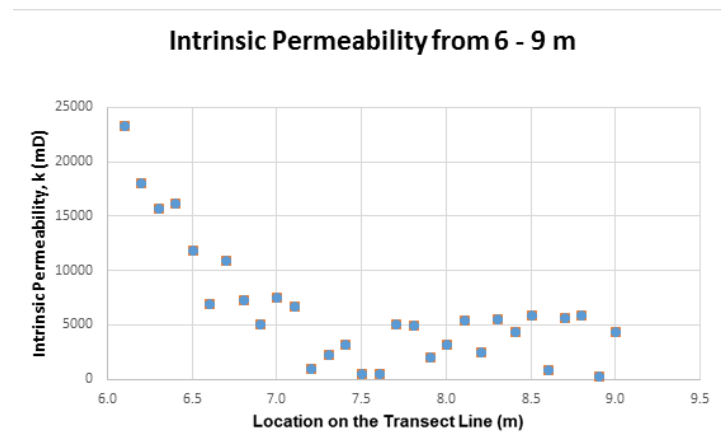
**Figure 15.** The intrinsic permeability of the last section of the survey line (6 m to 9 m)

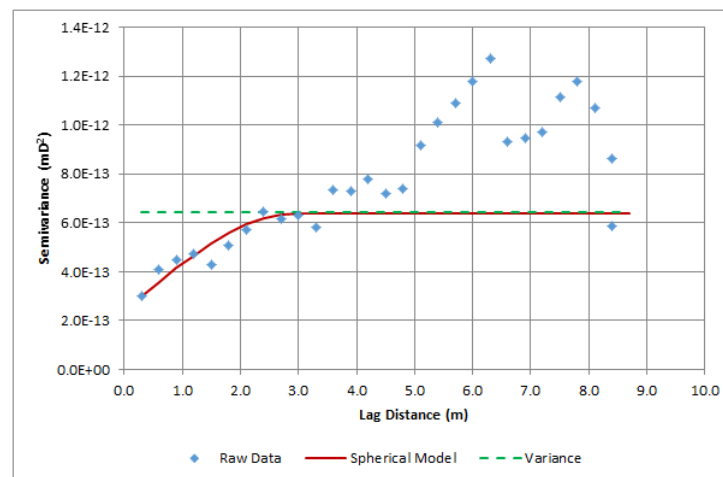
**Figure 16.** The plots of the experimental variogram and variance with the two models fit to the experimental variogram.

fit semi-variogram models. The experimental semi-variogram was fit with two models: spherical and exponential. Of the two models, the spherical model seemed to be better representative of the continuity. The spherical model fits best with a nugget of  $2.40E-13$  and a range of 3 m. The small nugget value suggests that there is significant variability in the permeability at small distances along the transect line. The range of three meters suggests a change of zone within three meters, which agrees with what was observed from the raw data. A plot of the best-fit model along with the experimental semi-variogram and variance is shown in Figure 16.

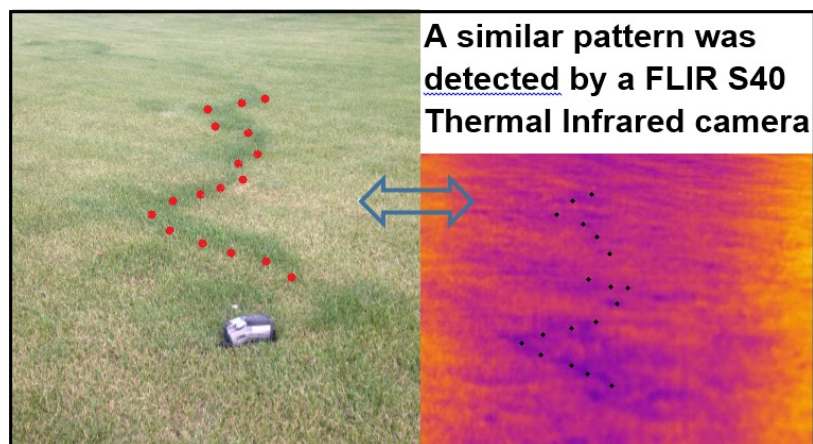
**Figure 18.** Water track captured by FLIR S40 camera when the temperature was relatively warm.

With the handheld Thermal Infrared (IR) cameras, the different thermal regime along water track, due to its higher moisture content, was successfully detected by both cameras (i.e., FLIR S40 and T620) at two different times of the year. When the ambient temperature was relatively warm in late summer/early fall, the higher evapotranspiration from the water track was sensed as cooler than the surrounding (Figure 18). Whereas, when the air temperature was starting to drop in late fall/early winter, the warm moisture reserved in the water tracks from the summer radiated warmer thermal regime along the track compared to the surrounding areas (Figure 19). Both thermal images (Figure 18 and 19) have high spatial resolutions since they were acquired with cameras being handheld. Unmanned Aerial Vehicles (UAV) should be able to acquire similar high-spatial-resolution images covering larger areas.

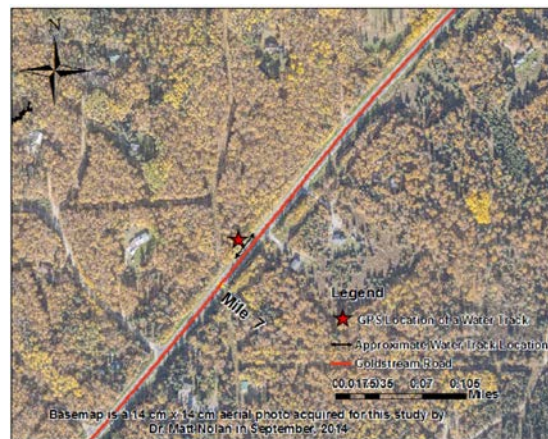
**Figure 20.** The location of the measured track along with the fifty-meter range of location.

A 300-meter resistivity profile around the location of the characterized water track was extracted from the 2012 resistivity survey data of Goldstream Road. The fifty-meter approximate position (Figure 20) of the water track was then located on the 300-meter resistivity profile (Figure 21). The red dashed rectangle in Figure 21 represents the fifty-meter approximate position of the characterized water track. The lowest resistivity drop in the 300-meter profile was observed within the red rectangle. This suggests that water tracks might have lower resistivity than their surroundings, but more correlations using different analysis methods and with resistivity data from different times of the year are necessary to validate the conclusion from this correlation.

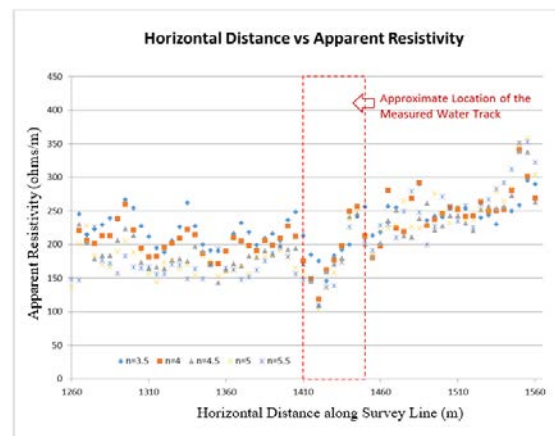
**Figure 21.** Resistivity profile near the characterized water track. The red rectangle defines the fifty-meter approximate range for the position of characterized water track. The n-factor is used to calculate the distance between the receiver and transmitter based on the dipole length.
