Stability Loss of the Cemented Stem of Hip Prosthesis due to Fretting Corrosion Fatigue

Aim of this project was to study the fretting behaviour of the cemented femoral stem fixation of a total hip prosthesis, trying to capture the loss of contact between the femoral stem and polymethylmethacrilate cement fixation. To have a landmark, studies were performed compared with cementless fixation, where no fretting phenomenon occurs, on real prostheses, under biological 3D loading conditions. A fatigue test device, installed on a servo-hydraulic triaxial dynamic testing machine was used. It allowed monitoring the flexion-extension, abduction-adduction, inner-outer rotation movements, and the variation of the torsional torque, depending on normal loading. The test ends when the sample does not fail after 2000000 cycles, or when it has reached a predetermined number of cycles. Test fluid medium used was NaCl mixed with distilled water, a favourable environment for appearance of fretting corrosion. After the failure of stem fixation at 2450000 cycles, the mantle of bone cement remaining adherent on femoral stem was removed. Microscopic inspection of the femoral stem and of the inner part of

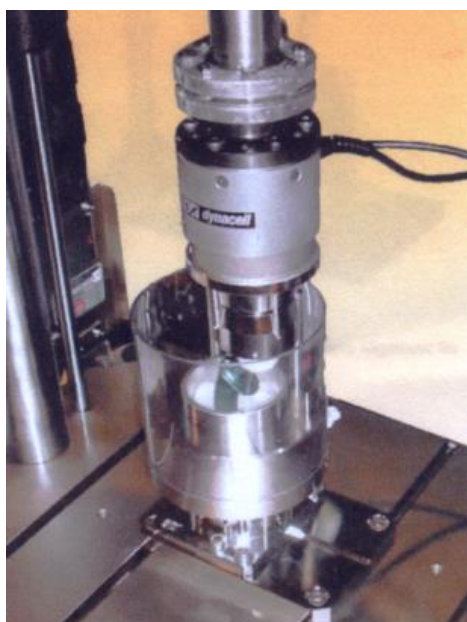
Fig. 1. (a) Instron® fatigue test device for the femoral stem cemented fixation of the total hip prosthesis, and (b) Instron® testing system scheme for prosthetic stem fatigue fixture.

Fretting tests were performed on a Instron® device for fatigue testing of the femoral stem cemented fixation of the total hip prosthesis – Fig. 1, installed on a servo-hydraulic multiaxial dynamic testing machine MTS Bionix, equipped with testing system for hip implants – Fig. 2.

Instron® device – Fig. 1(a) simulates fatigue loading of a hip cemented stem during a gait cycle. Device consists of a support made of a composite femur model from Sawbones® transparent plastic with intramedullary channel, in which the prosthetic stem is cemented. It has a low friction loading head, incorporating a low friction bearing and an adapter for mounting to the system loading cell – Fig. 1(b). This device is mounted in a sealed saline chamber, which contains a NaCl high concentration solution (~ 0.2 M) at a temperature of 38 °C. The ensemble has a temperature regulator and a circulation pump for in vivo testing. The flexible support for prosthetic stem allows a wide variety of hip geometries, offset angles, materials and embedding depths to be used. The device applies compression, bending and torsion to meet the ISO 7206-4 requirements.

Loading compression through the loading head makes the femoral stem specimen to be subjected to loads and frequencies as specified in ISO 7206-8. The test ends either when the sample does not fail after 2000000 cycles, or when it has reached a predetermined number of cycles. In the case of this research, the test was stopped at 2450000 cycles, when indices of fretting appeared. Test fluid medium used was NaCl mixed with distilled water and testing frequency was 10 Hz.

The joint of the hip implant presented in Fig. 1(b) is a spherical joint with 3 degrees of freedom, which represents the three rotations around the coordinate axes ($\omega_x, \omega_y, \omega_z$) - Fig. 9.

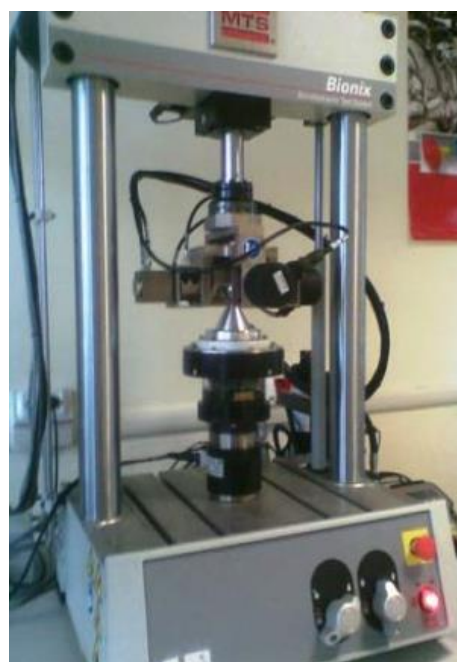
Fig. 2. MTS Bionix servo-hydraulic multiaxial dynamic testing machine, equipped with system for testing the hip implants.

MTS Bionix servo-hydraulic multiaxial dynamic testing machine (Fig. 2) allows triaxial testing of hip implants and in tribological terms [11].

MTS Bionix system is equipped with three rotating motors for inner-outer rotation (IOR), flexion-extension (FE) and abduction-adduction (AA) movements and with three displacement transducers, one for each type of movement. In addition, it has a transducer for the moment of torsion, with two Wheatstone decks, one for measuring linear force and the other to measure the torsion moment. The moment transducer is of resistive type and it is coupled with a current converter type 662 20 h-04, to process received signals from each Wheatstone deck.

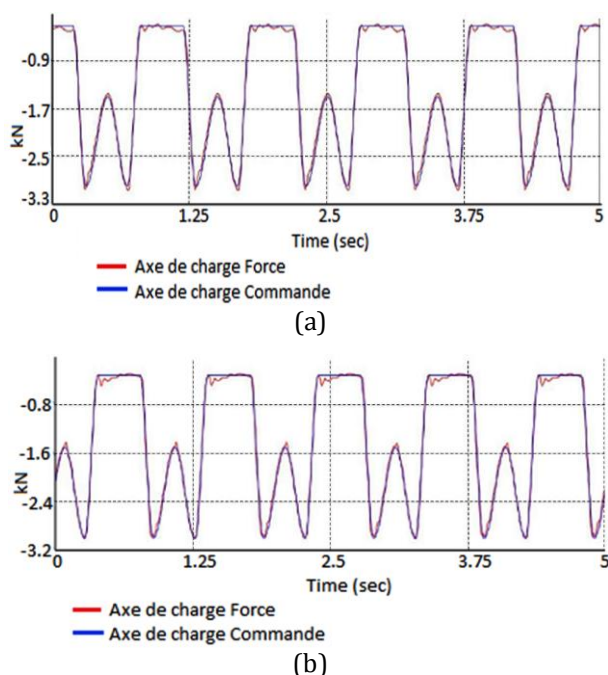
Fig. 3. Time graph of the vertical contact force, command-response (blue-red) when testing the cemented prosthesis (a) and (b) a cementless prosthesis (press-fitted stem).

For MTS Bionix system calibration, the prosthesis was subjected to simultaneous requests of FE, AA and IOR during a cycle and was considered a time of 5 seconds, where human subject achieves 5 complete cycles. In Figure 3 are shown the graphs of vertical contact force: the answer come from the force transducer is represented by the red colour and blue is the command set.

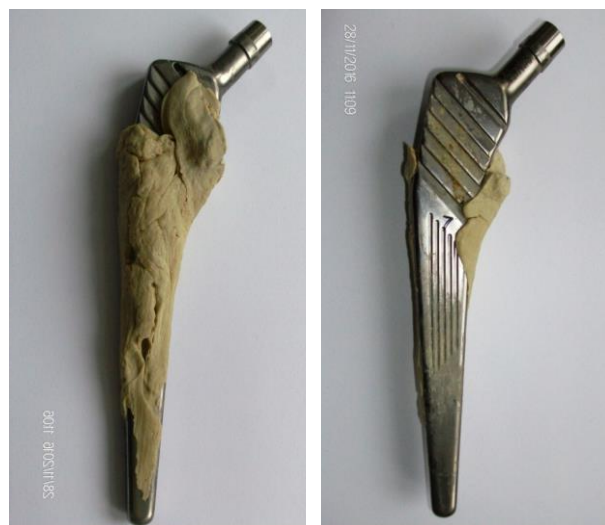
Fig. 10. The sides of the cemented stem prosthesis together with a part of the cement mantle, extracted after 2450000 cycles of fatigue test, from Instron® device.

Stem prosthesis was easily extracted from the composite bone support, after some left-right movements, together with much of the PMMA cement mantle. Figure 10 shows images of both sides of the cemented stem prosthesis with a part of cement mantle, extracted after 2450000 cycles, from Instron® device.

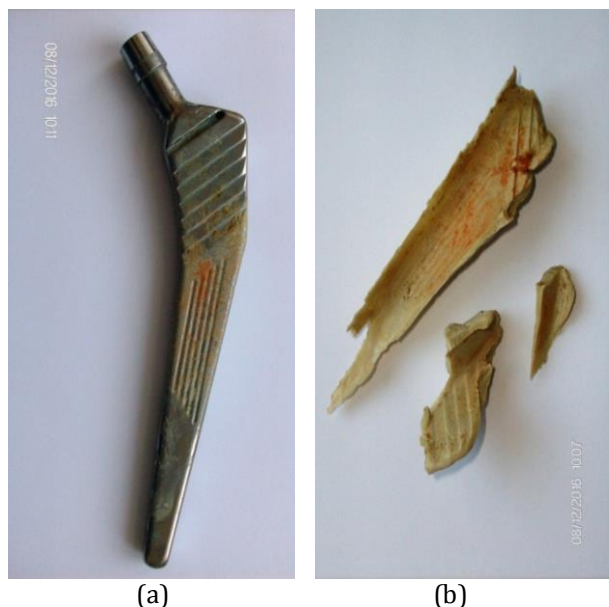
Fig. 11. Contact sides appearance of cemented stem (a) and cement mantle (b), extracted after 2450000 cycles of fatigue test, from Instron® device.

Obvious corrosion of the femoral stem surface beneath the cement mantle, and reddish Fe_2O_3 deposits on the femoral stem surface and, by

transfer, on the inner part of the PMMA mantle were observed. These are due to fretting corrosion.

In Fig. 11 are shown photographic images of contact sides of the Ti6Al4V femoral stem and of the PMMA mantle, after fretting experiment.
