## **HISTORY OF TECHNOLOGY**

### **A petrochemical study of Mughal plasters of Quila-I-Ark, Aurangabad with respect to technology and repair**

**Abstract.** *This paper reports the mineralogical composition of western India's 16-17th century Mughal plasters of Quila-I-Ark, Aurangabad to prepare compatible repair mortar and document ancient Indian lime technology. Analytical studies were undertaken for aggregate grain size distribution, thin section analysis, Fourier Transform Infrared Spectrometer (FTIR), X-ray diffraction (XRD), and chemical composition of the plasters by x-ray fluorescence (XRF analysis). The analysis revealed the inclusion of large size basaltic aggregate grains mostly sourced from the water channel of nearby Harsullake. Some of the plaster works show prominent inclusion of small size grains pointing different periods of construction. Creamy white zeolites were found specifically added in the mortar mix to maintain a certain level of humidity during the dry season. The zeolite is highly porous and breaks easily both in dry and wet conditions. The calcite rich limestone with traces of magnesium was sourced as raw material for the plasters. Based on mineralogica

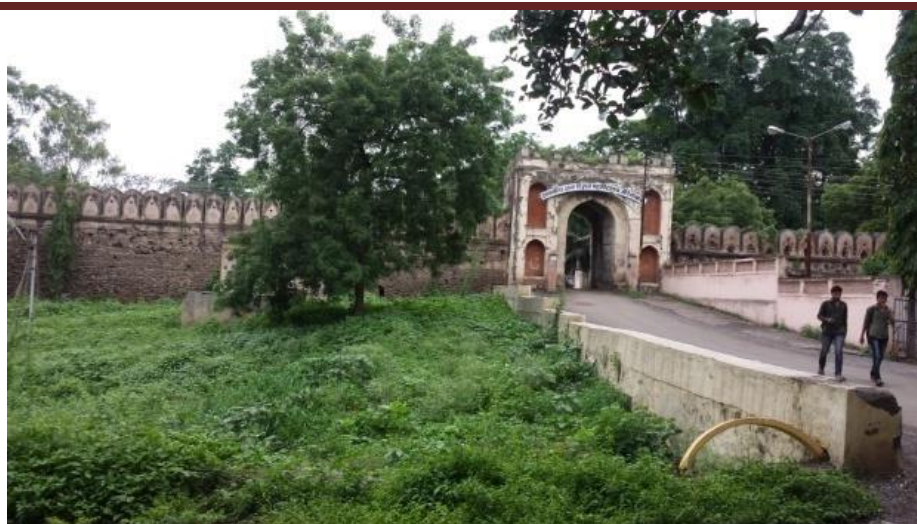
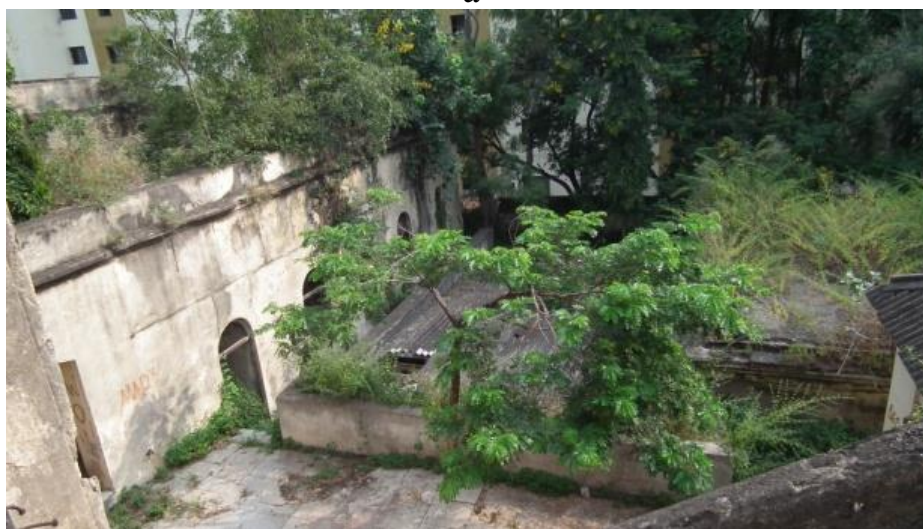
**Figure 2.** Quila-I-Ark: a – general view of Quila-I-Ark; b – growth of trees and shrubs on the monument; c – view showing layers of damaged plasters.

On visual inspection and observations under a magnifying lens, it is seen that lime plaster is applied in two layers. The inner thick rough plaster layer and outer smooth layer (Fig. 3).

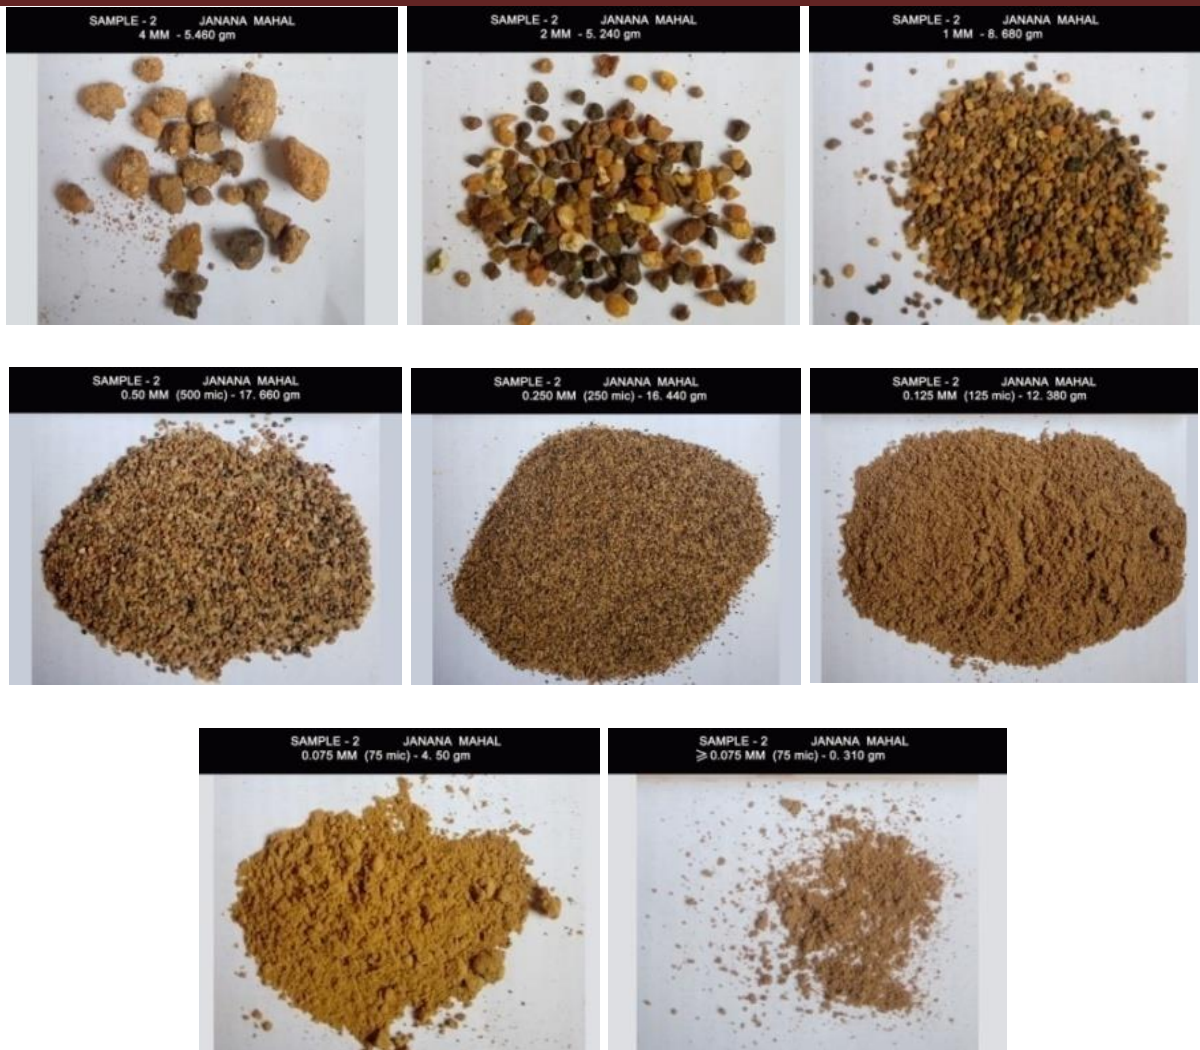
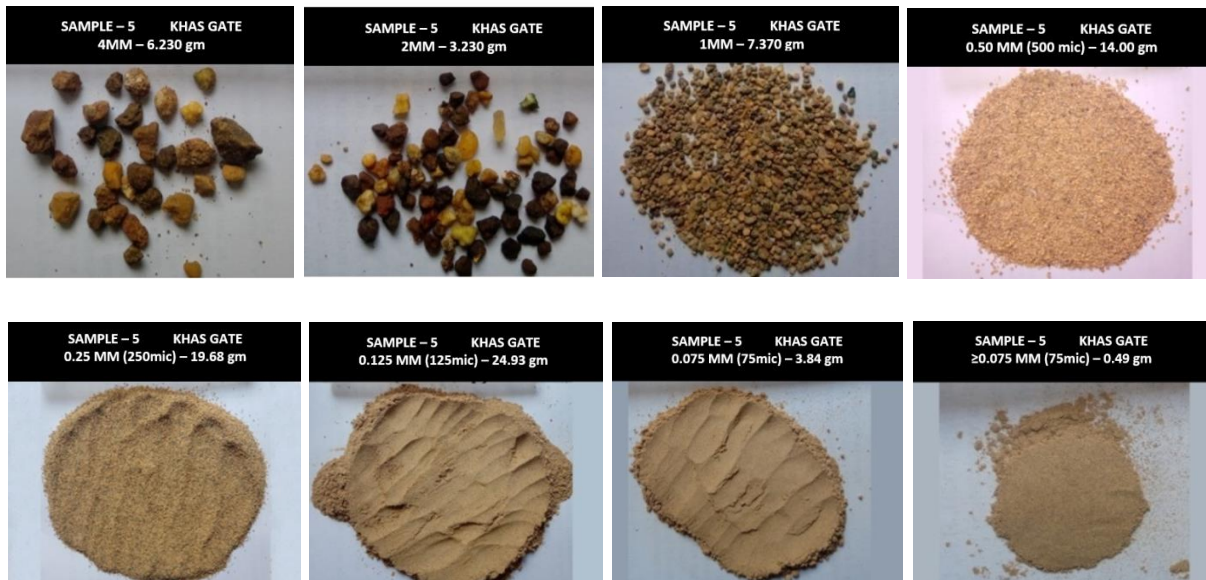
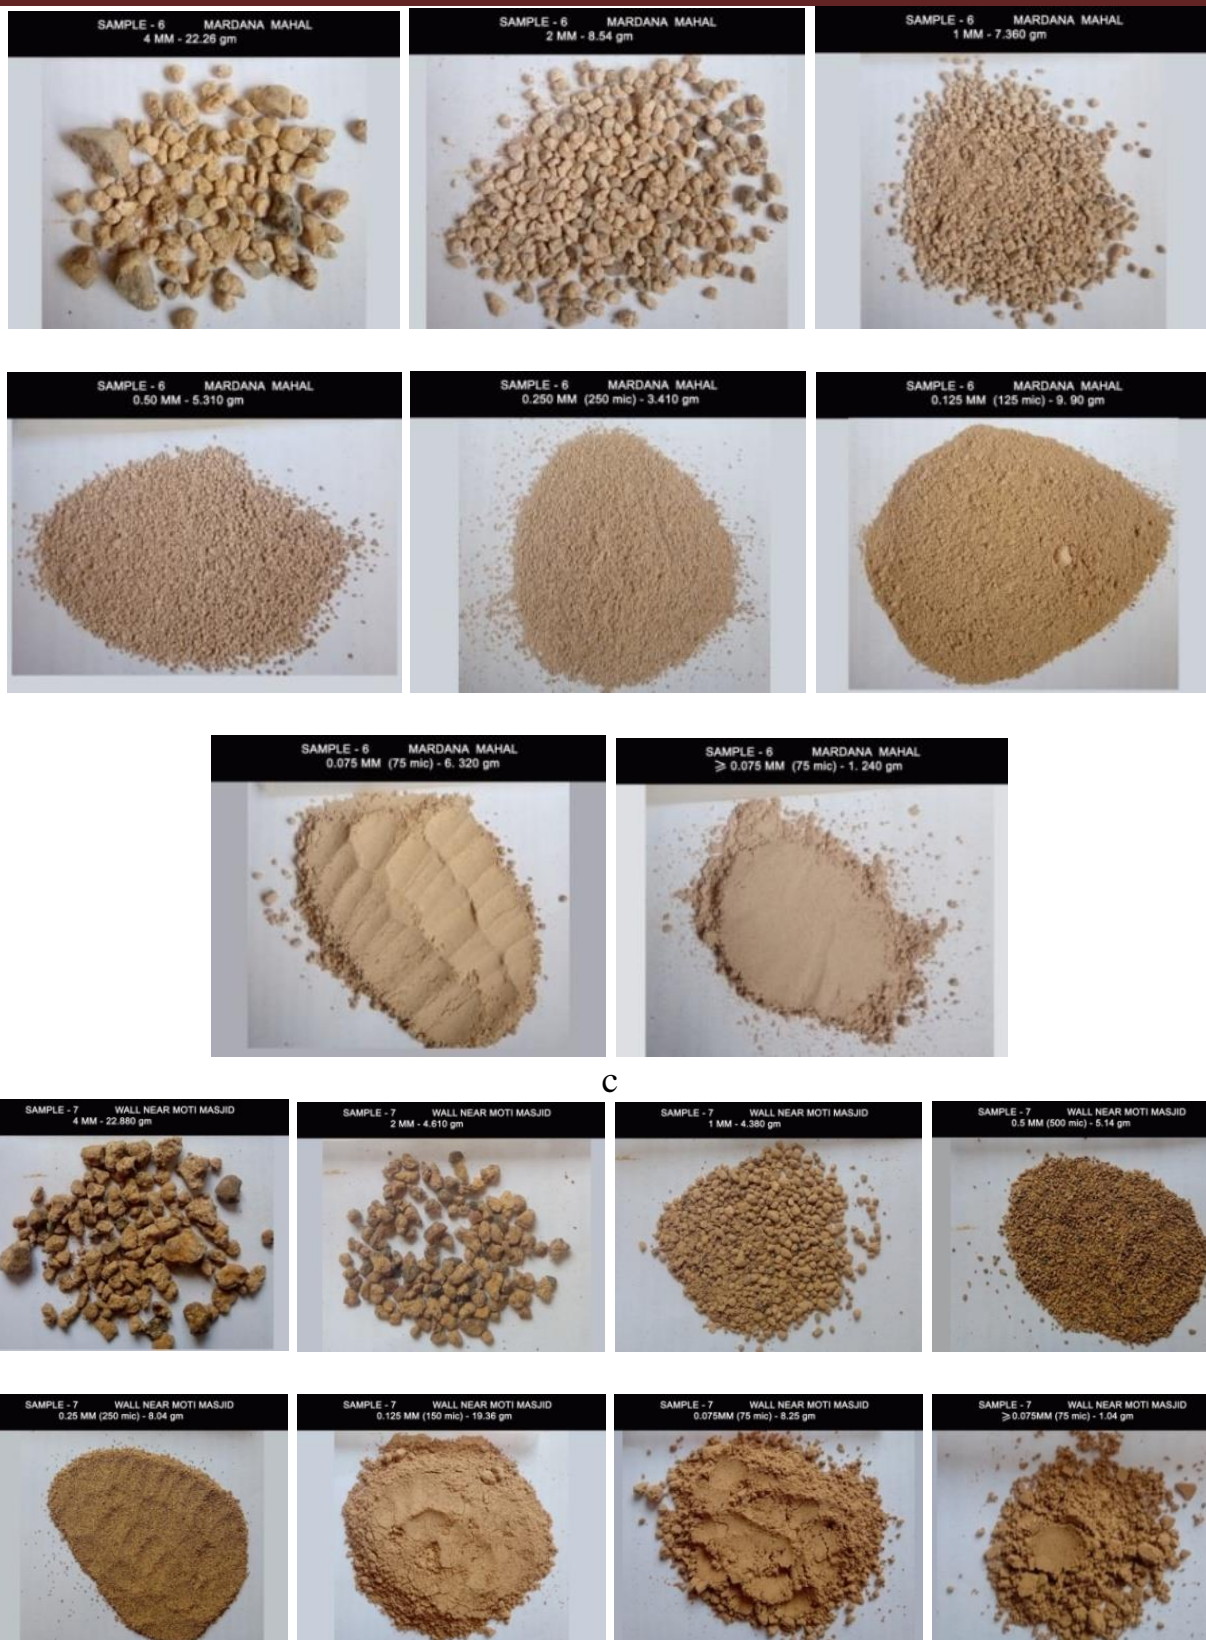
**Figure 3.** Acid insoluble aggregates in the plaster samples: a – No. 2; b – No. 5; c – No. 6; d – No. 7.

The acid-insoluble part of the plaster was mechanically sieved to examine the size of the aggregate grains. The plaster samples 2, 5, 6, and 7 were subjected to aggregate analysis, and insoluble fractions separated through sieve analysis are shown in figure 3. All the samples showed coarse to medium grained inclusion of aggregate grains as filler. The coarse grain aggregates vary in size from 4 mm to 1 mm and mostly derived from weathering of basaltic rocks of local origin. From figure 3 it is observed that all the fort plasters were preferably mixed with greyish brown, light brown to creamy white colored unsorted aggregate grains of local origin. The creamy white aggregates soak water and changes to reddish-brown color. The creamy white aggregate also crushes very easily both in dry & wet conditions and shows porous nature. Aurangabad and its surrounding are the dry regions of Maharashtra having acute drinking water deficiency. The climate is mostly dry with day temperature reaching up to 38–40°C in the summer season. The hot climatic condition may desiccate the lime works of the region and cause loss to the plasters. It appears that the technicians deliberately added the hygroscopic creamy white porous aggregates to retain moisture for the long survival of plasterworks. The increased moisture in the plaster has also facilitated a better carbonation reaction. The creamy white aggregates have been identified as zeolites of local origin (Singh & Arbad, 2015). All the aggregate grains mixed in the plaster are the decay product of amygdaloidal basalt of light brown to reddish-brown color. The other finer fragments of aggregate grains are in the size range of 500 to 75 micron with particles < 75-micron size is very less in the quantity (Fig. 3).
