Published in the USA
 Propaganda in the World and Local Conflicts
 Has been issued since 2014.
 E-ISSN 2500-3712
 2021. 8(2): 115-122

Letter to the Editor

The Agit-Steamer Krasnaya Zvezda in Later Photographs

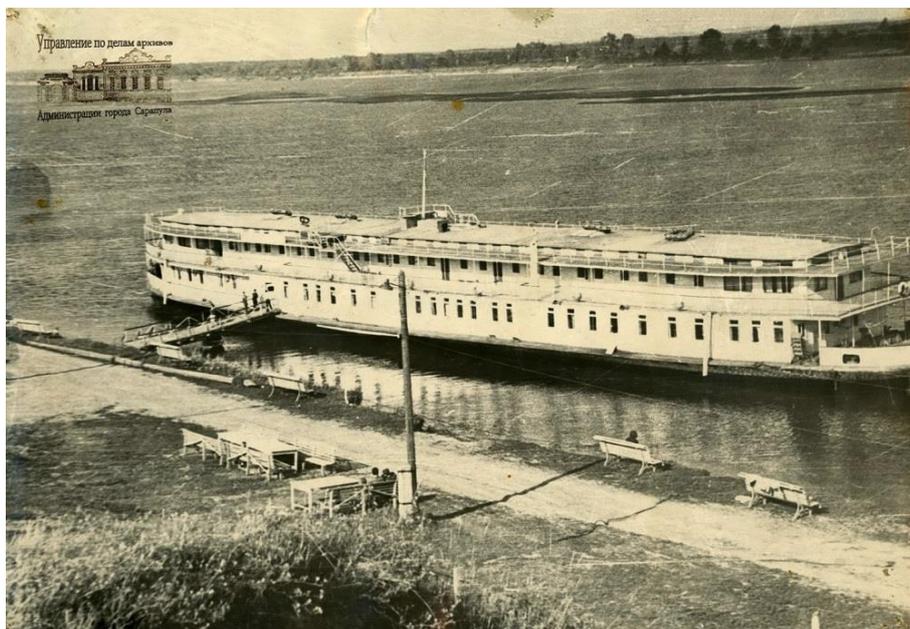
The first photograph (Figure 1) must have been taken in summer, which is suggested by the exuberant vegetation in the fore- and backgrounds. The picture also takes in two people, who are sitting on a bench in the foreground with their backs to the photographer, two more people, who are standing on the ramp at the entrance to the steamer, and one more person, who is sitting on a bench on the left, all wearing summer outfits, which confirms the assumption that the picture was taken in summer. The steamer is missing its wheels and smoke funnel. There being a trodden road and a well-fitted-out holiday area near the steamer is suggestive of the spot being the vessel's permanent dock by a holiday center.

Fig. 1. Photograph of the steamer *Krasnaya Zvezda* (SGA. F. R-840. Op. 3. D. 810)

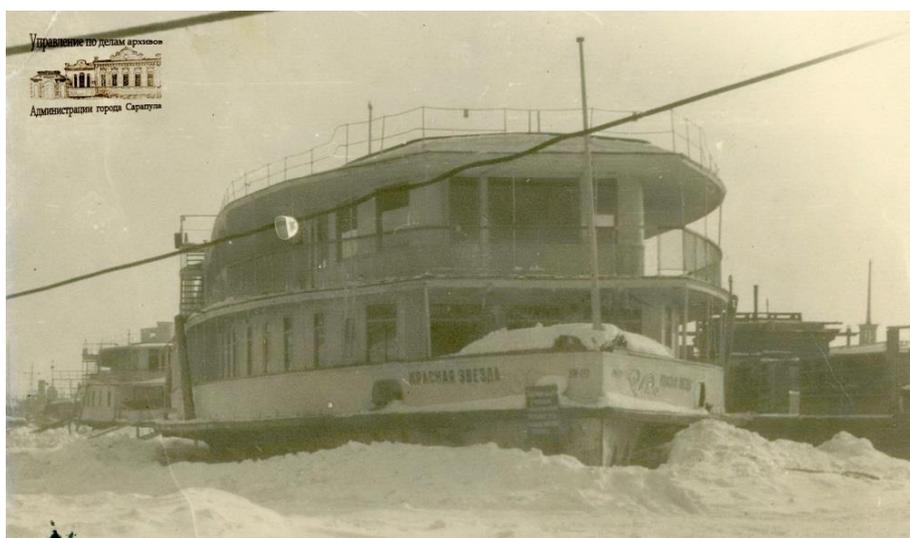
The second photograph was taken at a time the vessel was wintering (Figure 2). It, likewise, is missing its paddle wheels and, apparently, its smoke funnel. A few other wintering ships can be seen in the background. The name '*Krasnaya Zvezda*' and the registration number 'KM-177' are clearly visible on the side of the vessel. There is a poster attached to its side. While it appears to be impossible to make out what it says, it seems to start with the word 'Comrade', so it can be suggested that it is a poster designed to warn people against getting on the ship from the ice.

Fig. 2. Photograph of the steamer *Krasnaya Zvezda* (SGA. F. R-840. Op. 3. D. 811)

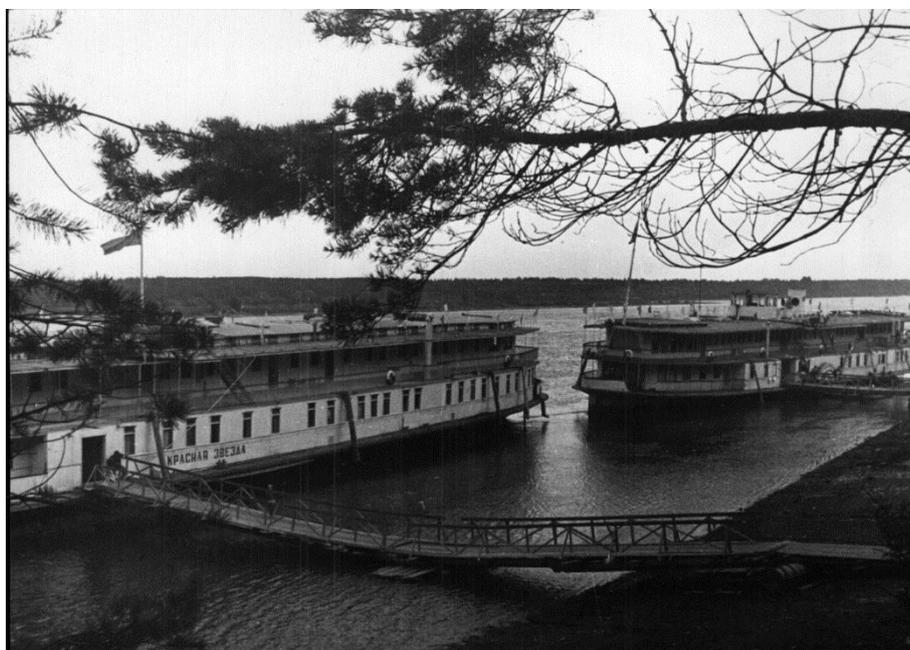
The holding R-750 contains a photograph showing the steamers *Krasnaya Zvezda* and *Lunacharsky* (Figure 3). The caption to it says the following: “The steamers *Krasnaya Zvezda* and *Lunacharsky* at the dock of the *Krutyye Gorki* holiday center of the *Sarapul Ordzhonikidze Radio Factory*, with their cabins used for the accommodation of holidayers” (SGA. F. R-750. Op. 1F. D. 10880). The photograph is dated May 1969. It was taken from a steep bank of the River *Kama*. On the left, there is an anchored steamer that has the words ‘*Krasnaya Zvezda*’ written on its side, and to its right there is another vessel with an illegible name. Both steamers are shown with their ramps down. As the spot is a shallow one, there is a small special raft propping the long ramp of the *Krasnaya Zvezda*.

Fig. 3. Steamers *Lunacharsky* and *Krasnaya Zvezda* by the *Krutyye Gorki* holiday center (SGA. F. R-750. Op. 1F. D. 10880)

It is well possible that these photographs were taken in the same place as the one shown in Figure 3. This is supported by the date – 1969. There is also a characteristically long ramp, although the raft propping the ramp in the middle was left out. Whereas the photograph in Figure 3 takes in just one branch of a fir tree, the one in Figure 5 clearly shows an entire forest on the bank. Of interest is also the second photograph, which shows two powerboats to the left of the ramp. The one closer to the photographer is most certainly a bridge erection powerboat. Unfortunately, the number on its side is illegible.

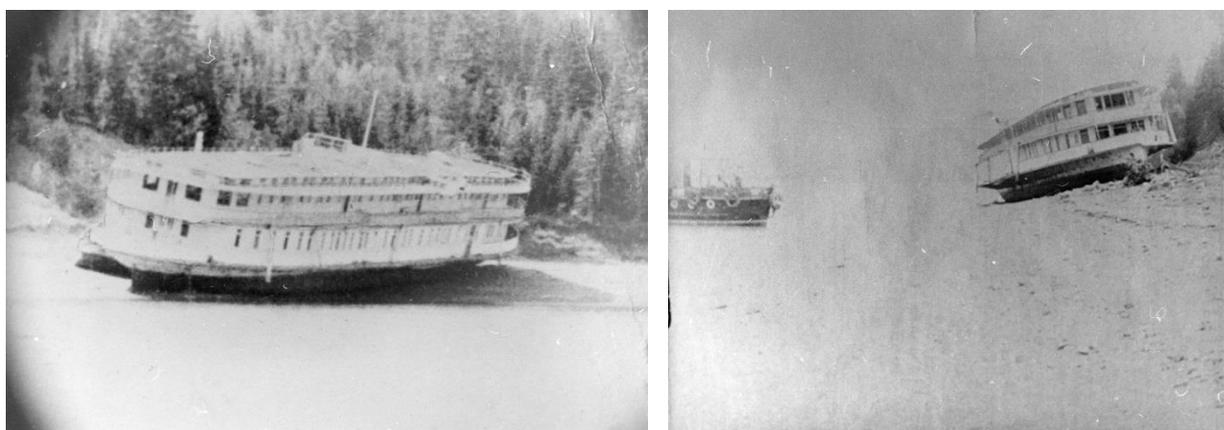
beaching of the steamer. The event resulted in a deformation in the ship's hull, making impossible its further use. Based on the captions, the photographs were taken in June 1973 (Figure 4). All three photographs are a film negative. However, given the fact that the image is quite blurry, it can be suggested that we have here a photograph reproduction. This is supported by the characteristic flaws of a paper image in the form of scuffs and creases, which would not have been there had the photograph been taken from life.

An analysis of the photographs indicates that two of them (Photo No. 20297/2429 and Photo No. 20297/2430) represent the same item (Figure 4, right). In the second photograph, the image of the steamer is cropped, and there is a black smear on the right. However, the images have the same point of view, as well as the same characteristic basic natural elements (some driftwood and rocks by the foreship). The third photograph (Photo No. 20297/2428) was taken from a different point of view (Figure 4, left). In it, the steamer is seen in stern view. One of the photographs takes in the front part of an unknown powerboat. The image is too blurry to determine what kind of powerboat it is. However, it may well be what the photographer arrived at the place on. The first photograph (Photo No. 20297/2428) must have been taken prior to the vessel hitting the beach, onboard the powerboat, and the rest of the pictures must have been taken later on the shore. This scenario is supported by the positioning of the photographs on the film, with them numbered in ascending order.

Fig. 4. Failed beaching of the steamer Krasnaya Zvezda in June 1973: left – Photo No. 20297/2428; right – Photo No. 20297/2429

steamer was transferred from the Kama River Shipping Company to the Izhevsk Mechanical Plant, within the timeframe under examination the vessel appears to have been on the books of the Sarapul Ordzhonikidze Radio Factory, which is indicated by the captions accompanying the photographs. In 1973, while being beached on the shore, the vessel sustained a severe deformation to its hull, which would eventually make impossible both its further use and restoration. Despite certain elements of the ship's hull being still in existence as of the early 2000s, it appears to be highly unlikely that one will be able to reconstruct the steamer just based on those remains.

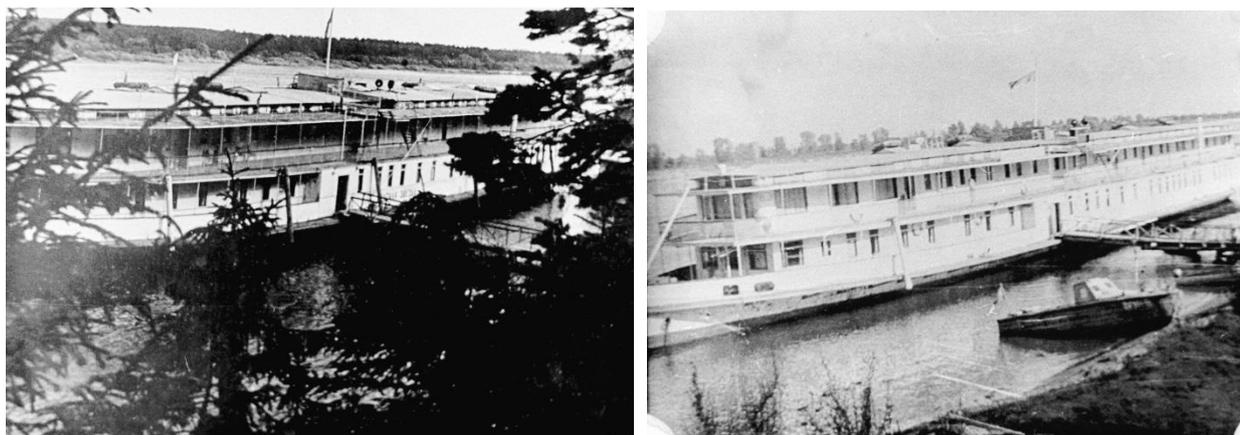
There are another two photographs from the holdings of the Sarapul Museum, and these were clearly taken earlier, despite their large accession numbers (Figure 5). Yet again one gets an impression that the negatives were made based on existing photographs. This, for instance, is confirmed by the characteristic worn corners, a result of being fixed in a photoalbum (Figure 5, left). Both photographs have the same caption and date: “The Krasnaya Zvezda, a one-time agit-steamer, served in 1969 as a holiday center for workers at the [Sarapul Ordzhonikidze Radio Factory]” (Photo No. 20297/2456, 2457).

Fig. 5. Krasnaya Zvezda serving as a holiday center for workers at the Ordzhonikidze Radio Factory: left – Photo No. 20297/2456; right – Photo No. 20297/2457

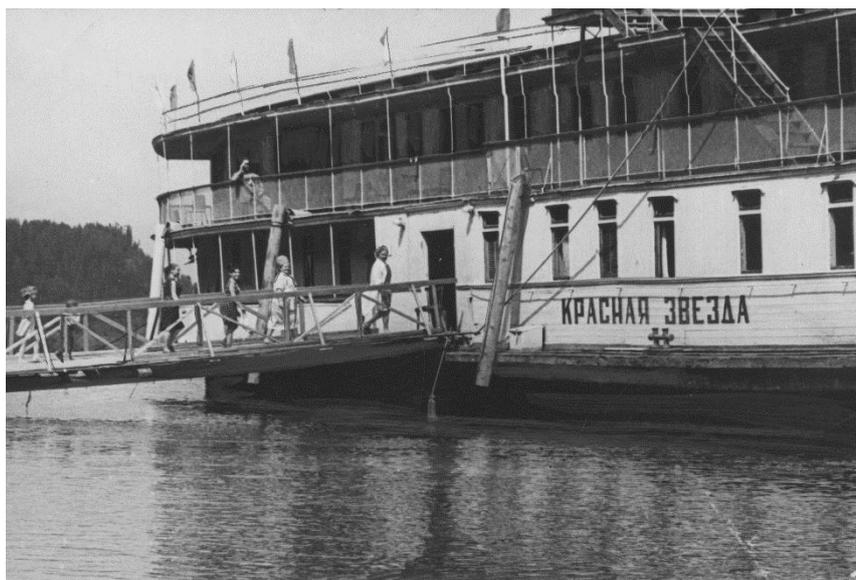
The holdings of the Center for Documenting Contemporary History of the Udmurt Republic contain one later photograph of the Krasnaya Zvezda. Holding 120 ('A Collection of Photodocuments') contains a photograph captioned 'Steamer Krasnaya Zvezda at the harbor of the city of Sarapul' (Figure 6). It is dated July 26, 1969 (TsDNI UR. F. 120. Op. 3F. D. 5620).

One of fairly high quality, the photograph shows the one-time agit-steamer Krasnaya Zvezda. The date, again, suggests that it is the holiday center of the Ordzhonikidze Radio Factory. While the photograph does not take in all of the long ramp, which is seen in Figure 3, the characteristic bend suggests that there is a supporting raft somewhere on the left. What makes the photograph particularly interesting is that it makes it possible to see a few parts that cannot be seen in the previous photos. Specifically, to the left of the ramp there is a garbage chute hanging from the second floor. That is where the kitchen must have been located on the ship. In the photo's upper right corner, one can clearly see a ramp leading upwards. Given that the roof of the second floor has no space for strolling, the ramp must be leading to an old captain's bridge. The photo also takes in the bridge's left wing, along with its support brackets. Thus, it can be suggested that during the taking down of the pipe the bridge and its wings were kept in place.

Fig. 6. Photograph of the Krasnaya Zvezda from the holdings of the Center for Documenting Contemporary History of the Udmurt Republic

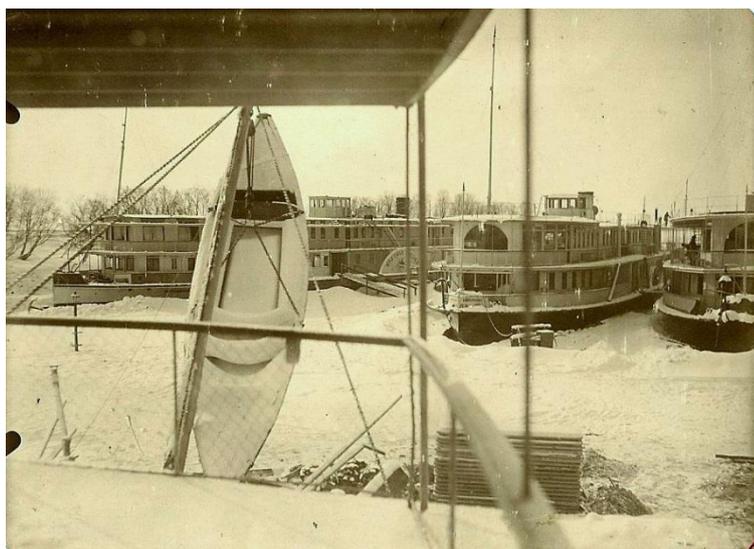
The private archive of well-known Perm collector G.A. Rakitin contains several interesting photographs of the *Krasnaya Zvezda*. [Figure 7](#) displays a photograph that, according to the collector, shows the *Krasnaya Zvezda* at the In Memory of Dzerzhinsky Dockyard in the township of Nizhnyaya Kur'ya. This must be the early 1950s, i.e. when the vessel was still on the books of the Kama River Shipping Company. The *Krasnaya Zvezda* stands on the left in a row of steamers, the closest to the shore. The photograph was taken onboard another wintering steamer. The second photograph ([Figure 8](#)) is perhaps more interesting, as it shows what the *Krasnaya Zvezda* looked like in the early 2000s, with the underbody being what was left of it, most of it eaten away with rust and full of sand.

Fig. 7. *Krasnaya Zvezda* in winter layup at the In Memory of Dzerzhinsky Dockyard (from a private collection of G.A. Rakitin)

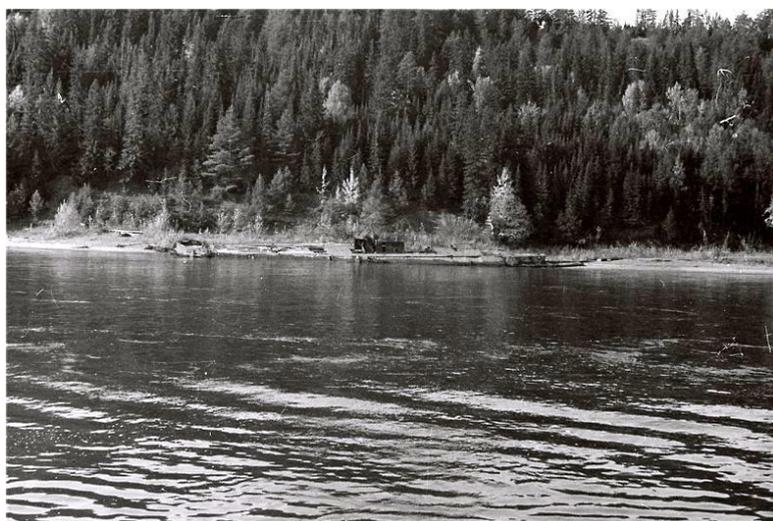
Fig. 8. Hull of the now-defunct *Krasnaya Zvezda* in the early 2000s (from a private collection of G.A. Rakitin)
