# Budownictwo i Architektura 20(4) 2021, 5-16 DOI: 10.35784/bud-arch.2705

## Comparison of methods of monitoring structure deformations based on tests of a flat plate slab

**Abstract:** This work includes a comparison of the methods of monitoring the deformations of a structure on the example of a flat plate slab test. Classic ESG (electrofusion strain gauges) and modern DFOS (distributed fiber optic sensors) were compared. During the research, both types of sensors were used on some of the reinforcing bars. The study aims to indicate the differences between the compared monitoring methods, both in terms of the obtained results and their utility values.

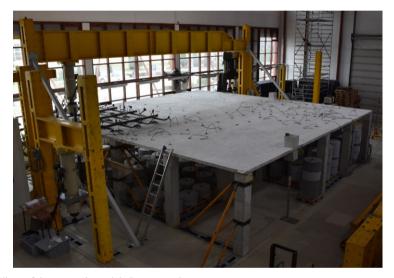
The tested model presented in fig. 1, was a sixteen-section flat plate slab, reflecting the work of the real structure.

Fig. 1. View of the research model. Source: author

The tested model was made on a scale of 1:3 so that it replicated the real object as accurately as possible. The model assumed a support spacing of 2.4 m, which corresponds to a ceiling span of 7.2 m commonly used in construction in scale 1:3. The slab thickness was assumed to be 80 mm and the dimension of prefabricated columns 300x300 mm. The total dimension of the tested slab was 9.9 x 9.9 m. The research model of the slab was monolithic. The upper part of the columns was monolithized with the slab plate in the laboratory – fig. 2. The slab reinforcement was designed assuming the ceiling loads had the following values: permanent load  $g_k = 3 \text{ kN} / \text{m}^2$  and variable load  $q_k = 3 \text{ kN} / \text{m}^2$ . Different bonding reinforcement was used in the tested element to create a secondary load-bearing structure in the event of local damage to the edge columns.

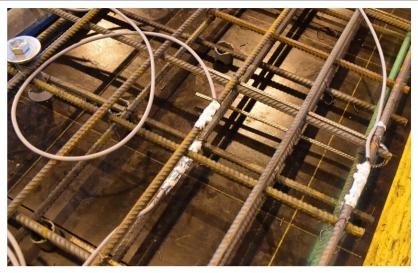
TFs 5/120 electrofusion film strain gauges were used to measure the strains of reinforcing steel and TFs 60/120 to measure the strains of concrete produced by TENMEX. The strain gauges were glued to the reinforcement in accordance with the manufacturer's instructions. The strain gauges bonding was performed on the already prepared reinforcement of the slab. The surface of the rod was cleaned by grinding, then smoothed with sandpaper no. 300-400 in two mutually perpendicular directions. The surface was degreased with ATEPO Z-12 remover and WBT-500 swabs used once. A drop of ATEPO Z-03 neutralizer was applied, spread out and allowed to dry. A strain gauge was glued onto the prepared surface with cyanoacrylate adhesive TB-1731. Then, the cables were soldered to the ends of the strain gauge and secured against adverse weather conditions and mechanical damage with self-adhesive ALG-2 shielding and protection tape. For each strain gauge, temperature compensation strain gauges were used, glued on the same material and surface-connected to the tested element. Fig. 5 shows the prepared electrofusion strain gauges before concreting.

Fig. 5. View of electrofusion strain gauges glued to the reinforcement. Source: author
