## Acoustic analysis of selected sacred buildings in Szczecin

**Abstract:** The aim of this study was to acoustically assess selected sacred buildings located in Szczecin. The research part contains the research methodology and the results obtained. The research was carried out using two methods. The first one is the integrated impulse response method where, using a bursting balloon, the time of sound pressure drop was measured at selected points of the object. In the second research method, the interrupted noise method, the sound pressure drop was measured after the noise generated by the omnidirectional loudspeaker had ceased. Reverberation time was calculated for the results obtained, which is the main and basic parameter determining the interior acoustics. On the basis of the above-mentioned measurements, the reverberation indicators for the temples were also calculated. When analysing the components of the reverberation indicator, it was noticed that poor acoustics in the sanctuary concerns speech, while interior acoustics is good for the reception of organ music. In the analysed church, the reception of liturgical music is also better than the reception of speech, but the di

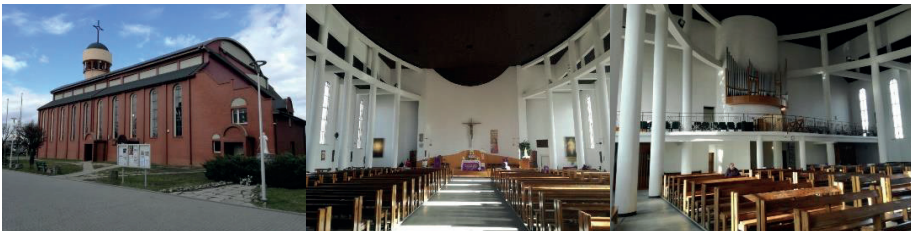
Fig. 1. Church at the parish of the Immaculate Heart of the Blessed Virgin Mary in Szczecin. *Source: own study* [15]

The church was built on a rectangular plan (Fig. 1). It is a single-storey reinforced concrete structure building without a basement. The structure is supported by reinforced concrete pillars elliptically arranged inside. On both sides of the church, there are lower aisles behind the pillars. Thanks to the large span between the pillars, the aisles form an integral part of the nave. The entrances to the church are: the main entrance portal with double brass doors, and 3 side entrances with wooden doors. Above the porch there is a gallery for the choir and the organist. From the level of the gallery there is a spiral staircase leading to the belfry topped with a dome. The interior of the church is unfinished. In the presbytery the walls and the floor

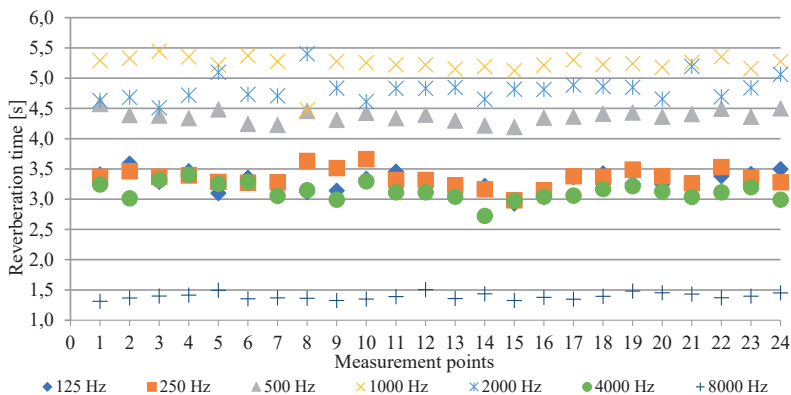
Fig. 8. Reverberation time diagram in individual frequency bands at various measuring points

The absorption on the surface of the partitions also had an influence on the obtained reverberation times in accordance with the Sabine equation. Despite the unfinished condition of the church, its interior features well-absorbing elements such as pews, platforms and panelling. The interior of the church was not finished on the day of the examination. In the presbytery, only the wall cladding is 2.5 – 1.5 m high and the floor is made of wooden boards.
