Damage potential of near and far-fault ground motions on seismic response of RC buildings designed according to old practices

Marsed Leti, Hüseyin Bilgin

Leti M, Bilgin H. Damage potential of near and far-fault ground motions on seismic response of RC buildings designed according to old practices. *Res. Eng. Struct. Mater.*, 2022; 8(2): 337-357.

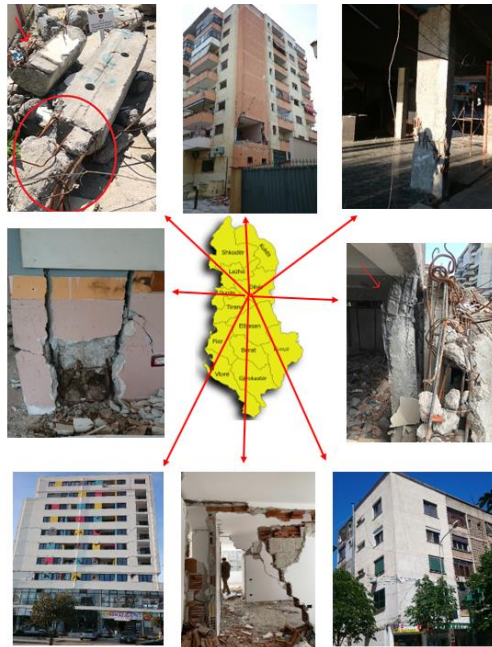
Fig. 2 Consequences to reinforced concrete buildings during the 2019 Albania earthquakes

This second strong earthquake proved the high seismic vulnerability of reinforced concrete buildings as shown in Fig. 2. The epicenter of the earthquake was located in Durrës (northwest Albanian region) and 30-km west of the capital city (Tirana). The mainshock occurred at 03:54 CET (UTC+1), at a relatively shallow depth of about 16 km, with a magnitude of $M_w = 6.4$ [18]. The horizontal peak ground acceleration measured in Durrës was approximately 0.20 g, and in Tirana, this value was about 0.12 g [25]. The Durrës station had an electricity cut after first 15 seconds of measuring the record, hence 0.20 g value received from this station should be considered as a lower limit of the actual peak ground acceleration occurred in the center.

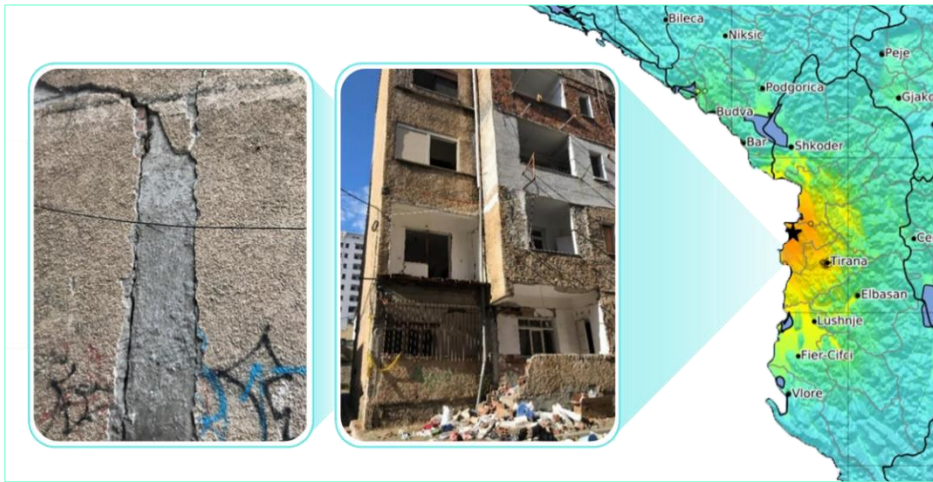
Fig. 3 Location of the damaged template design building considered in this study with respect to epicenter of November 26, 2019 earthquake.

A site survey was carried out in Durres and Tirana cities to select the commonly encountered typologies among the residential buildings. As an important center for tourism and export, Durres represents a mid-size city in the Albanian earthquake zone [25]. After November 26, 2019 earthquake, authors made several visits to the earthquake-stricken area to investigate the reasons of the damages on the environment. It was observed that the most used templates for residential RC building typologies are Template Design Buildings (TD). An example falling into this category and taken during the investigations, is shown in Fig. 3.

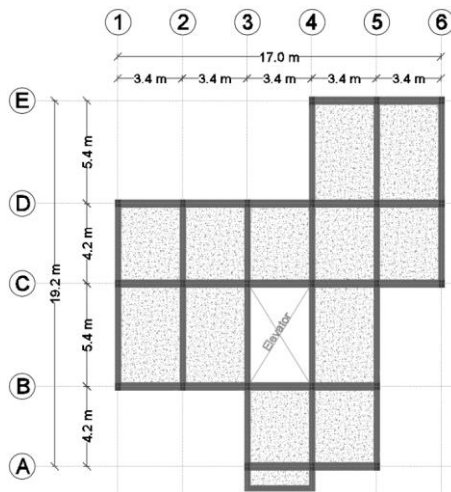
Fig. 7 The plan view of the Template Design 4 (TD_4) building

In this study there are considered four buildings and labeled as TD_1, TD_2, TD_3 and TD_4. Each of the template designs is reinforced concrete (RC) residential building having no shear wall in any direction. They were designed in 1982 according to KTP 2-78 and are still in use nowadays. Each of the designs fall into the category of midrise buildings, TD_1 and TD_2 is 5-story and TD_3 and TD_4, 6-story. The maximum height of TD_1 and TD_2 reaches 14.42m considering the parapet used in the roof story as shown in Fig. 4 and Fig. 5. The structural plan of first three buildings is a regular one. TD_2 and TD_3 have the same planimetry which has one more frame than TD_1. However, TD_3 (Fig. 6) has 6 stories and reaches the maximum height of 17.22m. The last building, TD_4 is 17.67 m long and has an irregular plan as shown in Fig. 7. All buildings have a typical story height of 2.8m except the last one which tends to be higher slightly differing from each other. Representative plan views of the selected buildings are given in the Figures 4-7.

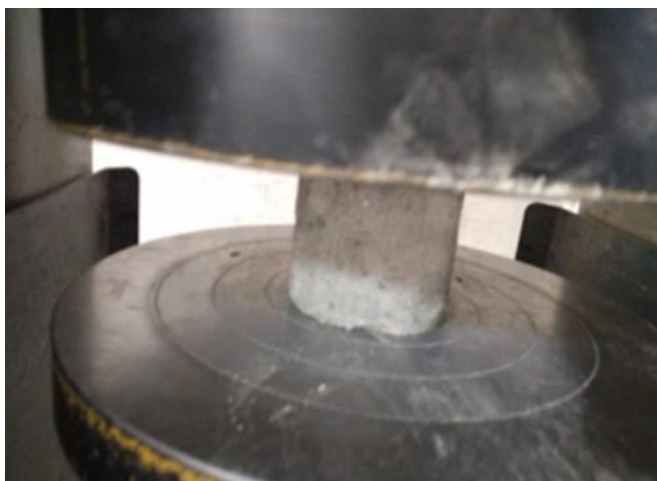
Fig. 9 Laboratory test for the concrete sample of TD_2 - 82/2

Concrete and steel specimens were extracted, and experimental tests were performed on one of the selected building typologies (TD_2 - 82/2). Based on the blueprints' details, the concrete class and the steel grades were determined for each of the buildings. Referring to each of the template designs, the concrete class M200 (C16/20) is used. For the reinforcement, 2100 Kg/cm² (Ç-3) steel material is used in the design. Table 5 and Table 6 summarize the detailed properties of the reinforcement steel and concrete respectively. Moreover, the laboratory tests for concrete sample, is shown in Fig. 9.
