## Application of Geospatial Information System for the Study of Illuminance in Carpet Weaving Workshops in Bokan, Iran

**Methods:** This study was carried out for the evaluation of illumination on the basis of Geospatial Information System (GIS) technology in two carpet weaving workshops of Bokan city. As per the norms of Illumination Engineering Society, the sensors of the photometer Testo 545 were placed at lowest and highest of 35 and 163 cm in workshop I, and at 40 and 245 cm in workshop II, which correspond to the lowest and highest work surfaces in the respective workshops. Total, natural, and artificial illuminance was measured in the center of each measurement station using the photometer, and data was analyzed using the Arc GIS software. The maximum and minimum illuminances as well as isolux curves were obtained for each workshop.

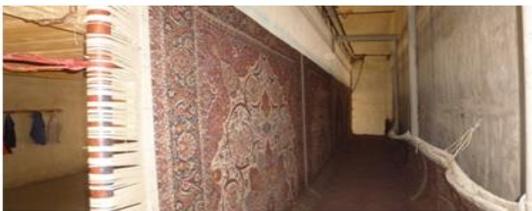
**Fig.1:** A carpet looms in a carpet weaving workshop in Bokan.

Various studies have shown the efficacy of GIS in other fields [4-6]; hence, this technology could also be employed for assessing lighting in carpet weaving workshops. The present study was designed to investigate the application of GIS-based software for monitoring natural, artificial, and total illumination in a carpet weaving workshop with 21 weavers in Bokan, Iran. Figure 1 shows a carpet loom in this workshop.

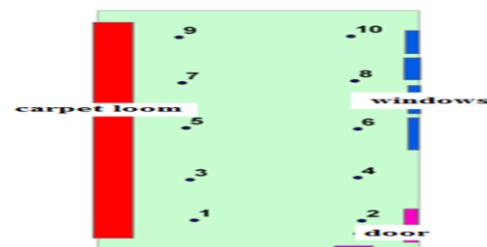
**Fig. 2:** Positions of measurement stations (1–10), carpet looms, windows, and doors in workshop II.

In each workshop, the floor was divided into squares of  $3 \times 3$  m, and the center of each square was marked as a measurement station, as recommended by IESNA (Illumination Engineering Society of North America) [7]. The positions of stations, windows, doors, and carpet looms in workshop II are shown (Fig. 2).

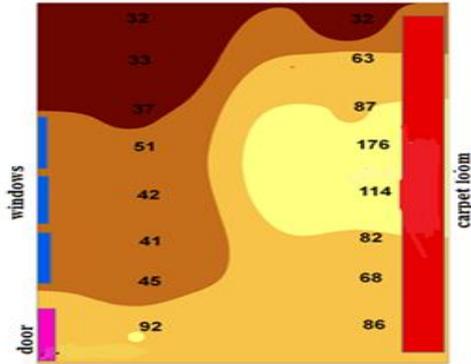
**Fig. 3:** Isolux curve for total illuminance (natural and artificial) measured in each station in the highest work surface (163 cm) of workshop I. The numbers represent illuminance (lux).

Figure 3 shows software-generated isolux curves using illumination data for the highest work surface in workshop I. Figure 3 clearly shows that the illumination in the highest work surface of workshop I was lower than 100 lux, except for stations 8 and 10. The isolux curves using illumination data for the lowest work surface in workshop I are depicted in Figure 4. The highest illuminance (172 lux) was found at the entrance, while the lowest value encountered was 26 lux. Ten stations were determined in workshop II due to its smaller size. The highest and lowest work surfaces of carpet weavers measured 245 cm and 40 cm, respectively. Illuminance measurements are shown in Table 2.

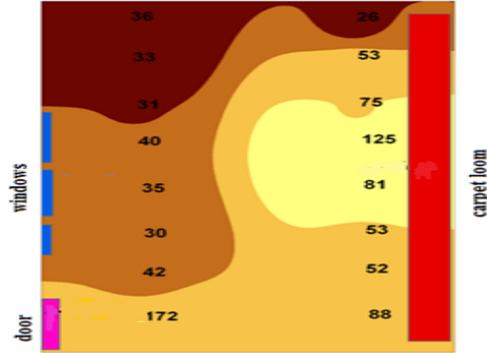
**Fig. 4:** Isolux curve for total illuminance (natural and artificial) measured in each station in the lowest work surface (35 cm) of workshop I. The numbers represent illuminance (lux).

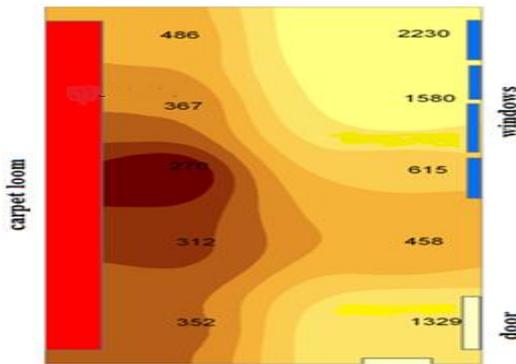
**Fig. 5:** Isolux curves for total illuminance (natural and artificial) measured in each station in the highest work surface (245 cm) of workshop II. The numbers represent illuminance (lux).

Figure 5 shows the isolux curves using illumination data for the highest work surface in workshop II. The data shows that illuminance in all stations of workshop II was

higher than 300 lux, with the exception of station 5. The isolux curve using illumination data for the lowest work surface in workshop II is depicted in Figure 6. The highest and

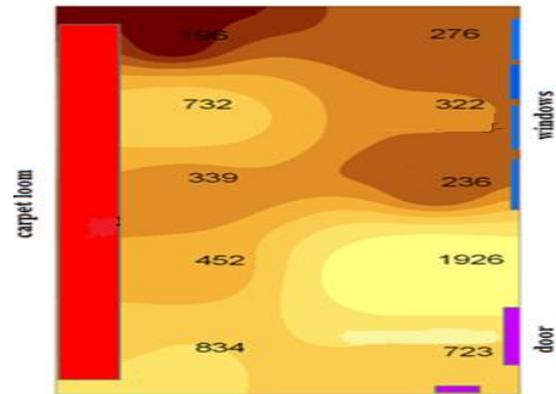
**Fig. 6:** Isolux curve for total illuminance (natural and artificial) measured in each station in the lowest work surface (40 cm) of workshop II. The numbers represent illuminance (lux).

lowest illuminance were found to be 1926 and 196 lux, respectively. As depicted in Figure 6, the illuminance in all stations in the lowest work surface of workshop II was higher than 300 lux, with the exception of stations 9 and
