Developing a Geoinformatic-engineering Stability Modeling Method, using Field Data and GIS Environment: A Case Study from Al Qarara Area in Wadi Musa, Jordan

Abstract - By applying detailed geological field surveys, the spatial factors affecting geo-engineering stability were used to develop a geo-engineering stability modeling method to identify areas under potential threat of landsliding. The factors affecting geo-engineering stability in Al Qarara area in Petra-Jordan were studied and given assumed rates of importance, where optimization process was run by lag iterations; the produced spatial layers of the different factors were gathered and modeled using GIS; a final stability map was produced using an optimized equation. The produced map was validated qualitatively and quantitatively, where a comparison was made between the reality in the field and several maps of different equation. The modeling method which was developed in the context of this study proved to be suitable to produce micro-zonation maps of areas having landslide risk. Further applications on the method in other areas suffering landslides will further improve it.

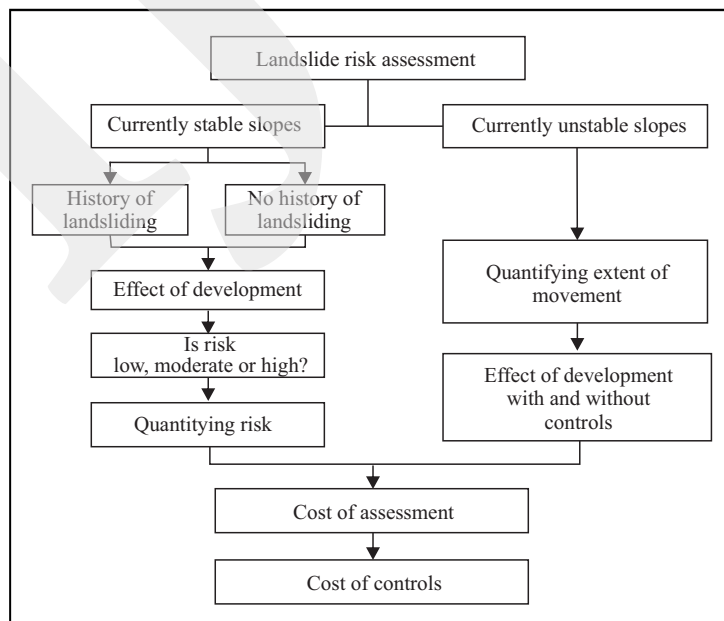
Figure 1. Flowchart showing the main elements of the risk assessment system (after Aleotti and Chowdhury, 1999).

In recent years, the assessment of landslide hazard and risk became a topic of major interest for both geoscientists and engineering professionals as well as for community and local administration in many parts of the world (Aleotti and Chowdhury, 1999). The main elements of risk assessment system are presented in Figure 1.

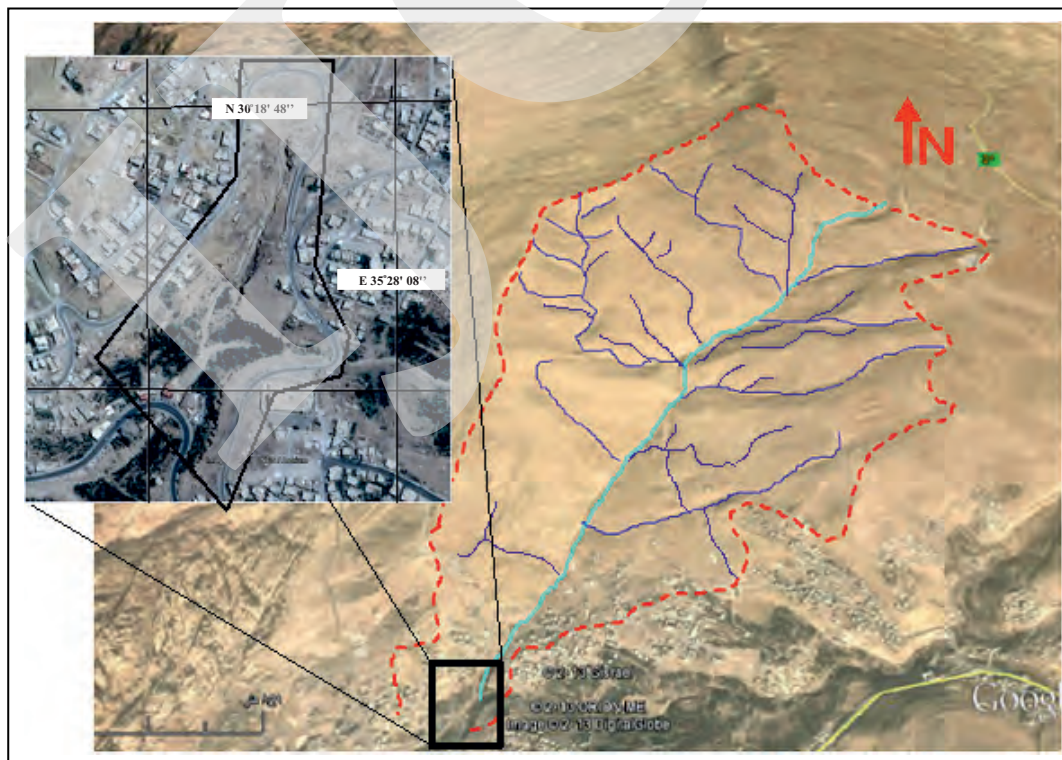
Figure 2. Locality map of the studied Al Qarara area (black lines), and Wadi Zurraba catchment area (red dashed lines) with its drainage pattern (blue lines).

Al Qarara is located in the central part of Wadi Musa, at the end of Wadi Zurraba catchment area, which extends along more than 8 km in a northeast-southwest direction. The area of the interest is 0.142 km². Al Qarara drains a catchment area which reaches to around 30 km², and witness flash floods in winter when thunder storms forms; this exposes some parts of the area for potential risks of landslide as the drainage path is toward it (Figure 2).

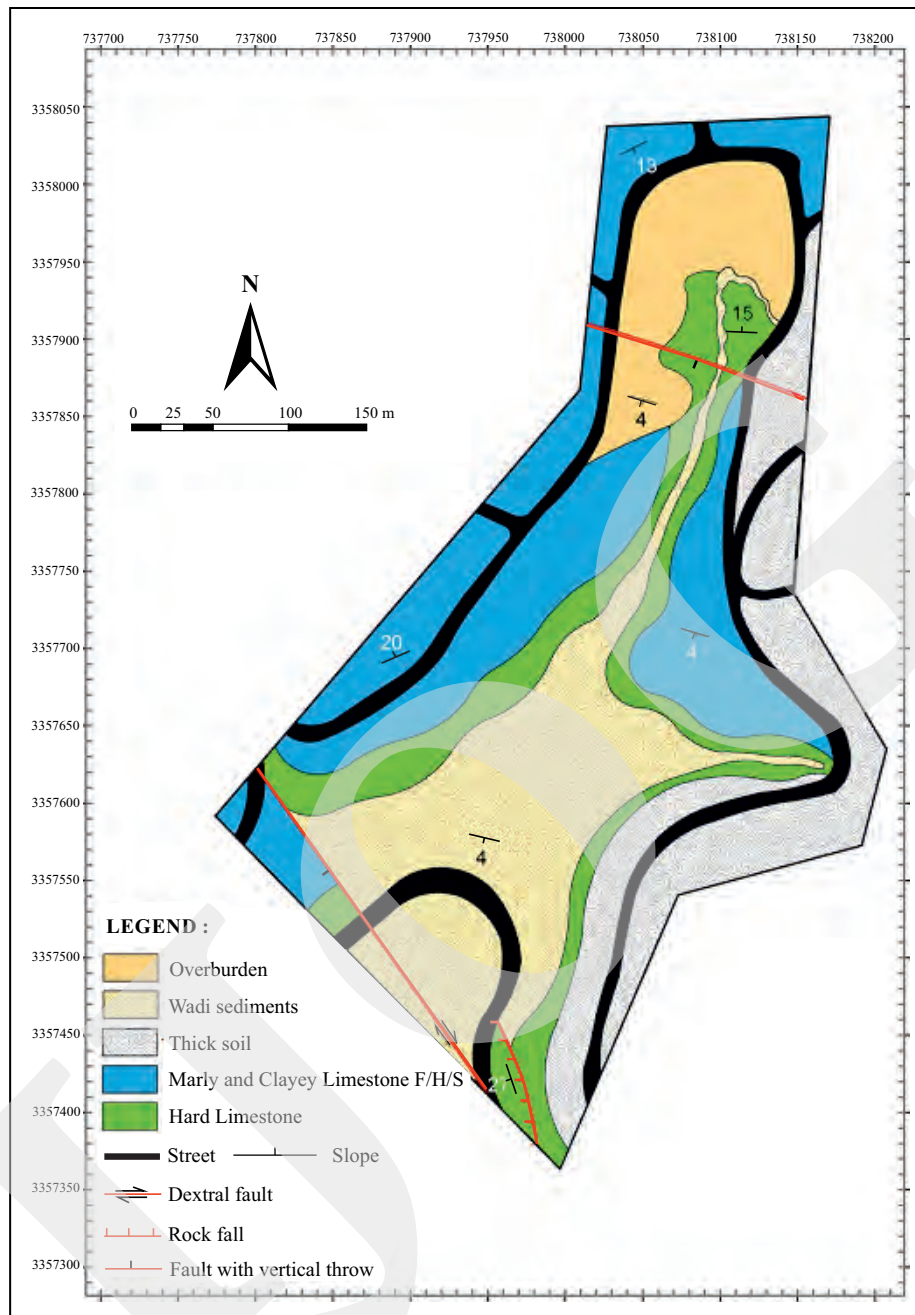
Figure 3. Geological map of the studied area showing the different stratigraphic units and structures, with a scale of 1:2000 using GIS modeling.

From the detailed field survey and the aid of the available geological maps and reports and using GIS, it was possible to produce a geological map of the study area with a scale of 1:2000 (Figure 3).

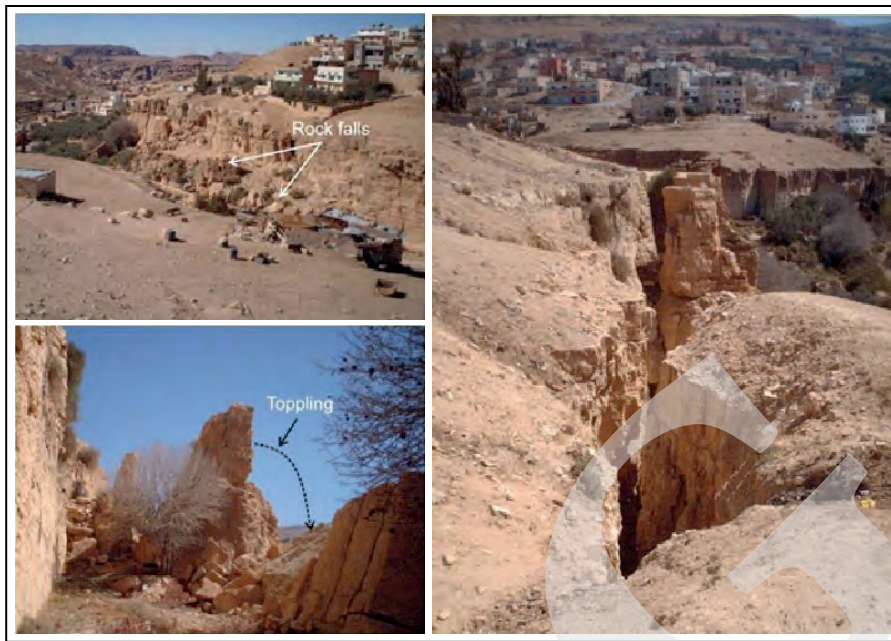
Figure 4. Toppling and rock falls in the studied area.

In the studied area, this formation outcrops with a thickness of 15 m in the close wadis. The beds of the upper parts of this formation are outcropping in some parts of the wadis in the studied area; and they tend to be composed of clayey marl. The upper parts of the formation are mechanically brittle and inflexible, and they are highly affected by rocks overlaying them. After precipitation events, the rocks tend to swell and then to be shrink when the water leaks out. With the presence of structural deformations and effect of gravity, the upper parts of this formation in the studied area are fractured and jointed, forming zones of risk at the limbs of the wadis and steep slopes, that led to toppling and rock fall phenomena (Figure 4).

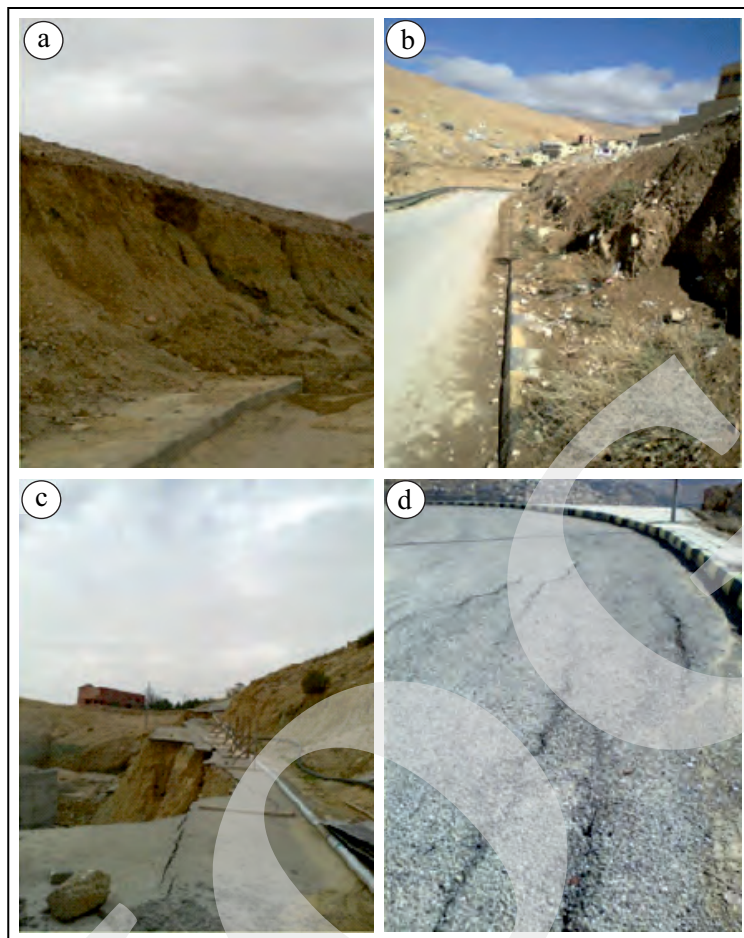
Figure 5. Registered landslides (a, c) and erosions (b, d) in the streets and roads of the studied area.

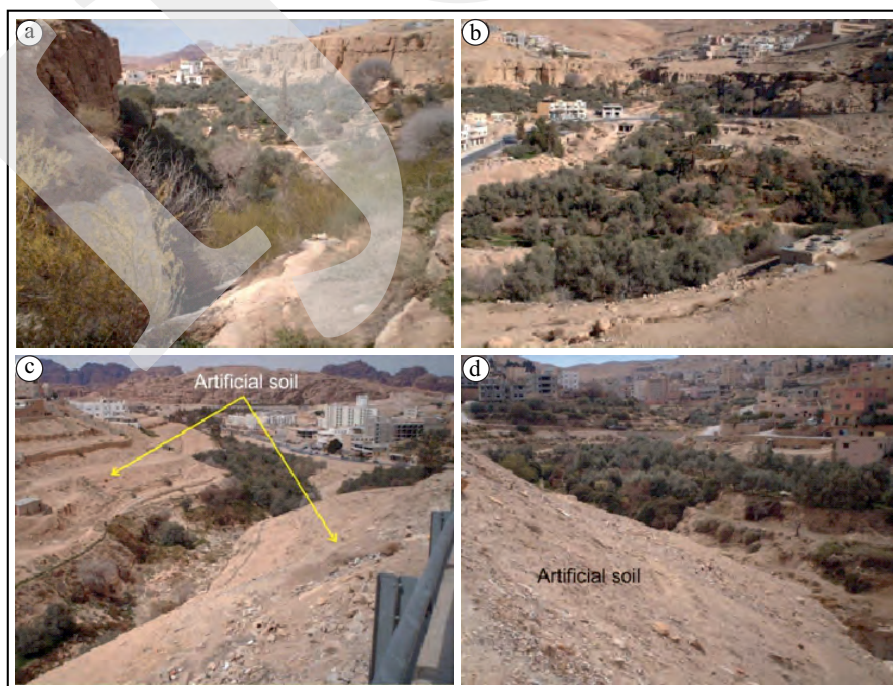
Figure 6. Digging (a, b) and overburden (c, d) engineering operations in the studied area.

eastern part of the studied area, and they are composed of clay/carbonate-marl soil fragments, containing small pieces of rocks with different sizes. These sediments found in the lower parts of the studied area, were derived from the higher ones. While the streams and wadis contain recent beds of mixed gravel, sand, and clay, with bad sorting. Under rainfall conditions, some landslides and erosions can occur in the streets and roads (Figure 5). In addition to the natural deposited recent sediments, there are man-made sediments resulted from cutting/filling processes, digging, and overburden (Figure 6).

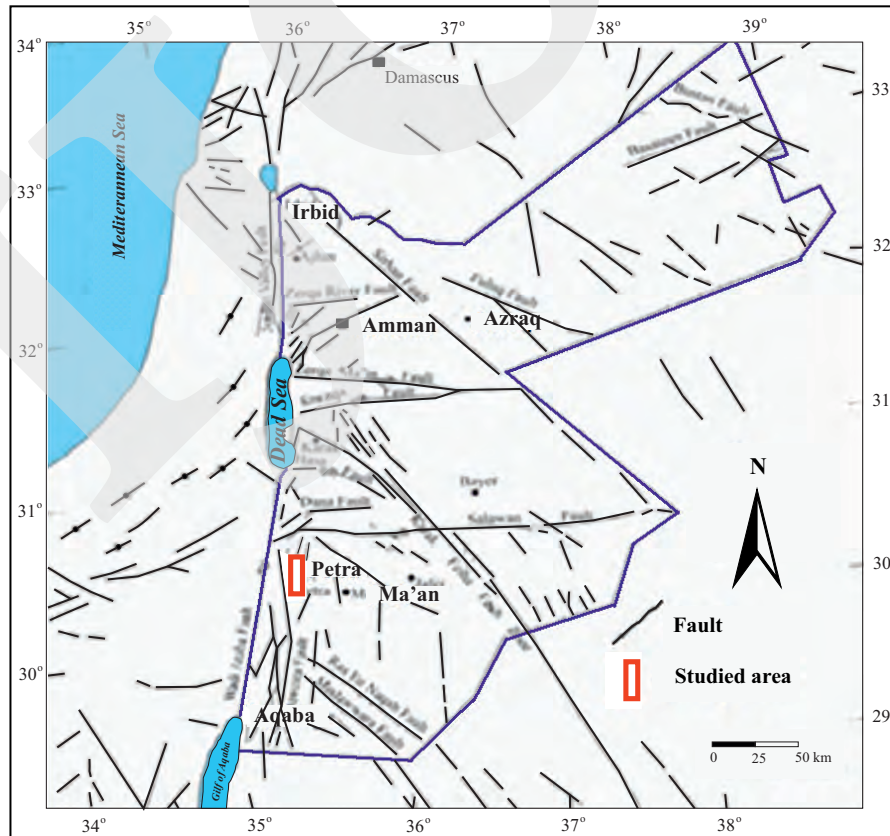
Figure 7. Structural pattern map of Jordan (Diabat and Masri, 2005).

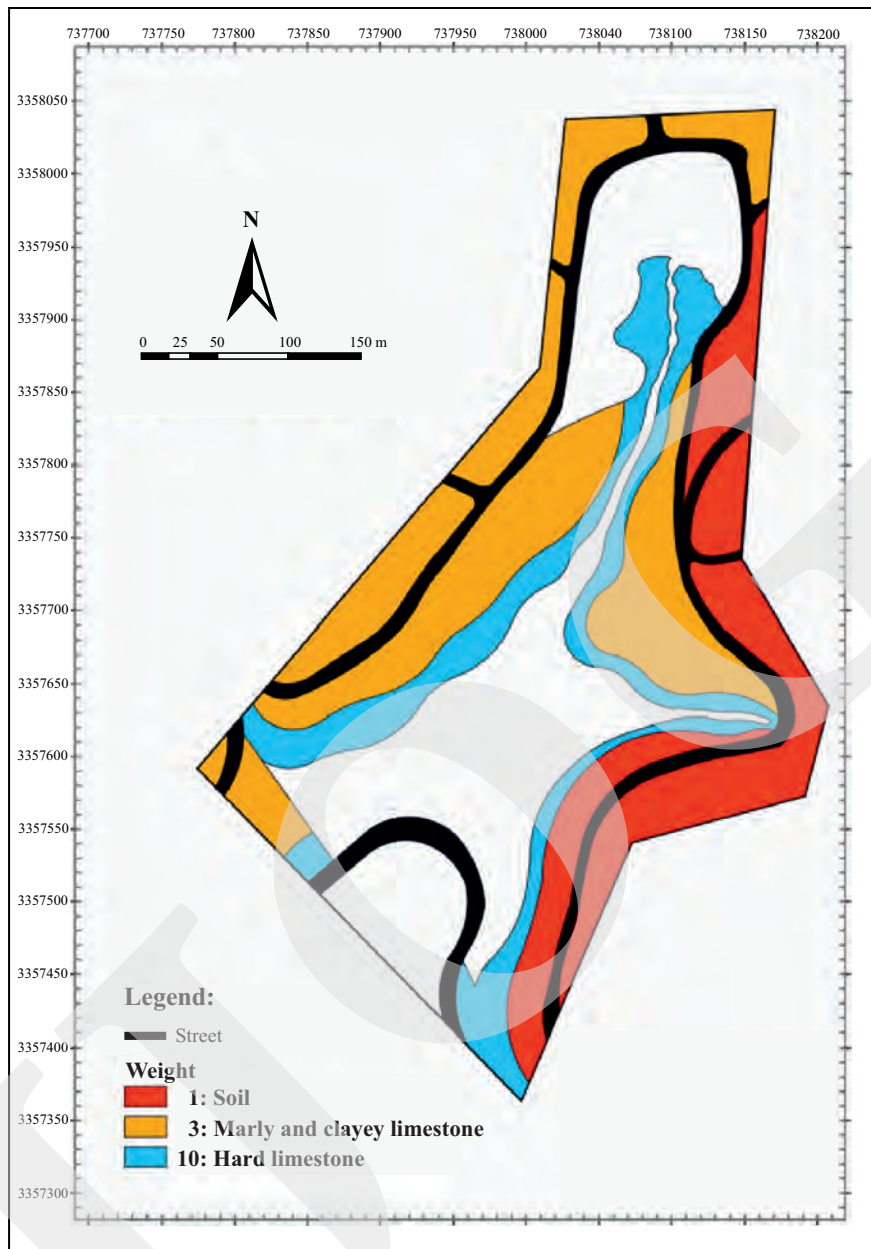
Figure 8. Produced map of the lithologically rating with a scale of 1:2000 using GIS modeling.

Lithology was considered in this study as an essential factor for the stability of the rocks and their suitability for building and different engineering purposes. Four main types of rocks were found in the studied area, each type was given a rate.

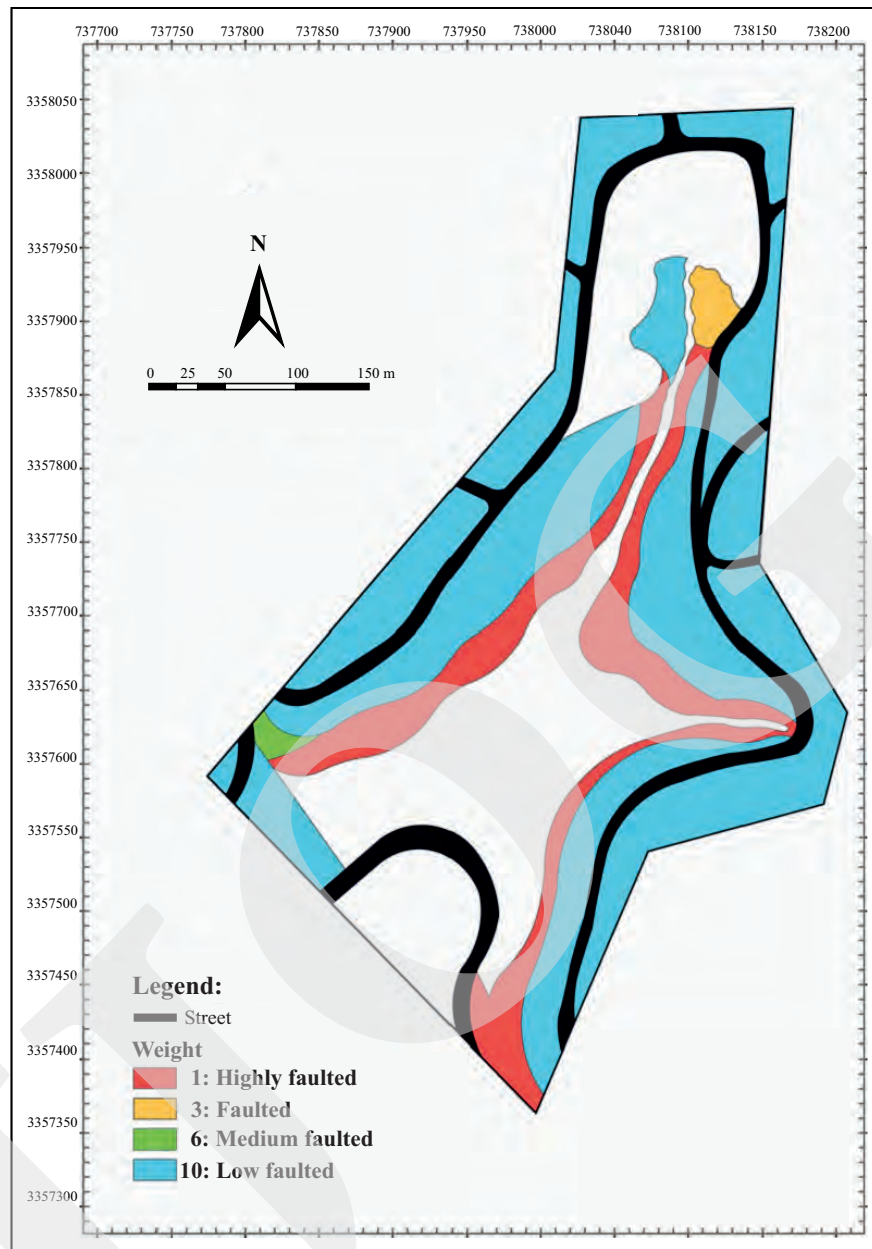
Figure 9. Produced map of the structural rating with a scale of 1:2000 using GIS modeling.

lateral support, for that they can show faulting, while the blocks of the rocks within beds of high dip values tend to have faults more than those within beds of low dip values (Table 2; Figure 9).

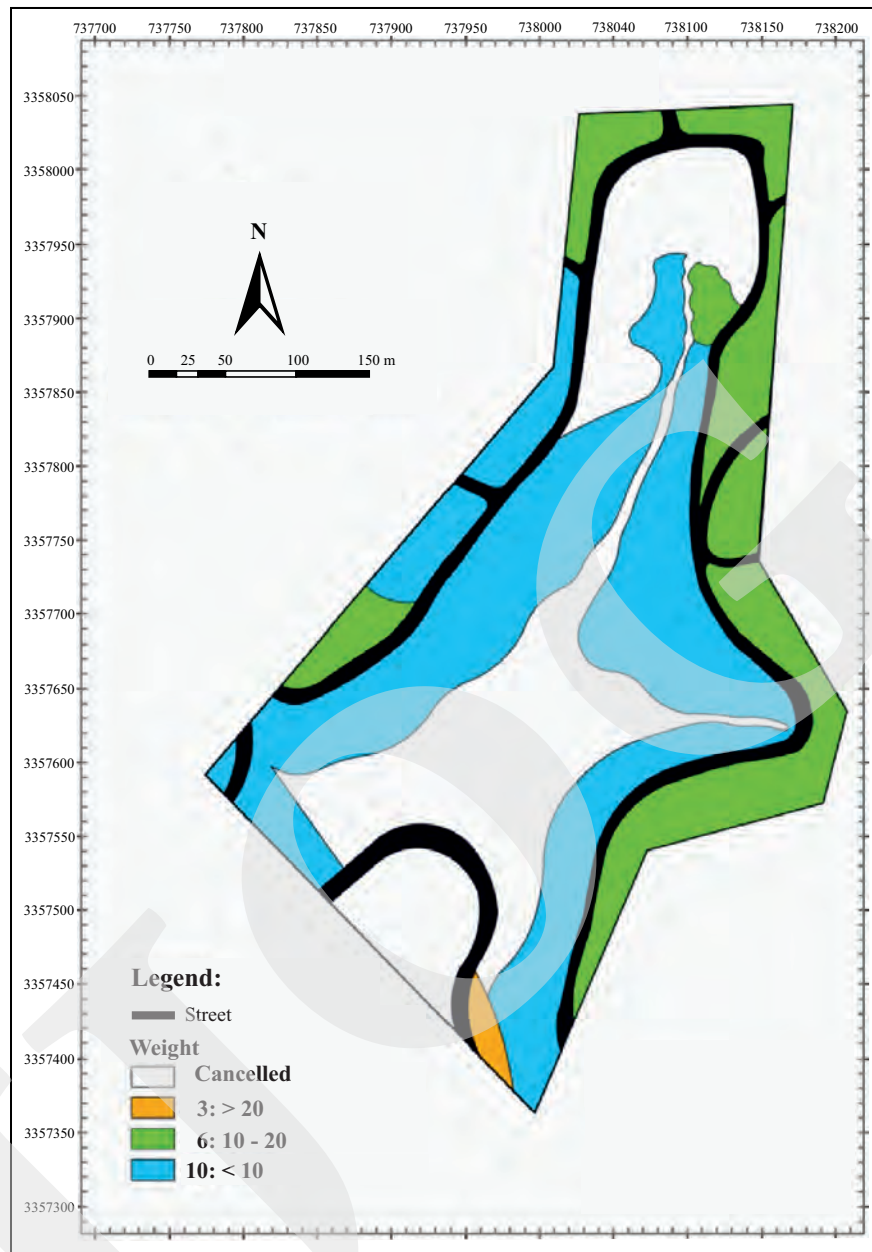
Figure 11. Produced map of topography/slope rating with a scale of 1:2000 using GIS modeling.

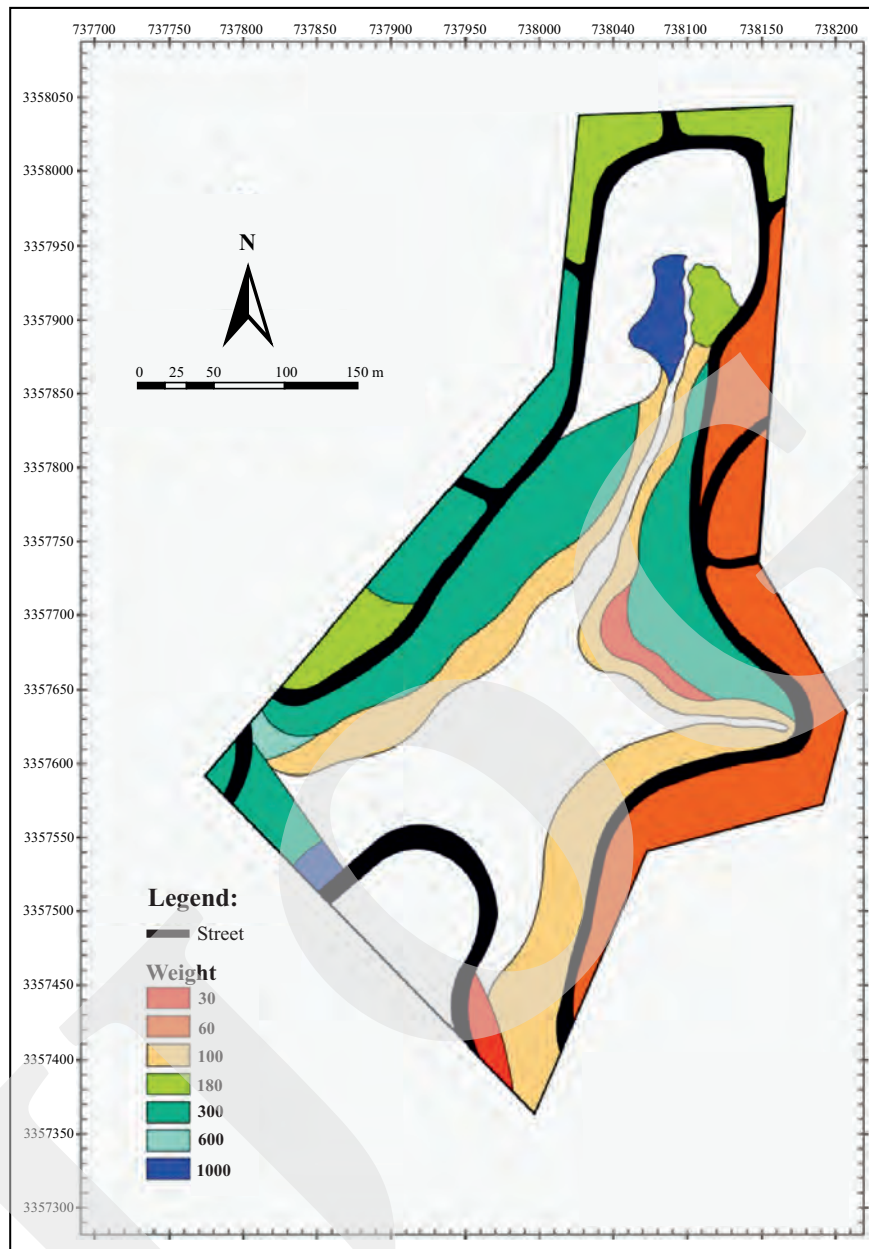
Figure 12. Produced map of stability with a scale of 1:2000 using GIS modeling.

of the geo-stability factors mentioned before. After multiplication of the produced layers, areas found with stability products between 30 and 100 were classified as relatively unstable, while areas having values ranging between 180-1000 were classified as stable zones.

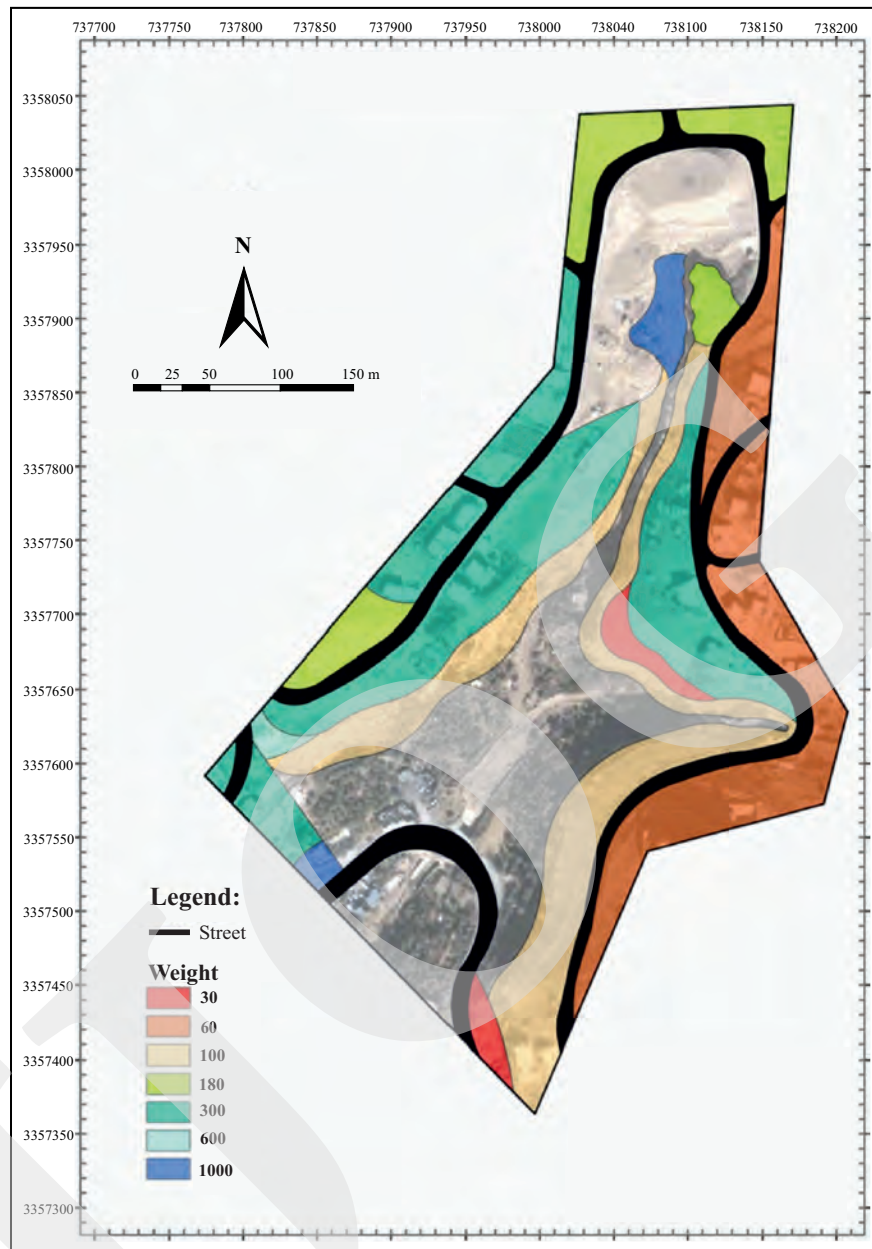
Figure 13. Map of stability on satellite image with a scale of 1:2000 using GIS modeling.

From the area of study, an area of 66% was found to be unstable, while stable areas form simple part of the area. Most registered landslides took place in the area, have been recorded

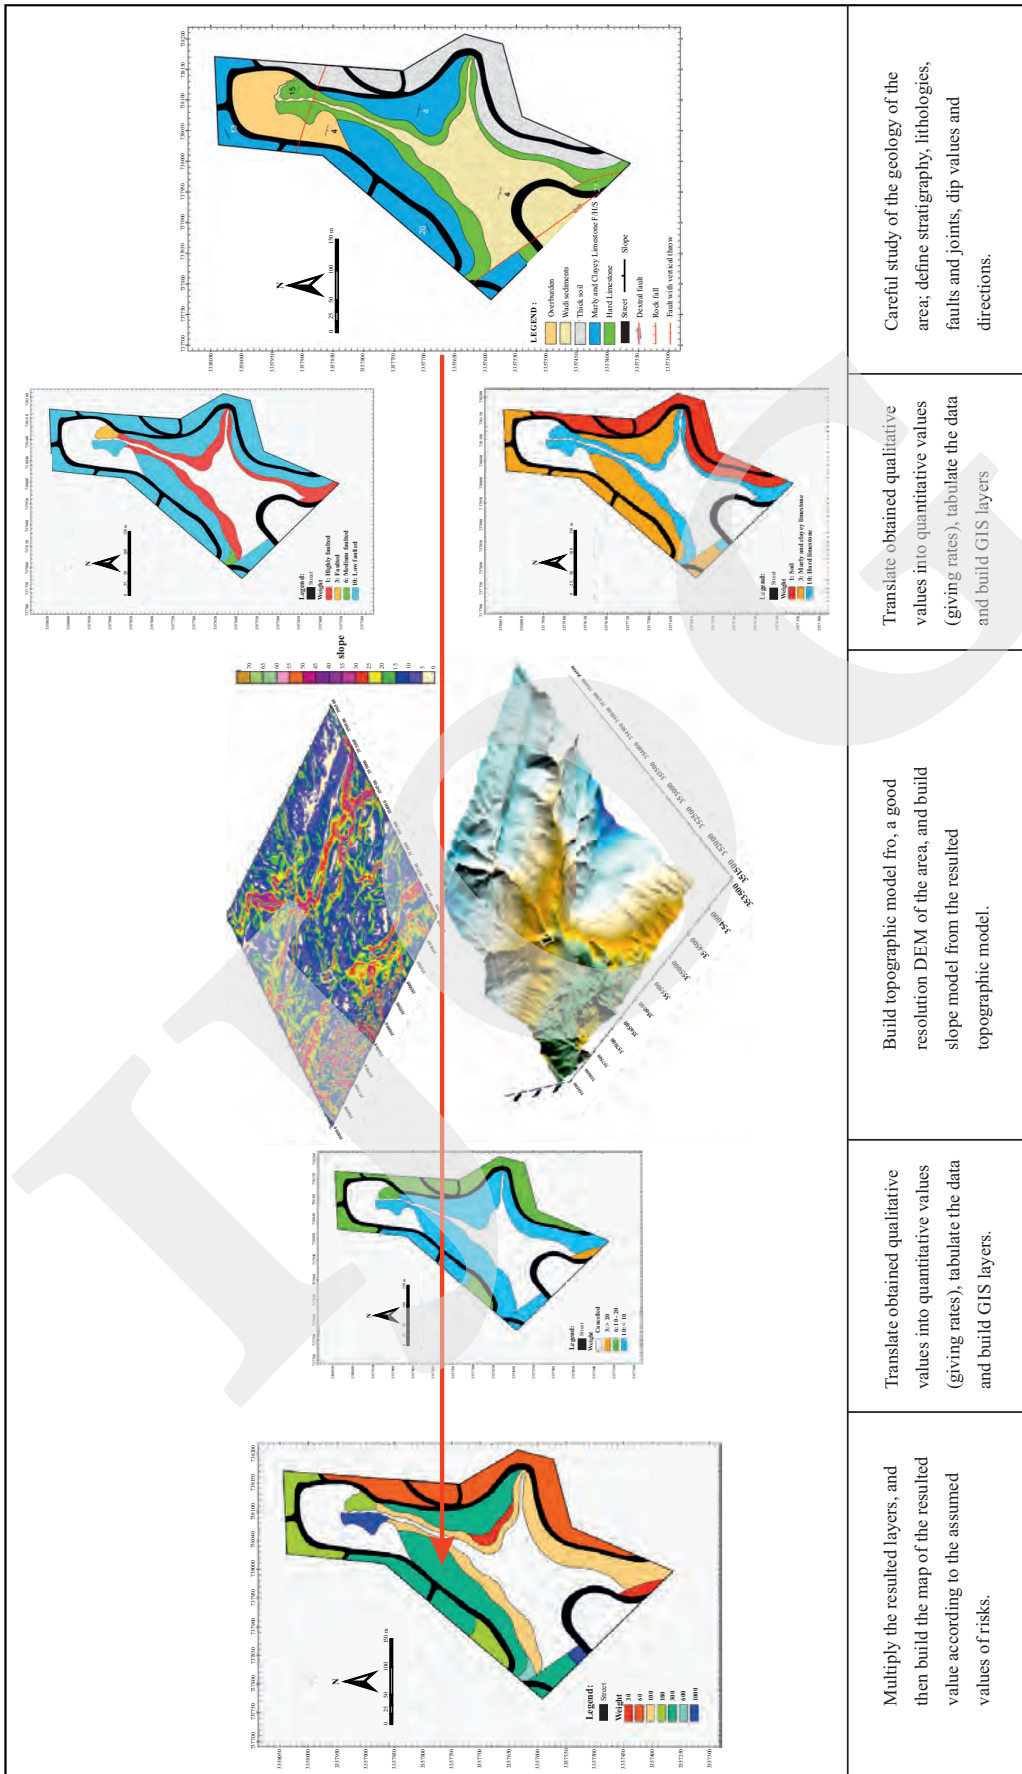
Figure 14. Chart illustrates the steps followed in modeling the stability of the studied area.

After validating, the results of the model show that the modeling method has proved to assess areas under risk of instability, for areas of the same geology. Further applications on the same method in other areas suffering landslides are strongly recommended. Figure 14 illustrates the steps followed in modeling the stability of the studied area.
