Environmental Impacts of Slope Failure: Protection Measures Against Landslides

Alamanis Nikolaos and Chouliaras Ioannis

Department of Civil Engineering, School of Technological Applications,
Technological Educational Institution of Thessaly, 41110, Larissa, Greece
alam@teilar.gr

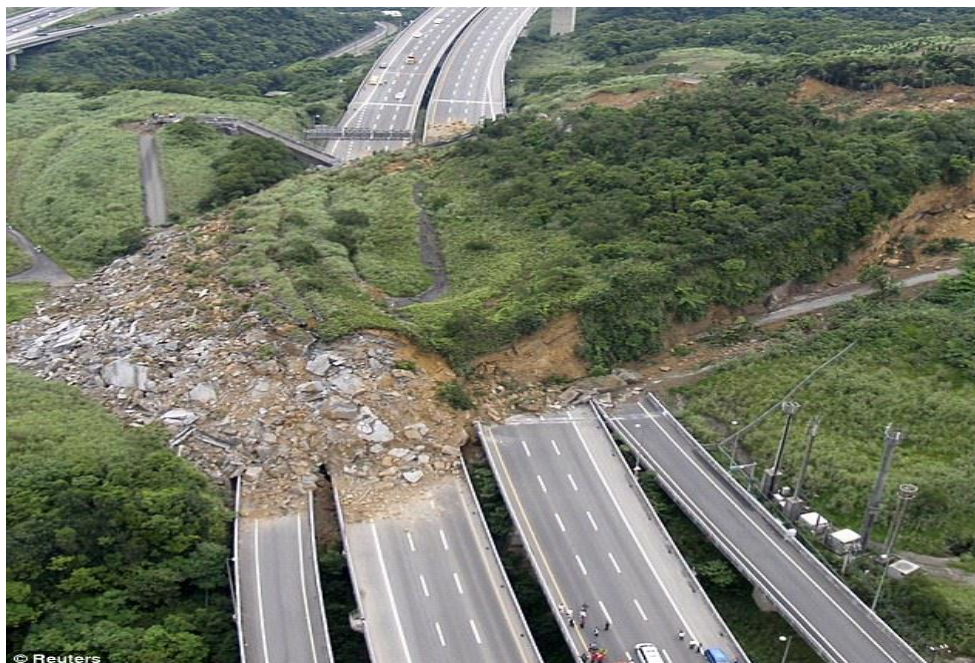
Fig. 2 Slope failure on motorway No. 3 of Taiwan (2010). For the removal of the soil, 50 excavators, 100 trucks and 1000 workers had to be used for 20 days (Source: Lee *et al.* 2012) [10]

Natural failures, where and when they occur, cause serious techno-economic and environmental disasters, such as those in Fig. 2 on Motorway No. 3 of Taiwan, and call for an urgent solution to the problem.

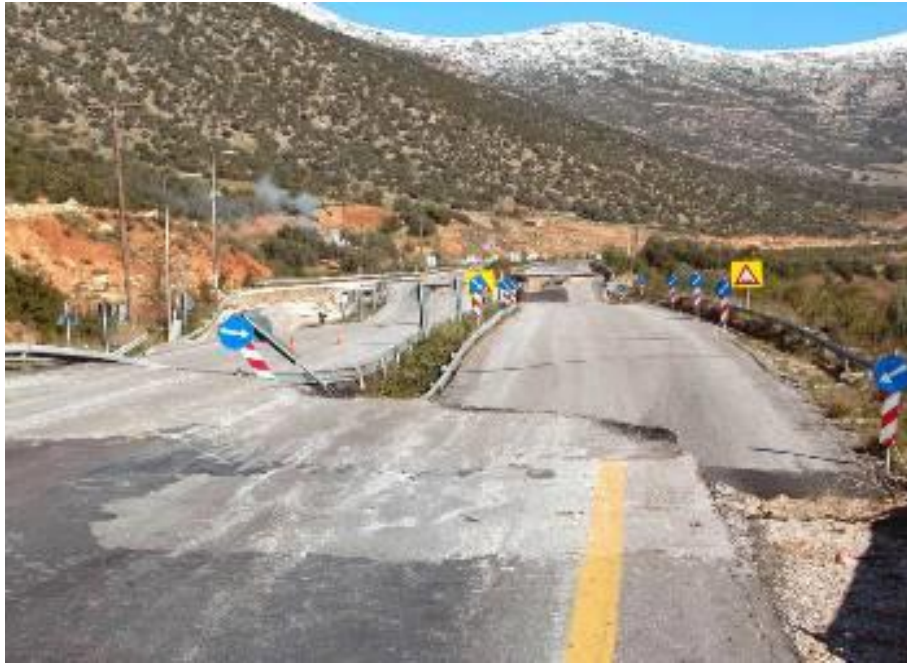
Fig. 3 The damaged road surface of the Athens-Thessaloniki National Road, from the landslide of Malakasa. (Source: <https://www.google.gr/search?q=Malakasa+landslide&sa>). [13]

Early in the morning of February 18th, 1995, a massive landslide took place on the 36th km mark of the Athens - Lamia road. Extensive damage was caused by this movement of the slopes, resulting in the disruption of road and rail communications of the capital with the northern part of Greece. (Figs 3, 4) [14], [16].

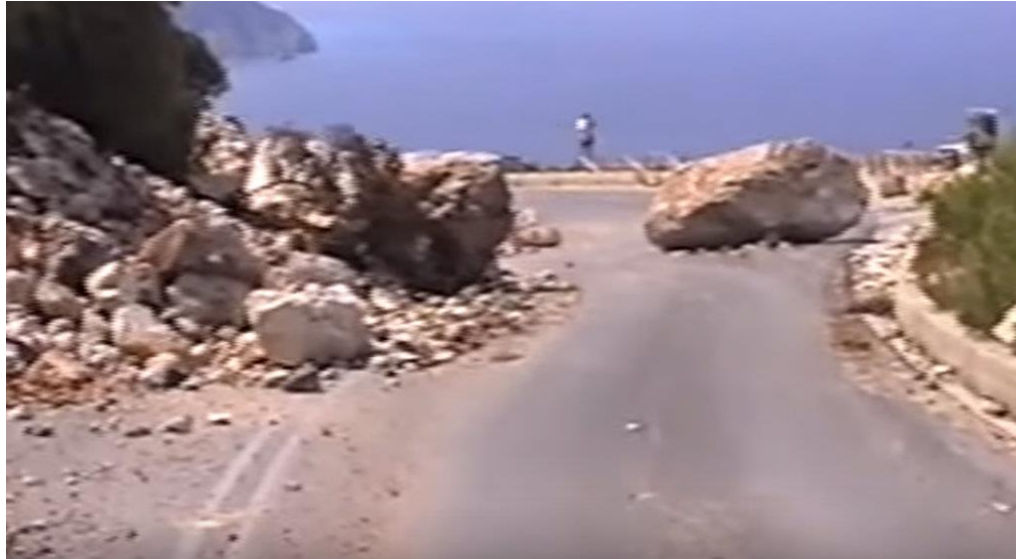
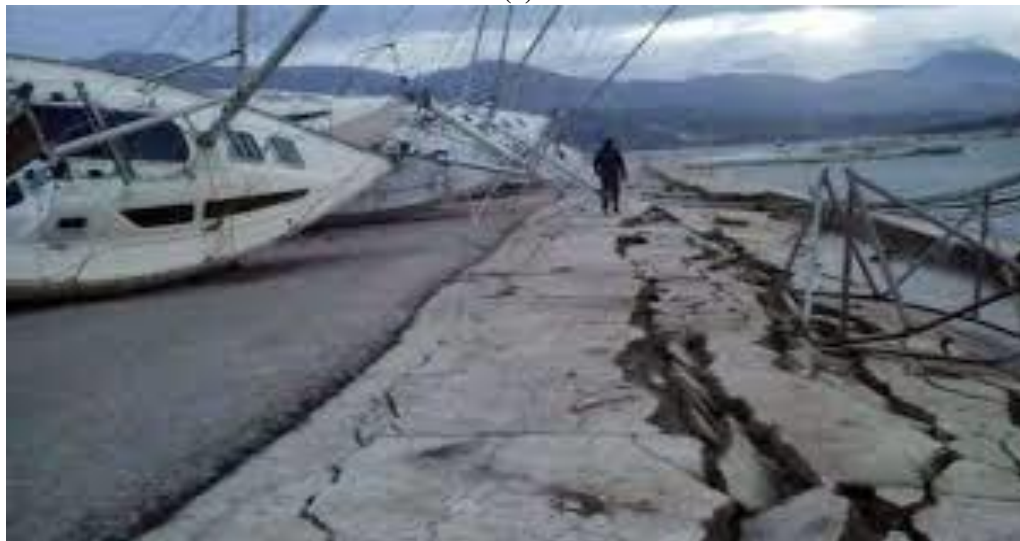
Fig. 6a & 6b Lefkada: landslides on the road network and crack system failures on the port (Source: <http://www.oasp.gr/node/497>) and (<https://www.google.com/search?q=lefkas+2003+earthquake>) [19-20]

An earthquake that occurred in Lefkada, having a magnitude of $M = 6,2$ and acceleration $\alpha = 0,42g$. extensively damaged the local environment of the island of Lefkada. Rockfalls and landslides were recorded in extent, along the western axis of the island and, at a lesser degree, the eastern part. Rock landslides are shown in Figs 6a and 6b, on road networks and ports, where destruction occurred at the dock. [19-20].

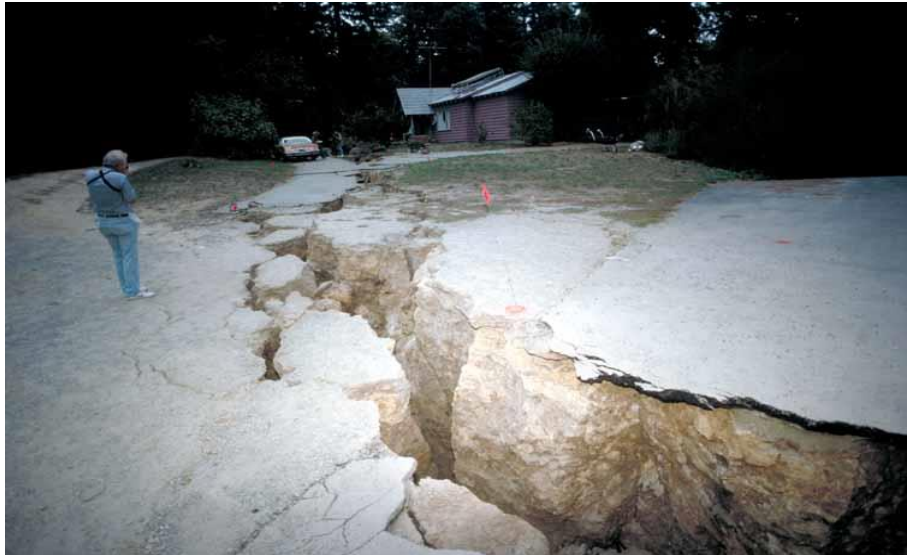
(a)

Fig. 7a A crack system destroys driveway adjacent to summit road 0.8 km (1/2 mi) southeast of Highway 17 [Source: J.K. Nakata, U.S. Geological Survey]. [21]

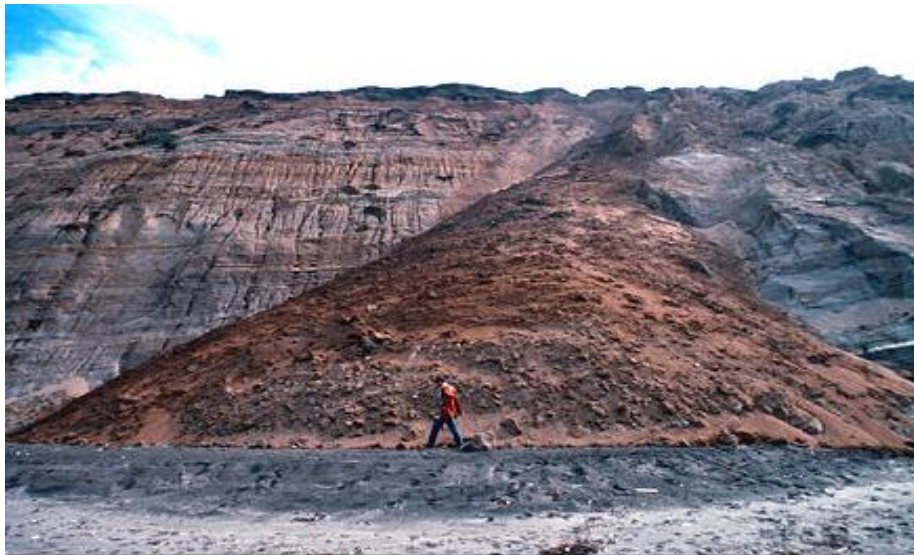
(b)

Fig.7b San Francisco and San Mateo County Coast. Landslide north of Fort Funston. This slide mass is approximately 2,830 cubic meters of material and is 30 meters high. (Source: <https://www.google.gr/search?q=sismo+loma+prieta+1989>). [22]

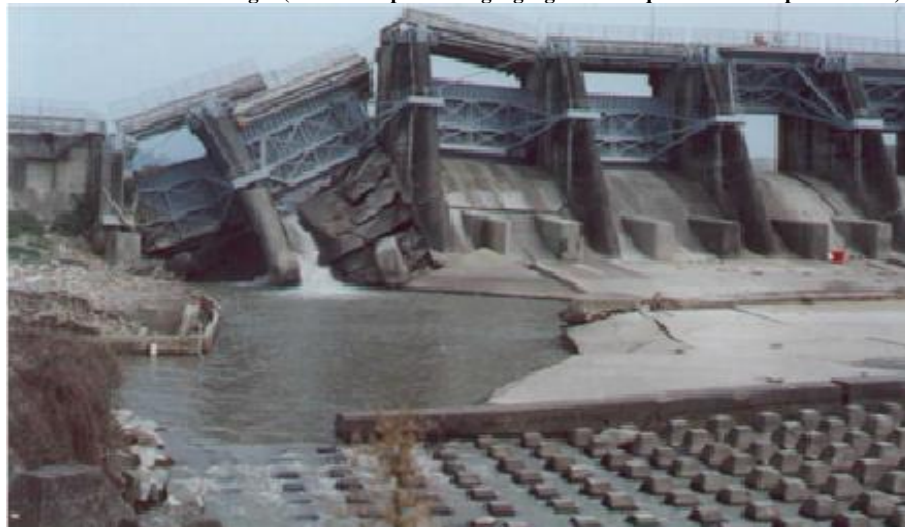
Fig. 8 Failure in the spillway of Shih-Kang Dam (Source: Wieland, 2009). [27]

The Chi-Chi earthquake took place on September 21, 1999 in the Chi-Chi area, which is part of Taiwan's western city of Nantou. It is worth mentioning that 2,415 deaths, 11,305 injuries were recorded in this earthquake, and more than 100,000 people became homeless after the earthquake, with the value of the damage being estimated at 10 billion dollars. The Shih-Kang Dam sustained a vertical displacement in the spillways in the order of 10-11m (Figs 8, 9). In order to understand the magnitude of the disaster, it is worth mentioning that the overflows are made of concrete with a height of 12.5m and a width of 36m. [24], [25], [27].

The study, the identification and classification of the environmental impact of the dam's failure gave the following results: the failure of the dam altered the normal functioning of the river and caused significant changes in local hydrology and downstream flowing waters, as well as in the transport of sediments. This change may lead to significant changes to the ecosystem that existed prior to the failure of the dam in the area. In addition, with the failure of spillways, the artificial blocking of river was removed, which reduced the time the water remained there, as well as its temperature, and changed the turbidity and thermal stratification [24].

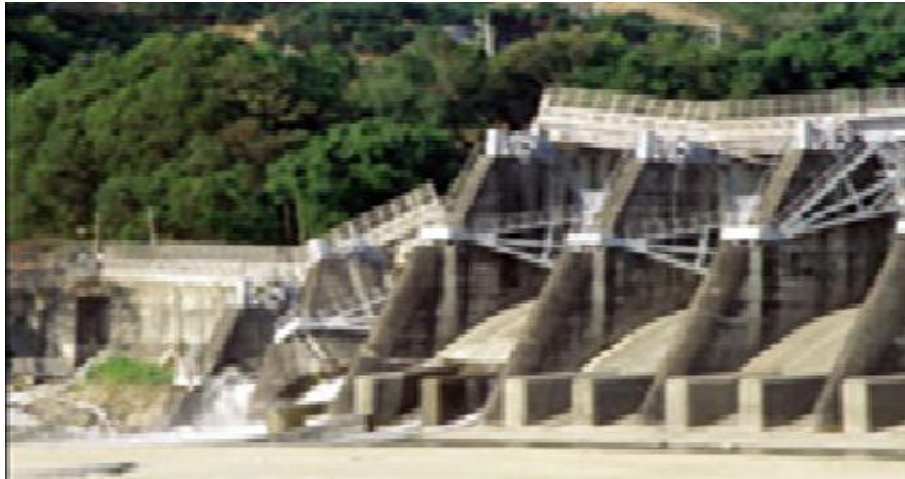
Fig. 9 Surface faulting caused major damage to the Shih-Kang Dam (Source: <http://mceer.buffalo.edu/research/Reconnaissance/taiwan9-21-99/docs/lessons.asp>). [26]

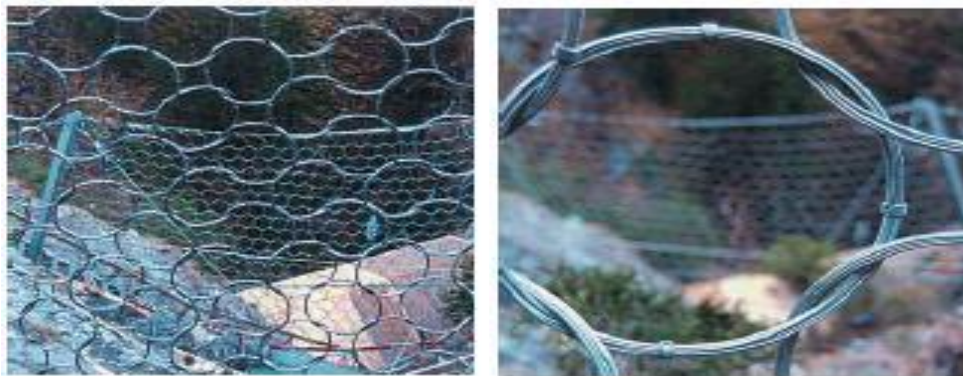
Fig. 12 Ring-shaped nets (Source: Marinos 2010). [30]

A metal mesh that covers the slope surface is used to deal with small scale falling rocks. This, on the one hand, prevents the falling of rocks and, on the other hand, reduces the kinetic energy of any falling ones. Metal nets are used to deal with large-scale rocks, such as Geobrug type ones [29- 30] (Figs 10-16).

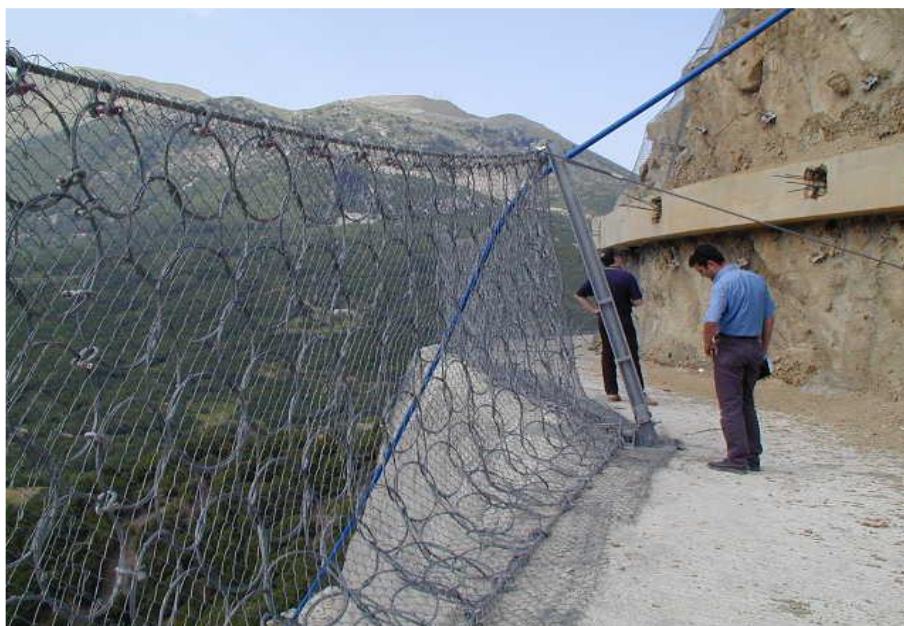
Fig. 13 Metal mesh for the protection from falling rocks. (Source: Rozos 2017). [29]

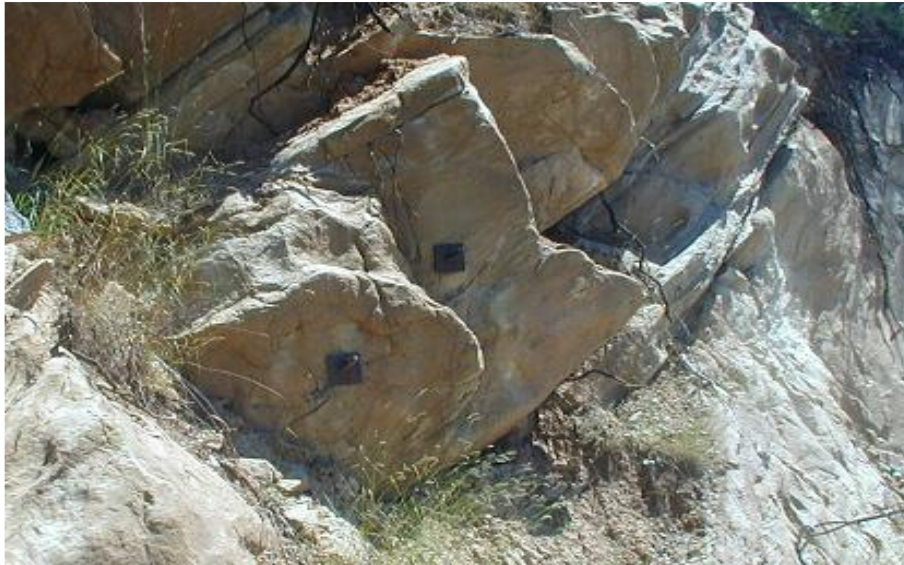
Fig. 14 Anchor (Source: Marinos 2010). [30]

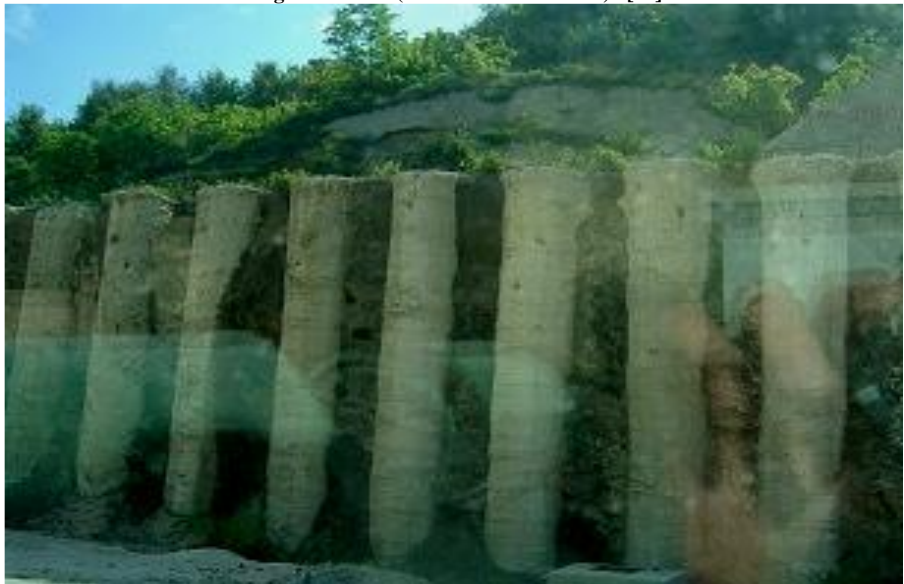
Fig. 15 Pile walls (Source: Marinos 2010). [30]

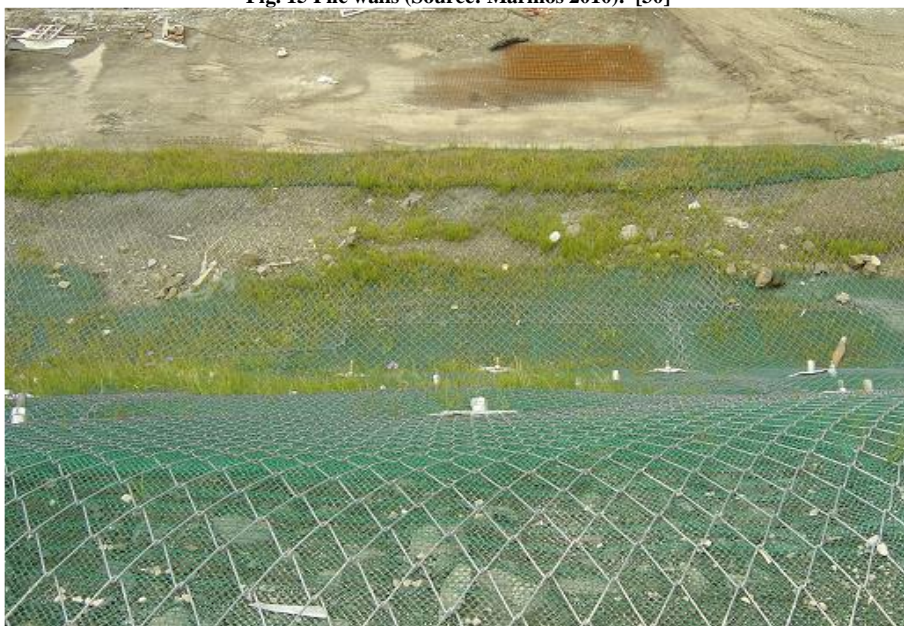
Fig. 16 Embankment with anchors and geosynthetics (Source: Marinos 2010). [30]

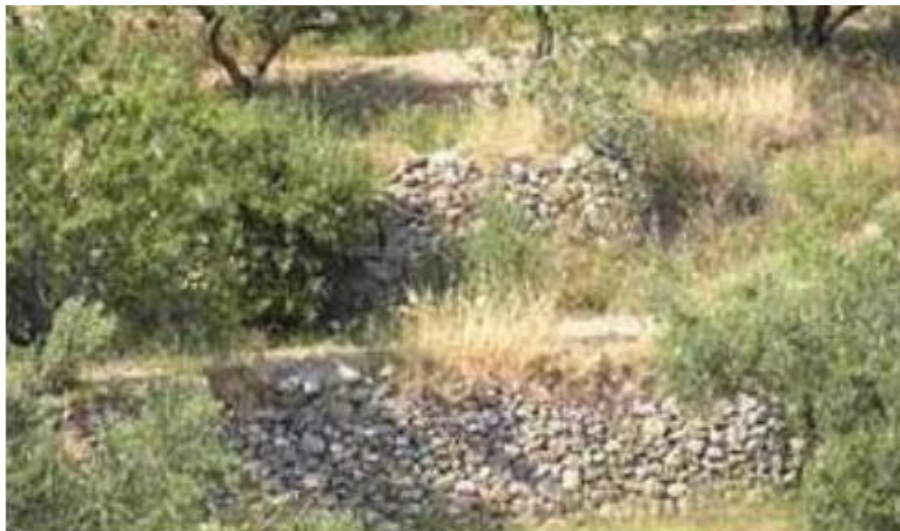
Fig. 17 Drywall retaining wall (Source: Marinos 2010). [30]

A prerequisite for the safe construction of a retaining system, such as the ones in Figs 17 and 18, is the geotechnical survey, through which the following should be ascertained:

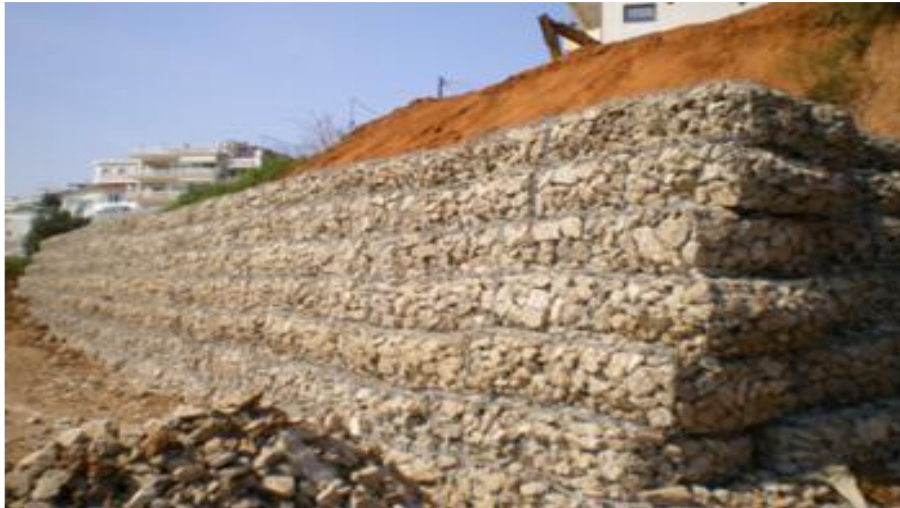
Fig. 18 Retaining wall with gabions (Source: Marinos 2010) [30]

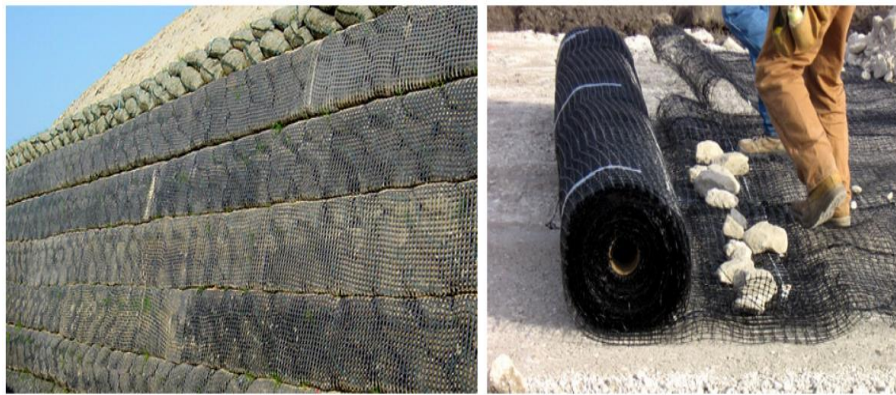
Fig. 19 Geogrids (Source: www.macproof.gr/ilika/geoplegmata-1) [34]

Geogrids are used as a substitute for natural arming materials, to solve increasingly complex geotechnical issues. They are divided into uniaxial & biaxial (and the latest technology is triaxial) and are mainly made of high density polyethylene (HDPE), polypropylene (PP) and polyester with a PVC coating. The geogrids are used [33-34] (Fig. 19):

- For the reinforcement of the embankment in a weak subsoil or even the embankment itself.
- For the construction of reinforced earth walls with steep (up to 90°) slopes.
- For the construction of reinforced granular bands for the distribution of loads in arrays of piles.
- To arm the ballast or substrate in railway works.
- For reinforcement of road-surfacing on older cracked surfaces, in order to avoid 'reflective' cracks.
- To strengthen the pavement base and subsoil and to reduce their thickness for an equivalent traffic result.
- For anti-erosion protection of unstable soils, in natural or artificial slopes.

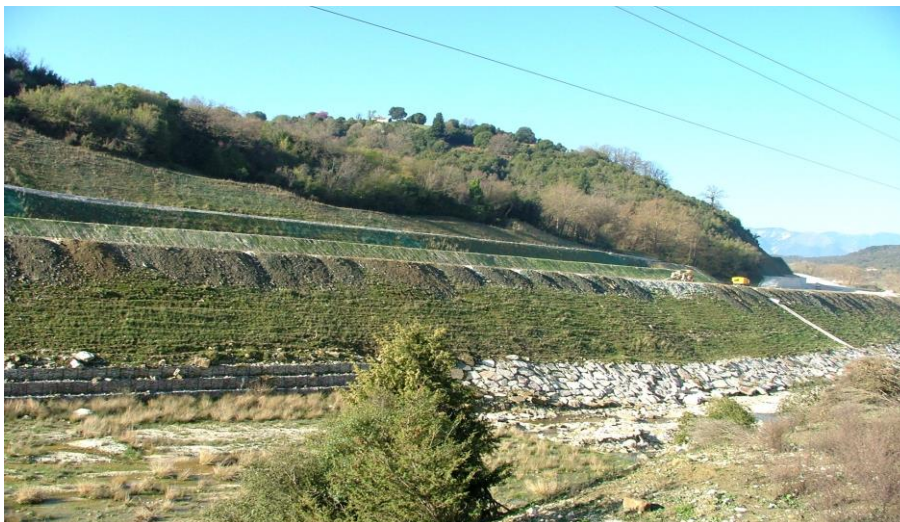
Fig. 20 Slope covered with a special geotextile for vegetation development. (Source: Rozos 2017). [29]

Plant cover is carried out during the last stage of treatment of a slope, especially when there is surface, layered slides. Slopes with deep sliding levels cannot be intercepted with vegetation, but this helps to reduce the surface water infiltration in the slopes and thus indirectly contributes to the stabilization of the slopes. The most useful trees are those that provide the most evaporation and are deep-rooted. [35-36]. Also for the protection of artificial slopes in soils, it is useful to plant turf or shrubs with the help of a special geotextile, which makes them more coherent and prevents water infiltration (Fig. 20). There are also geosynthetics that are embedded in rocky slopes and, with their form, allow the development of a soil layer of at least 10cm. The growth of vegetation is thus facilitated and at the same time the slope is protected from erosion. These geosynthetics consist of a polyester geotextile of cellular structure [29] (Fig. 21).

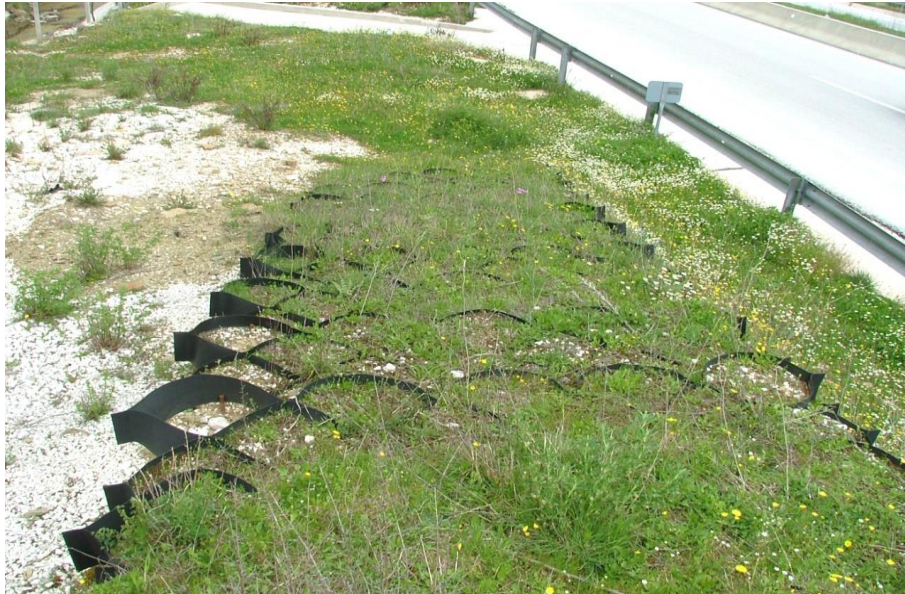
Fig. 21 Polyester geotextile of cellular structure for the growth of vegetation (Source: Rozos 2017) [29]

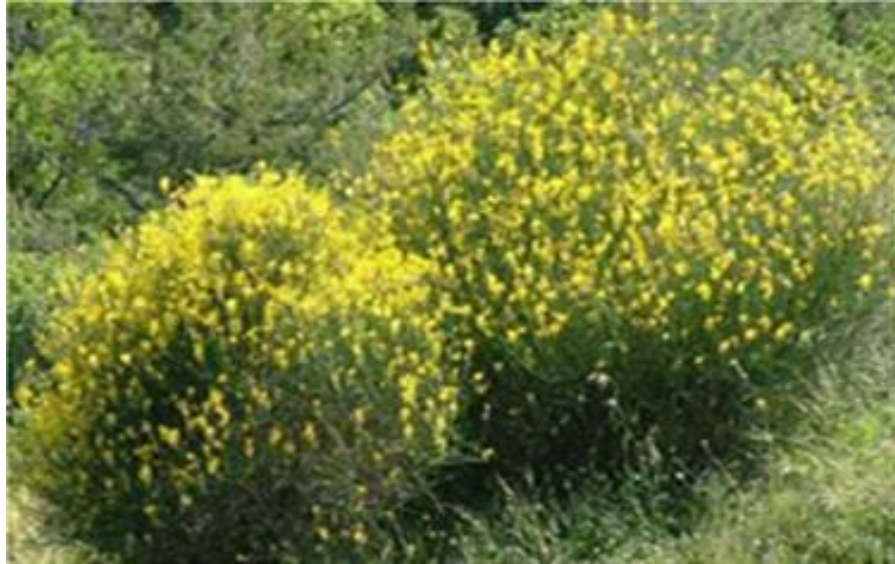
Fig. 22 Spartium slope cover (Source: Goura 2007) [37]

The predominantly used plants for the stabilization of the slopes are given in Table 1 below. Of these species, the spartium (*spartium junceum*), an angiosperm, dicotyledon plant species which belongs to the order of fabales and the family of Fabaceae (Fig. 22), is widely used on highway slopes. It is a shrub from the Mediterranean region and reaches a height of 2 m. It is an evergreen species with a particular root system, which reaches a depth of about 1m and has a secondary root width of 2m. Consequently, it is ideal for restraining both the grains of the slopes and further

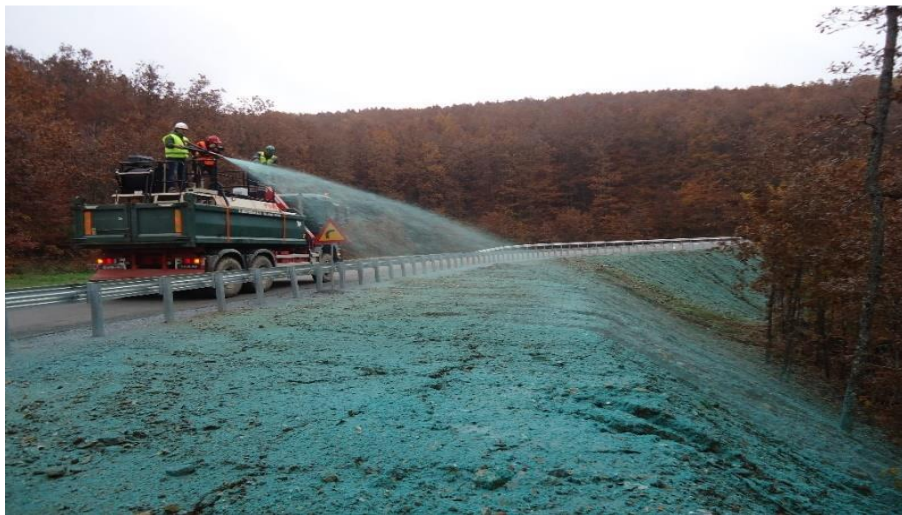
Fig. 25 Hydroseeding in a forest road embankment (Source: Galatsianou 2017). [40]

| 3. Bush-mattressconstruction (Fig. 24) | 10. Hydroseeding (Fig. 25) |
