Restoration and Preservation of Cultural Heritage Monuments

Digital Presentation and Practical Solutions

In this paper it will be discussed the chalk limestone monument from Dobrudja named Basarabi Churches Ensemble. This monument is dated IX-XI centuries, is located in a hill of chalk cliff into a Roman career style, with churches, galleries branched vaults, housing the tombs. The monument is located into a lithological generated hill, consisting of chalks and chalky marnes. The limestone is compact, with variable thickness from 42 m to 95 m, and below them there are marl and limestone. From mineralogical and chemical point of view, the stone is mono-mineral (CaCO_3). After the discovery 1957, the assembly elements were partially crushed and the rock has been repositioned in a structure of reinforced concrete and cement mortar. A protective building of concrete has been built for more than half of the site; the rest remained under provisional protection of wood and tar paper. These constructions have not assured proper microclimate, especially in the facing incised. The moisture, environmental humidity and water external sources could cause a crushing of the chalk rock, and this

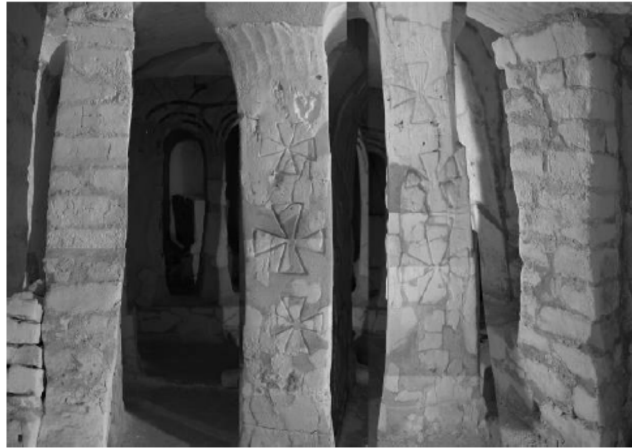
Fig. 2. The photo of naos

Basarabi archaeological site is located in a hill which from lithological point of view consist of chalks and chalky marl, Figure 2.

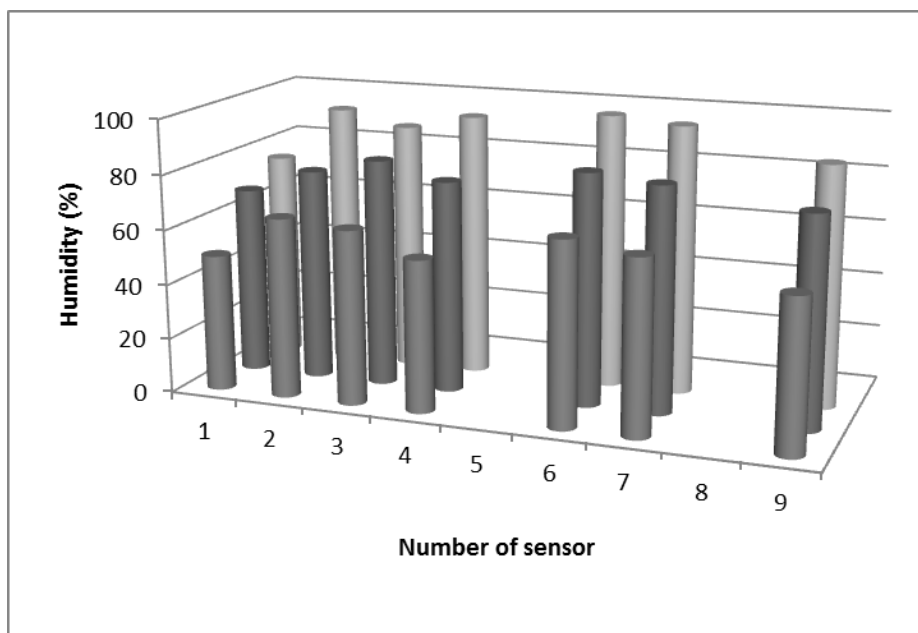
Measuring the humidity in those 9 points from monuments interior, was possible to see a similar conclusion as previously reported [9]. As the deepest is the measurement points, the highest is the humidity. So, inside of the monument (naos) is a higher humidity and the degradation processes are stronger, Figure 3.

Fig. 3. The humidity variations for Basarabi church (in 9 points executed in naos)

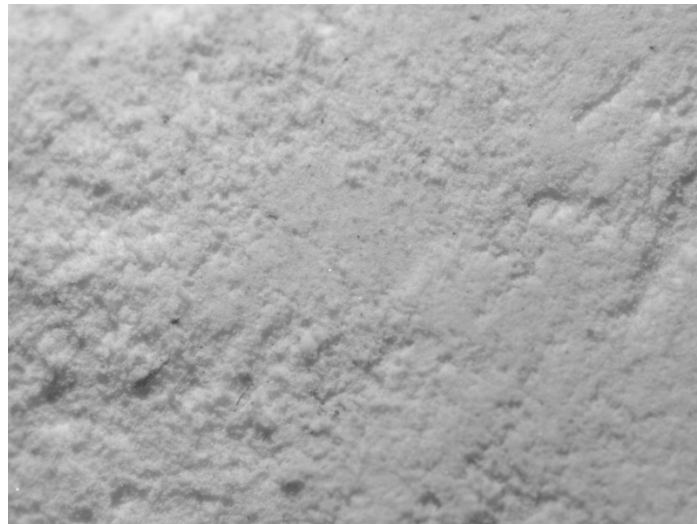
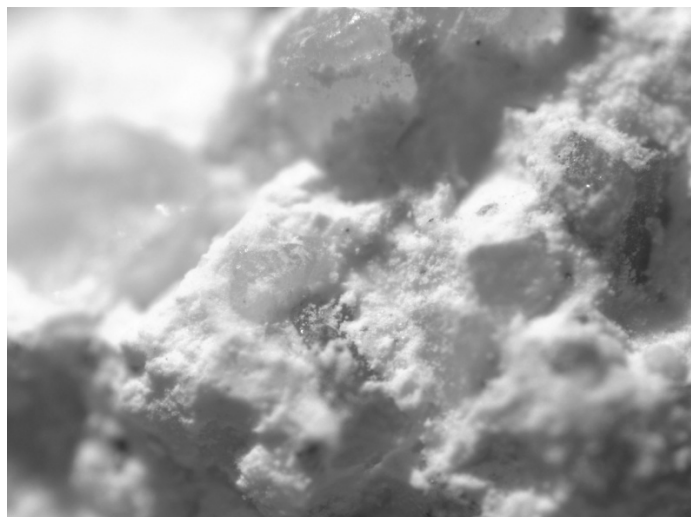
Fig. 4. The aspects of the chalk wall dried (up) and wet with efflorescence (down)

The groundwater conditions hydro-geological site near the monument, water accumulation and possible leakage of leachate from rubbish to landfill career, have been achieved building six bore holes to depths of 15 to 20m, located outside the site and research role hydrogeology and geology. The determined degree of saturation, defined as the ratio between natural humidity (W_n) and the humidity of the same rock but saturated with water (W_{sat}), has the value of 0.3-0.994. From petrographical and mineralogical analysis, could be concluded that some varieties of calcite, as vaterite, which is very unstable (is stable only under 10 °C) and has the tendency to form framboidal structures, in the presence of CO_2 [10]. These framboidal structures are aggregations of smaller, mostly spherical, particles, with an average size of these elementary spheres comprised between 36 and 150 nm. It is very sensitive to water, too. If water can enter a rock through crevices, fractures or capillary spaces and subsequently freeze, the rock will be subjected to extremely high pressures which may cause shattering or cleaving if the rock is weak. The Chalk is considered highly susceptible to the actions of frost because has a high % void space within its structure allowing moisture to enter the rock and is a fine grained rock with multiple planes of weakness making it a relatively weak rock with low tensile strength and little resistance to frost action, Figure 4. In conjunction with these factors, the presence of salt within the moisture from the sea may facilitate the disintegration of rocks [11], by lowering the freezing point producing longer periods of thaw which would allow for longer periods of moisture adsorption. This test method does not provide an absolute value but rather an indication of the resistance to freezing and thawing; therefore, the results of this test method are not to be used as the sole basis for the determination of rock durability [12]. At the completion of 20 freeze-thaw cycles, the mass loss of the samples was determined to be significantly (7%).

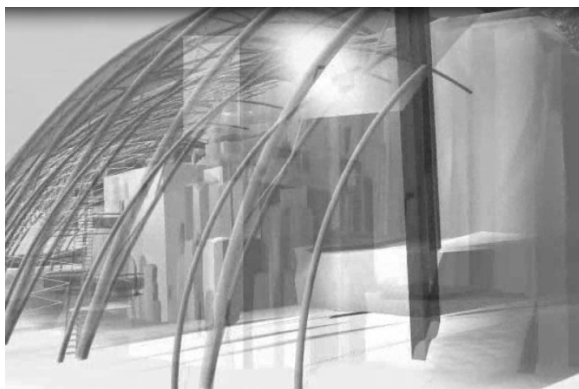
Fig. 8. The protection overlapping the church

Laser scanning, 3D modelling, digital scanning and photogrammetry are the most used methods to digitize cultural heritage in order to provide 3D models. By means of Laser scanning technique, for this monument was possible to measure topographic quantities, the direction of a virtual optical line joining some points from the surface of the monument to a reference point on the measuring device and the morphological characteristics on th monument that can be acquired and measured with a very high accuracy [13]. It has been obtained a mathematical representation of a 3D surface, by means of CAD modelling to create the 3D model of the external projection of the church, Figure 6. As an alternative, the common digital photos can be used, to obtain 2D or 3D coordinates from some photos. The method can be aided by CAD software, which can produce good models for scales of 1:100 and higher [14-16]. In our case by using 3D photogrammetric has been obtained the 3D model of the envelope of the church that should be applied over the church, Figures 7 and 8. The created 3D model was 0.72-0.95% precise.
