## Appraisal of Salt Crystallisation and Rising Damp Problems in Building

Aw Nien Wei, Md Azree Othuman Mydin

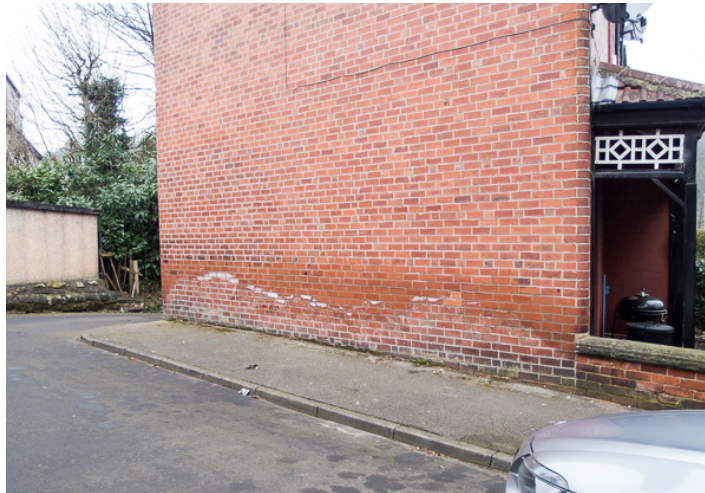
**Figure 3.** Rising damp on a painted brick wall

In order to verify the rising damp, non-destructive equipment can be used which is moisture meter. Moisture meter can be placed on the affected area thus the reading of the level of moisture content can be obtained. Another destructive test can be done by collecting the sample from the affected wall and undergo laboratory test. Figure 3 shows rising dampness on a painted brick wall.

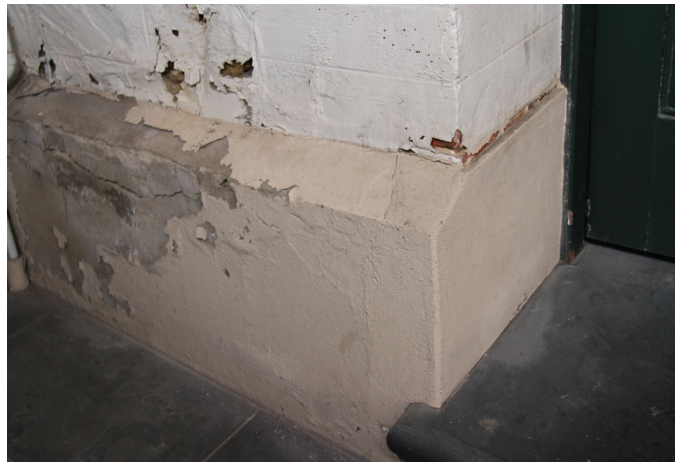
**Figure 4.** Rising damp exacerbated by hard cement render repairs

Rising damp also can be occurred as a result of condensation. This occur when the warm moisture being cooled to a dew point which is the temperature which moisture condenses against a cold surface. Normally this happens in that particular room or area. This phenomenon is the main cause of damp in the base of walls rather than rising damp alone. Figure 4 shows the indication of rising dampness problem which exacerbated by hard cement render repairs.
