Assessment of Damaged Building by Using Retrofitting Techniques- Case Study

Kalpesh R. Kolhe¹, Manish D. Mata²
^{1,2}(Civil Engineering Department, SSGBCOET, Bhusaval)

Name of Building: Thane Municipal Corporation School

Name of Building: Scottish chemical industries

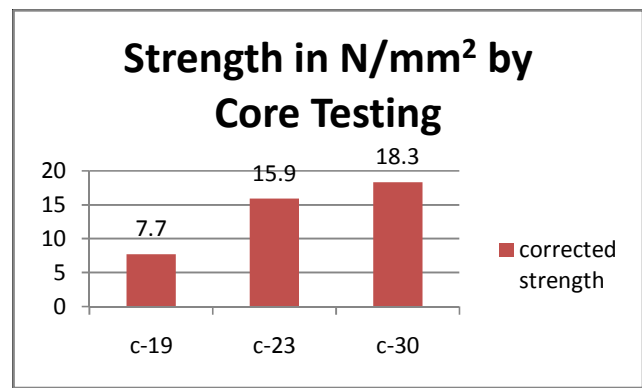
The core test results indicate that the average equivalent in-situ cube compressive strength of the concrete of the column based on the balance cores is 175.1 kg/cm² which can be considered as just equivalent to M20 concrete as per the acceptance criteria provided in IS 456:2000.

Fig.1 Bar chart showing core test results

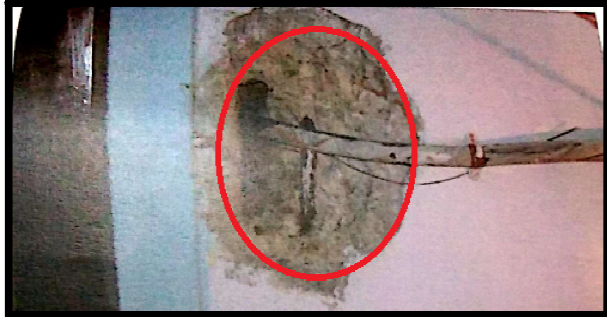
- Columns C-1,C-9,C-17,C-19,C-22 are observed with corrosion cracks.
- Columns C-9,C-12 is observed with seepage cracks.
- Beams B-28,B-32,B-33 are observed with corrosion cracks. Column C-17 is observed with honey combing.
- Beams B-6,B-28,B-33 are observed with seepage marks.
- Staircase landing bottom is observed to be damaged and steel is exposed.

Fig.3 Showing slab breaks with exposed steel shows in red mark

- All the corrosion distresses shall be attended to by using the application of the single patch polymer modified mortar in patchwork after removing loose concrete, cleaning the reinforcement, protecting, grouting, augmenting the reinforcement as per the manufacturer's specification.
- The more important members like columns with corrosion distresses all over the entire length, shall be jacketed from foundation level from all the four sides using 75mm thick micro-concrete. This shall be particularly done to all the corners columns, so that building remains in robust condition.
- The separation cracks shall be treated using polymer modified using standardized procedure.

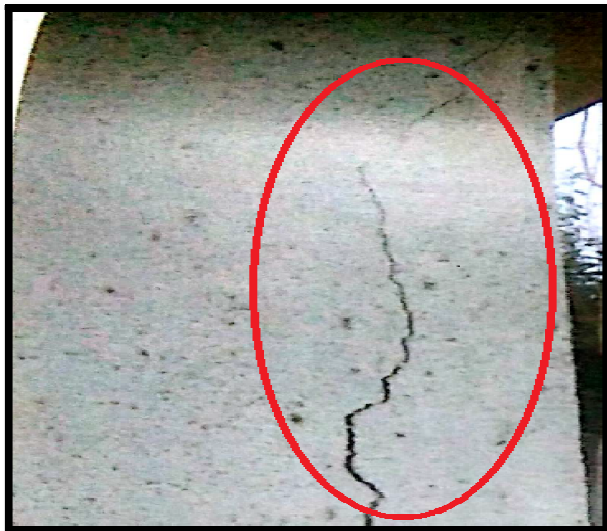
Corner column is observed with corrosion cracks. Wall is observed with seepage marks.

Fig. 4 Showing corner column shows corrosion cracks

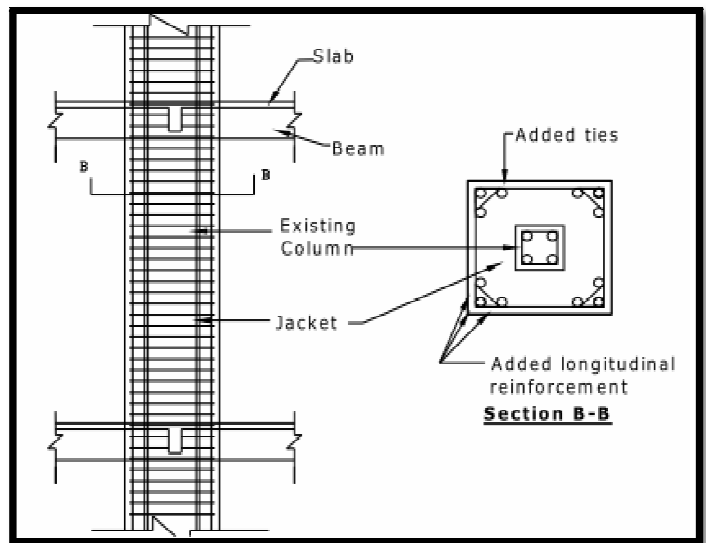
Jacketing is the most popularly used method for strengthening of building columns. The most common types of jackets are steel jacket, reinforced concrete jacket, fibre reinforced polymer composite jacket, jacket with high tension materials like carbon fibre, glass fibre etc.

1. To increase concrete confinement by transverse fibre reinforcement, especially for circular cross-sectional columns,
2. To increase shear strength by transverse fibre reinforcement,
3. To increase flexural strength by longitudinal fibre reinforcement provided.

Fig. 5 Showing jacketing of column

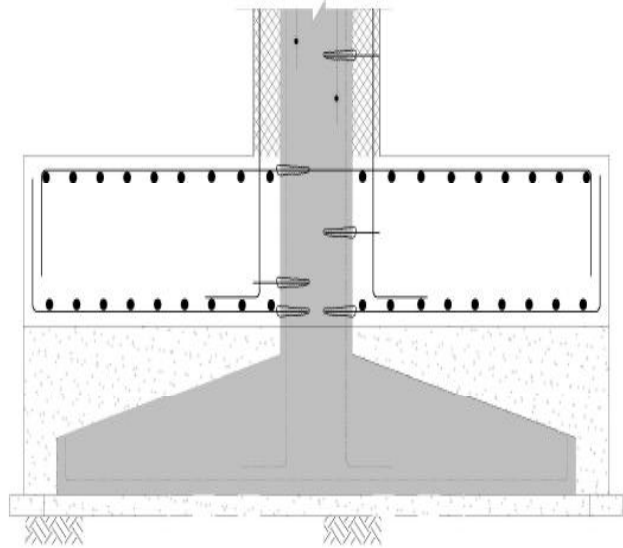
Fig. 6 Showing Footing Strengthening with Reinforcement & Concrete Jacketing

- Footing strengthening

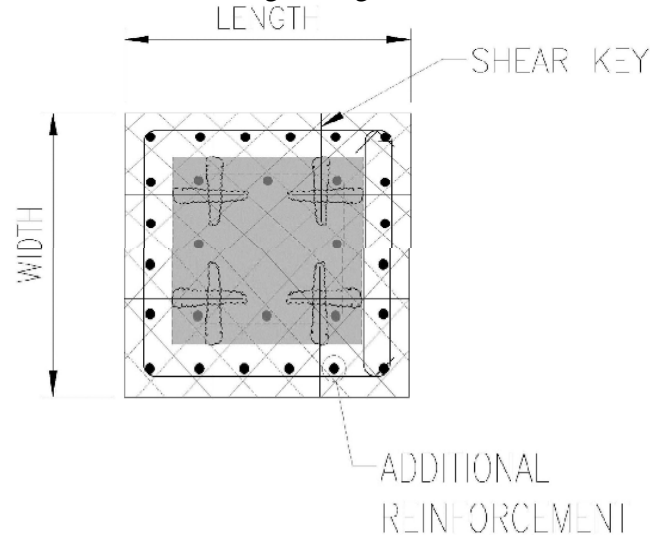
Fig. 7 Showing Column Jacketing with Reinforcement & Micro Concrete

- Column strengthening

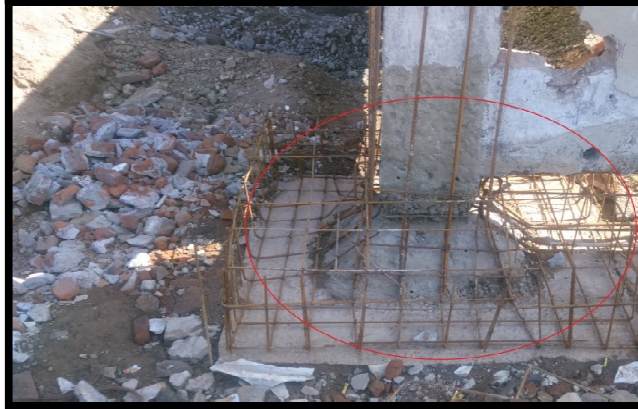
Fig. 8 Shows that footing is strengthen with extra reinforcement

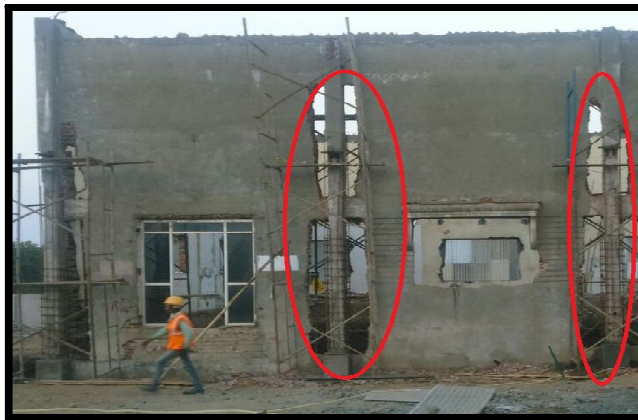
Fig. 9 Showing columns with red mark shows that they are strengthen with the help of jacketing.
