## Water Erosion on the Thiès Tray (Senegal): Study of the Factors of the Phenomenon using a Geotechnical Approach

Mamadou L. LO<sup>1</sup>, Alassane BA<sup>1</sup>, Papa B. D. THIOUNE<sup>1,2</sup>, Abdoulaye DIEDHIOU<sup>1</sup>, El Hadji B. DIAW<sup>1\*</sup>

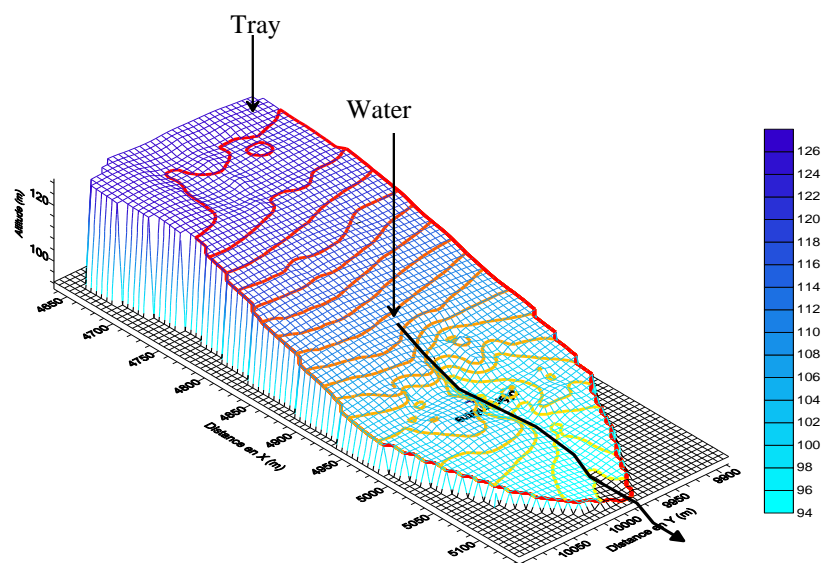
Figure 2: Kissane watershed

The 1:50 000 scale topographic maps available for the area did not allow us to delineate the Kissane watershed site of our present study. Thus, topographic surveys have allowed us to delineate our field of study and determine its topographic and hydraulic characteristics (Figure 2). This watershed is characterized by the presence of three parts: a first zone with fairly high altitudes (max. 138 m) constituting the plateau, a second constituting the slopes and a third the plain where the basin outlet is located. It is also important to note the existence of a non-perennial water source.

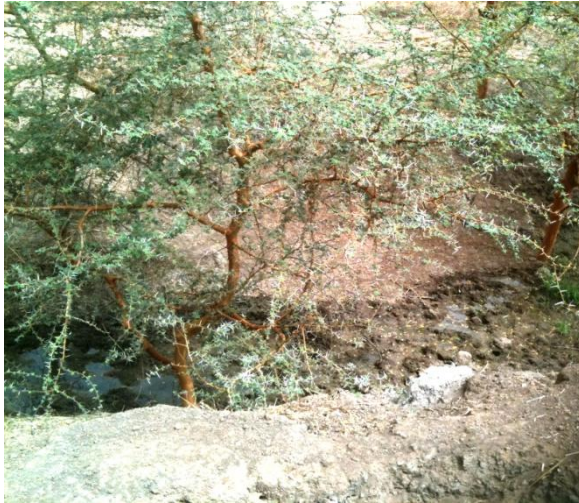
*Figure 3: Continuous gullying with presence of a water source*

At the level of the village of Kissane, the consequences of water erosion are visible with a continuous gullying and even the appearance of new ravines (Figures 3 and 4). On the plains we are witnessing loss of land for agriculture; the land becoming unfit for cultivation due to the deposition of stones torn off by the strong runoff on the slopes (Figure 5).

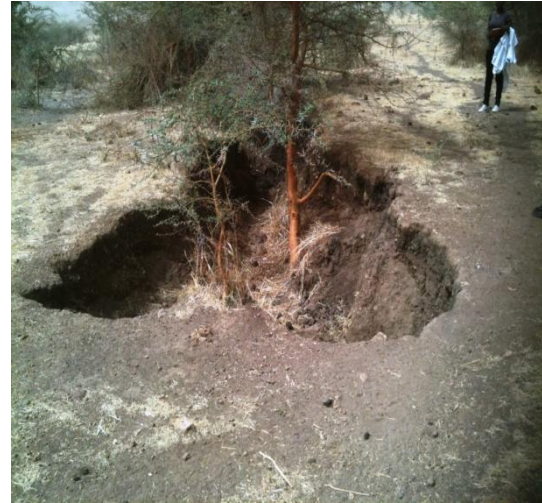
*Figure 4: beginning of a new ravine at the foot of the Thiès tray at Kissane*

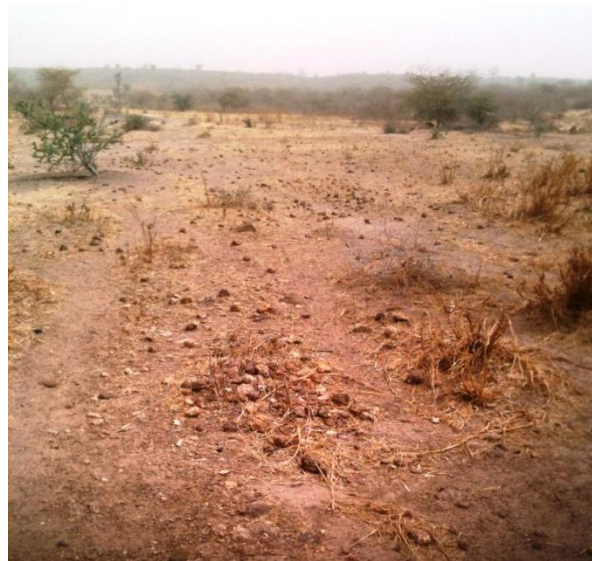
*Figure 5: Stones transported by runoff from the slopes to the plains*

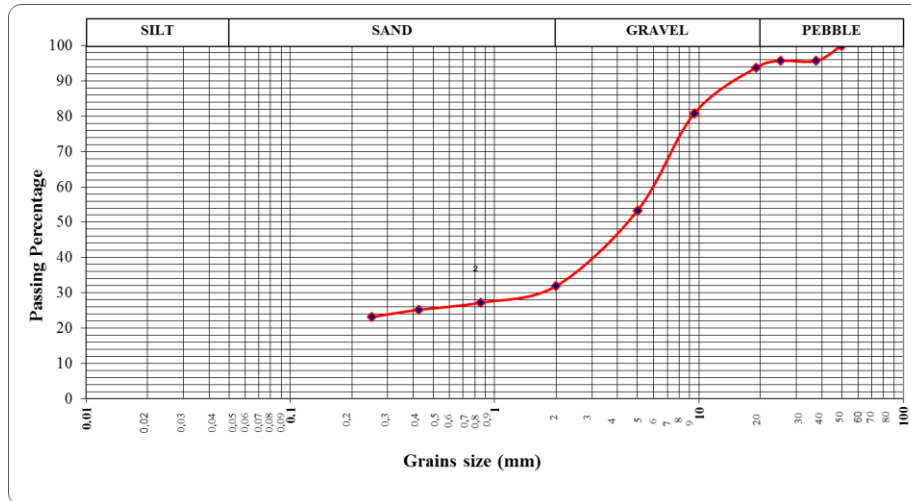
Figure 7: Soil sample granulometric curve Borehole No. S32

The results are presented in the form of granulometric curves shown in Figure 7.

Soils containing more than 50% fine sand (particles with diameters between 50 and 100 microns), a percentage of clay and a low organic matter content are very erodible [11]. According to the USCS soil classification system, the samples taken in the boreholes are composed of 45% clay gravel (GC) 25% silty sand (SM) 21% clay sand (SC) 9% very plastic clay (CH).

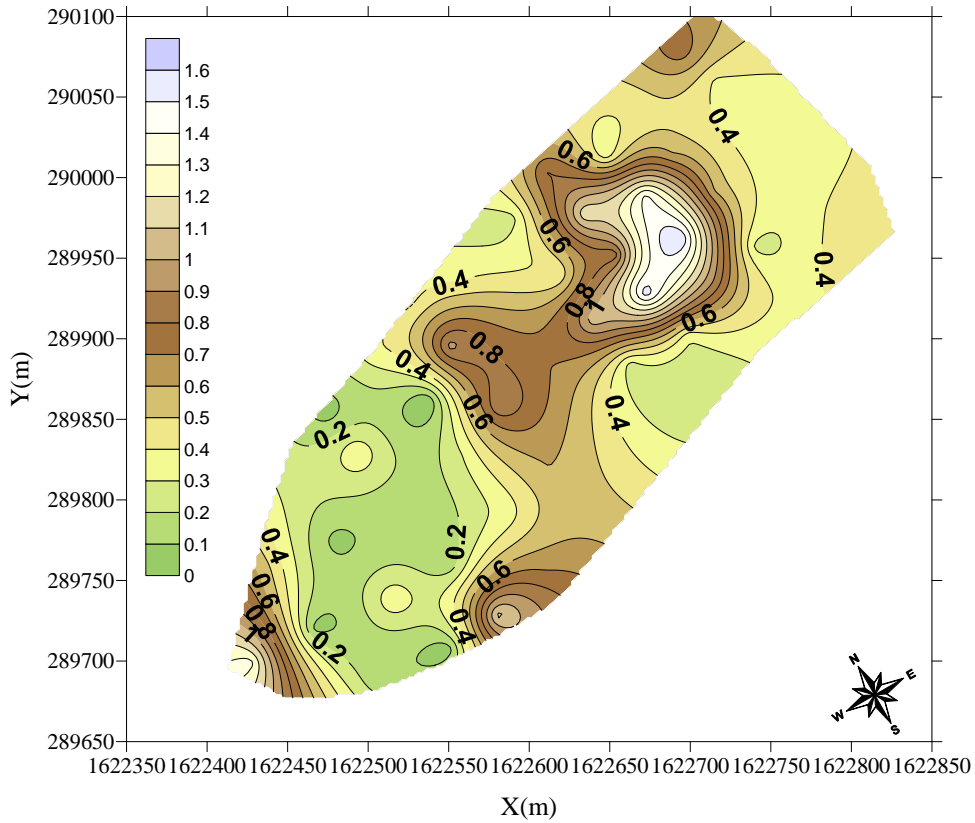
Figure 8: Soil erodibility map based on Hémin structural stability index

The laboratory tests made it possible to determine the textural classes of the soils, their consistency limits and the structural stability index of Hénin and Bouyoucos. The results obtained thus enabled us to map soil erodibility at the Kissane watershed level based on the structural stability indices of Hénin, the consistency limits and the Bouyoucos index. Figure 8 shows the soil erodibility map based on the structural stability index of Hénin.

It allows to highlight that the highest stability index values are found on the slopes. This part of the watershed is characterized by its fairly steep slope which results in an increase in rainfall runoff velocity.

By examining the stability indices of Hénin ranging between 0.03 and 2.22, we note that the erosion in the Kissane catchment area is largely due to its relief. Indeed, when the logarithm in base 10 of the stability index is lower than 1 ( $\text{Log}_{10}I_s < 1$ ), we are in the presence of very stable soils. Thus, we can say that water erosion in the Kissane catchment is mainly due to a purely mechanical phenomenon linked to rainwater runoff.

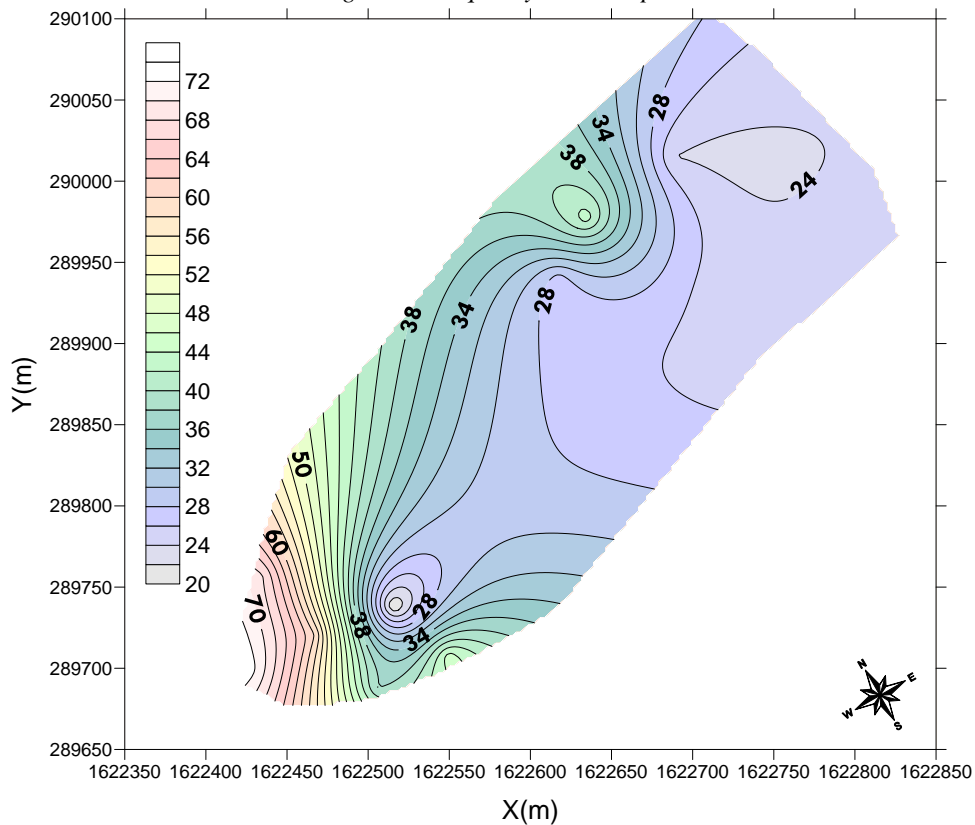
Figure 11: Plastic limit map

Figure 11 based on the plasticity limit shows that the highest values occur in the vicinity of the outlet. Indeed, the sedimentation phenomenon is more intense in this part of the watershed, which explains the predominant presence of clay particles. The two figures (10 and 11) allow, in the case of a Summary Preliminary Draft, to have a good idea of the plasticity and liquidity limit values.

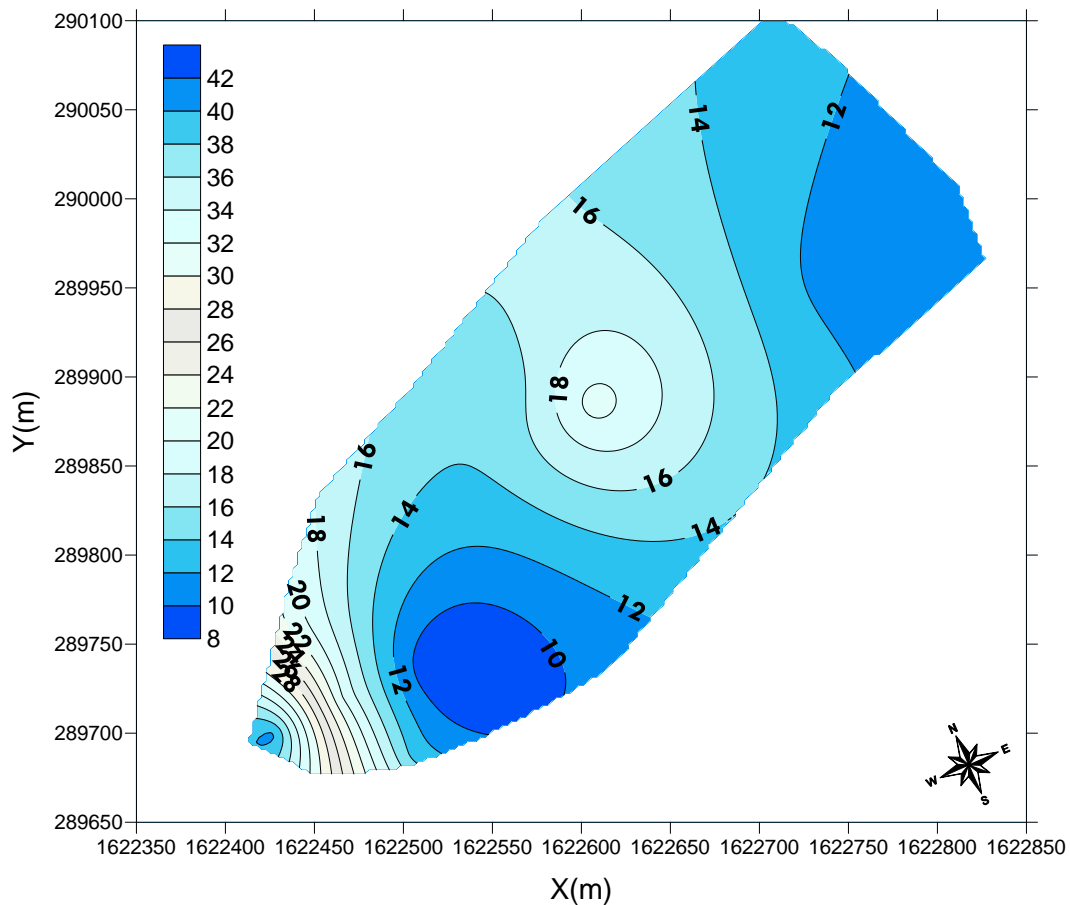
Figure 12: Plasticity index map

Figure 12 established on the basis of the plasticity index shows that the highest values are found near the outlet. The sedimentation phenomenon is more intense in this part of the watershed, which explains the predominant presence of clay particles.

This map also allows, in the case of a Summary Preliminary Draft, to have a good idea of the values of the plasticity index.
