Performance Analysis and Fault Classification in a Large Electric Motor Using Vibration Assessment Technique

Abstract: This research paper presents an analysis of electric motors performance by the assessment of vibration characteristics caused by bearing faults, housing bearing looseness and rotor unbalance. In this study, an analysis of fault that occurred in electric motor has followed ISO 10816-3 Standard. Bring the used electric motors for testing and measuring the vibration of the electric motors by using the Spectrum Analysis & Field Balancing Analyzer model ADASH A440-VA4 Pro. The vibration results of 22kW, 55kW and 75kW motor imply the malfunction of bearing faults, housing bearing looseness, and rotor unbalance. The results obtained from the analysis will be used as references and guidelines for predictions of faults in the electric motors, including maintenance scheduling of electric motors.

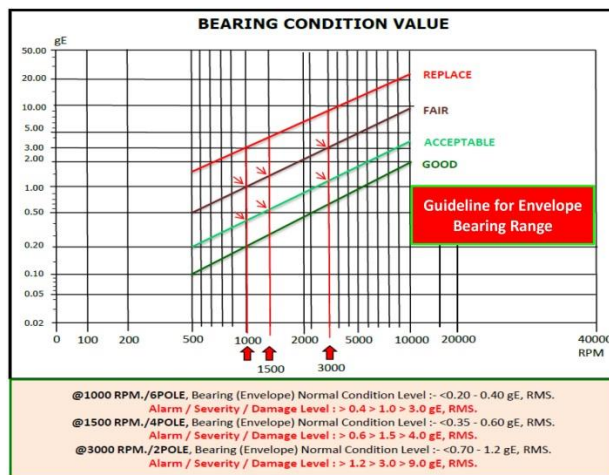
Figure. 3 Guideline for envelope bearing range (gE) [9]

Vibration measurement [8] of ball bearing distinguishes problems in lubrication, dust particles, bearing installation, and fatigue in the ball bearing based on the principle of “Acceleration Enveloping, gE” that gE values indicate the performance of bearing condition as shown in Fig. 3.

From Table 2, before maintenance, it found a high gE value, in which indicates the defects caused by the bearing as shown in Fig. 3. After replacing the bearing, the gE value is decreased and the loose bearing disappears.

levels is based on the principle of Acceleration Enveloping)gE(as shown in Fig. 3.

From Fig. 3, the gE values indicating the effective performance of bearings are considered by the RPM of specified motors. All 3 experiment motors. Before maintenance, the measured gE, representing the defects caused by the bearing. After replacing the bearing, the gE value was decreased.

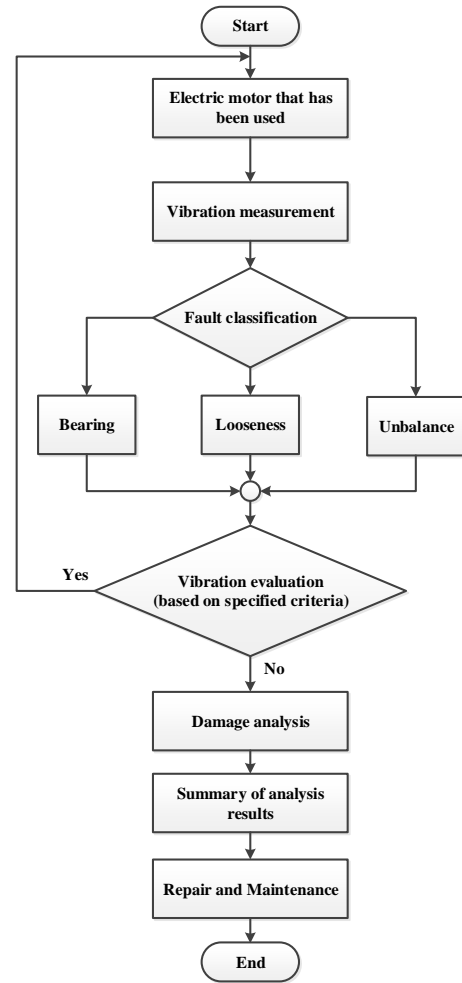
Figure. 7 Operating procedures

3. Design and operating procedure

- 1) Enter the voltages for the electric motor to achieve the RPS as specified by the motor nameplate.
- 2) Measure the electric motor vibrations and gE values.
- 3) Damage analysis.
Perform repair and maintenance and repeat the processes 1 to 3 respectively.

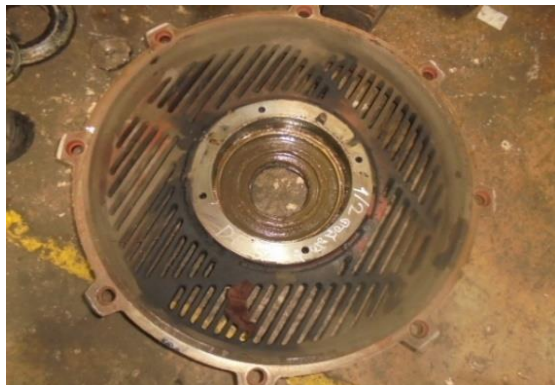
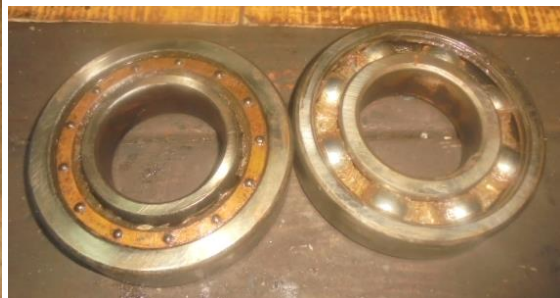
Figure. 10 Parts of 22kW motor before maintenance: (a) bearing housing and (b) bearing

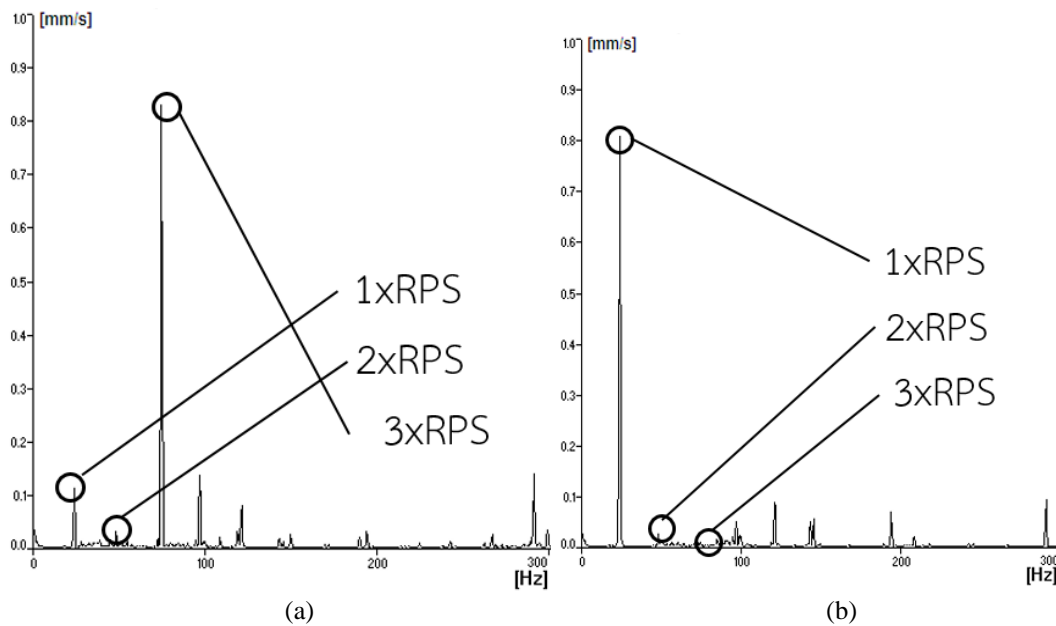
Figure. 13 Vibration results from 55kW motor: (a) before maintenance and (b) after maintenance

Horizontal	1xRPS (mm/s)		2xRPS (mm/s)		3xRPS (mm/s)	
	Before	After	Before	After	Before	After
Front	0.12	0.80	0.04	0.02	0.84	0.005
Rear	0.11	0.27	0.04	0.03	0.46	0.015

From Table 3, before maintenance, vibration values occur at frequencies: 1xRPS, 2xRPS, and 3xRPS, indicating harmonic values and bearing looseness. After maintenance, values at the frequencies 2xRPS and 3xRPS is decreased, while the frequency 1xRPS is increased, indicating the rotor unbalance with a good level of vibration.

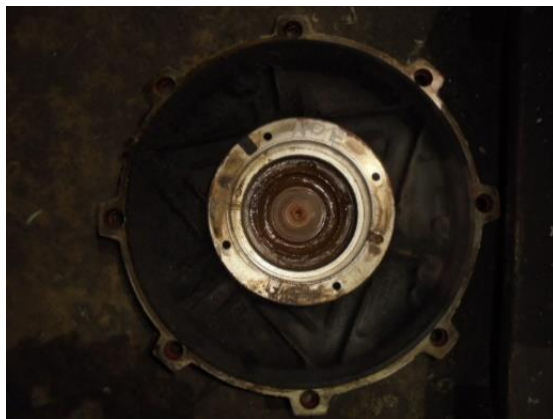
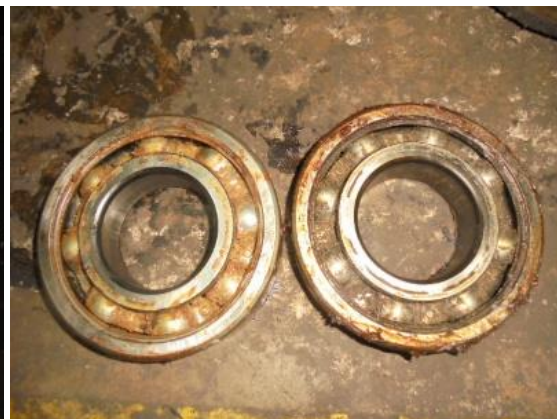
Figure. 14 of 55kW motor before maintenance: (a) bearing housing and (b) bearing

From Table 4, before maintenance, the gE value was at 1.92, representing the defects caused by the bearing. After replacing the bearing, the gE value was decreased.

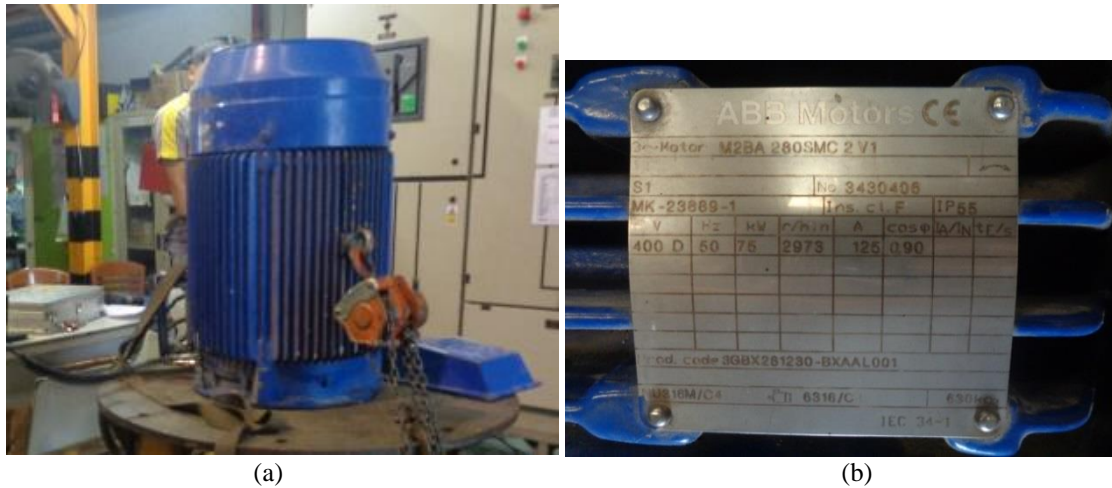
Figure. 16 75kW motor with 2,973 rpm in the experiment: (a) tested motor and (b) motor's nameplate

3) Results of the experiment on the 75 kW motor with 2,973 rpm as shown in Figs. 16-19 and Tables 5-6.

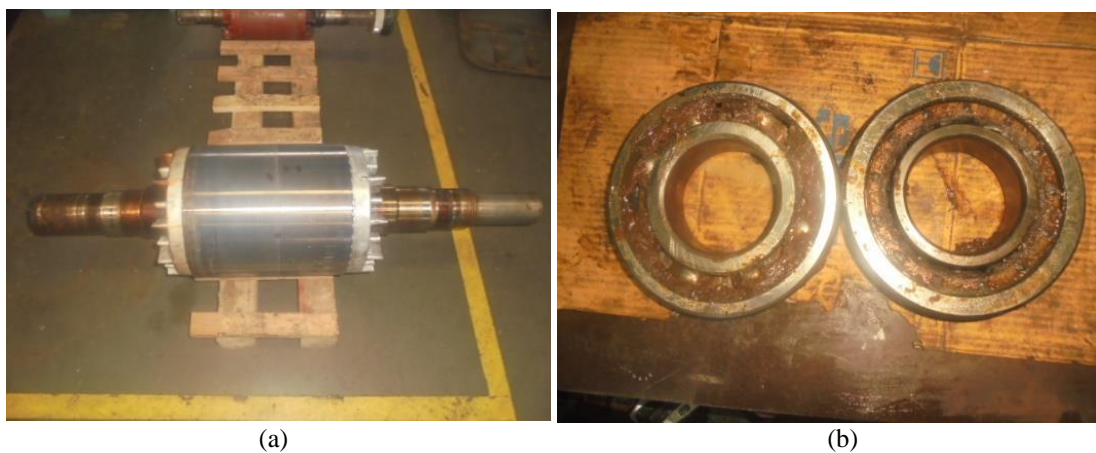
Figure. 18 Parts of 75 kW motor before maintenance: (a) rotor and (b) bearing

From Table 5, before maintenance, the vibration value at the frequency 1xRPS was rather high when compared to other frequencies, indicating the rotor unbalance as shown in Fig. 4. After correcting, the value at the frequency 1xRPS was decreased.

From Table 6, before maintenance, the gE value was at 1.980, representing the defects caused by the bearing. After replacing the bearing, the gE value was decreased.
