UTTRAKHAND TRAGEDY OF 07 FEB 2021: REMINISCENCE OF 2013 UTTRAKHAND FLOOD DISASTER

Colonel MK Chauhan¹ & Anurag Jaiswal², Ph. D.

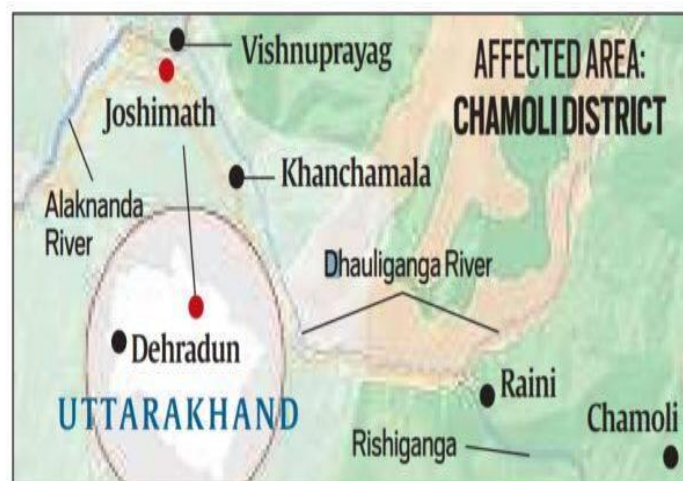
On February 7, 2021, the people of Reni village — the birthplace of India's environmental consciousness as this is where the women stopped the felling of trees — say they heard a loud bang. Within minutes the muddy deluge gushed down
Copyright © 2021, Scholarly Research Journal for Humanity Science & English Language

damaging the 13.2 MW Rishiganga hydropower project and then washing away the under-construction 520 MW Tapovan-Vishnugad project downstream. It is not clear (as yet) if the glacier melted; or there was unseasonal snow that melted; or that it was a combination. What's clear is that there was a landslide or avalanche that blocked the river and when the natural dam broke because of the force of water, it brought the power of kilolitres of water mixed with moraine, rock and silt.

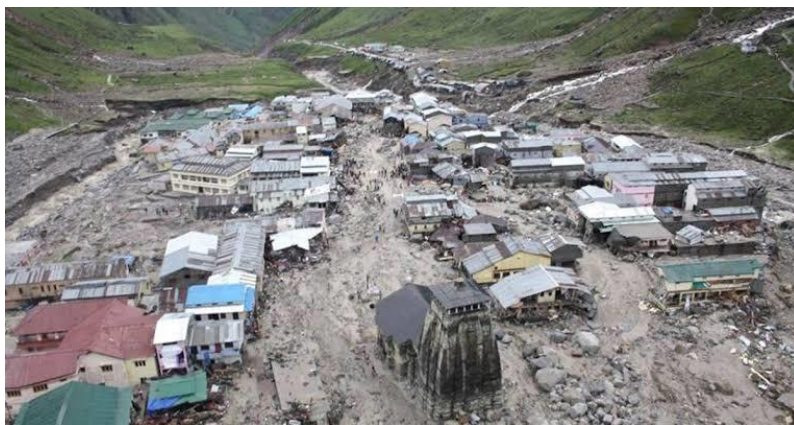
On 16-17 June 2013, the state suffered its worst disaster in the living memory with huge loss of lives and widespread destruction. On June 16, 2013, many things went wrong with the Himalayan state of Uttarakhand. Heavy monsoon rains wreaked havoc in the hill states that triggered Ganga, Yamuna and their tributaries at most of the places, sweeping away a number of bridges, roads and buildings. As per the initial estimates the disaster claimed a massive death toll and numerous persons were reported missing. The disaster coincided with the peak tourist and pilgrimage season significantly enhancing the number of the casualties which resulted in adverse impact on the immediate rescue and relief operations. The mountainous region of Uttarakhand forms

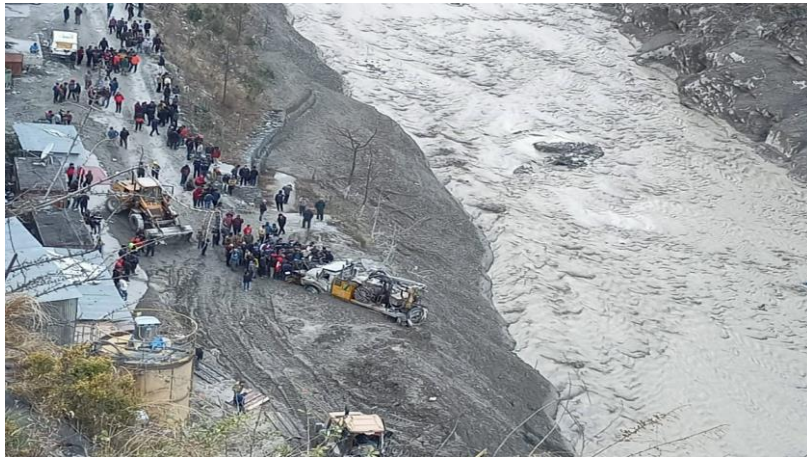
WHAT HAPPENED?
Around 10am on Sunday, huge chunk of what is suspected to be a glacier in the Nanda Devi landscape breaks and falls into Dhauliganga river near Raini village, 26km from Joshimath in Garhwal Himalayas, sending a massive wave of water, mud and rocks downstream

- > 7 bodies recovered so far
- > 170 people missing. Most of those killed or missing believed to be workers at hydropower projects
- > 5 bridges washed away
- > 2 hydropower projects hit. The 13.2MW Rishiganga hydropower project washed away. Another 520MW run-of-the-river Tapovan-Vishnugad hydropower project badly damaged. Some small pvt projects may also have been hit
- > Around 200MW power supply to national grid cut from major plants

1 Glacier bursts in Raini village of Chamoli in Garhwal Himalayas, damages hydropower plant at NTPC Tapovan, several bridges and nearby villages

2 A swollen Dhauliganga flows down to Vishnuprayag

3 The river, Alaknanda at this point, washes away 13.2MW Rishiganga hydropower project near Joshimath

4 The stream now reaches Srinagar

5 Then Devprayag

6 Rishikesh

7 Haridwar

The badly damaged NTPC Tapovan hydropower project

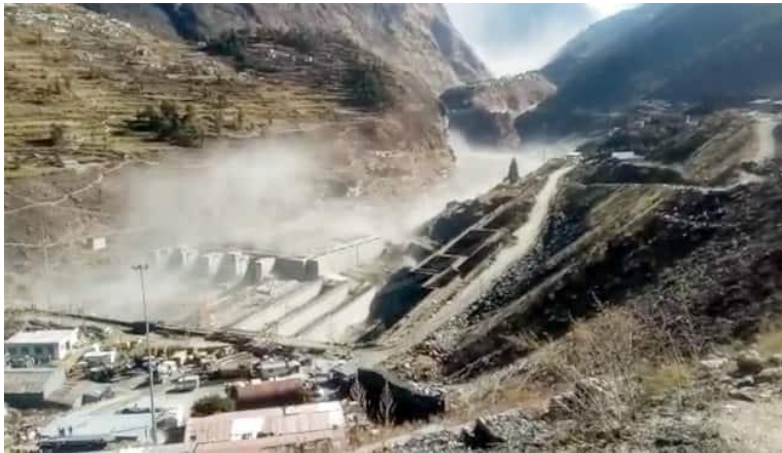
The flash flood in high Himalayas, which has claimed 72 lives and wiped out two hydroelectric plants on the Ganga, should be a grim reminder of the mistakes we continue to make. It's easy to understand and guess why this devastation happened. The Himalayas are the world's youngest mountain ranges, prone to erosion and landslides and unstable because of high seismic activity.
