Rehabilitation of Severely Attrited Teeth Using Full Crown, Onlay, Endocrown & Buccal Half Crown

Dr. Manisha Khanna, Dr. Shefali Singla, Dr. Rajni jain, Dr. Monika

Dr Harvansh Singh Judge Institute of Dental Sciences and Hospital, Chandigarh

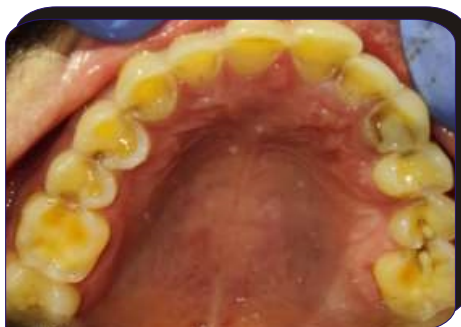
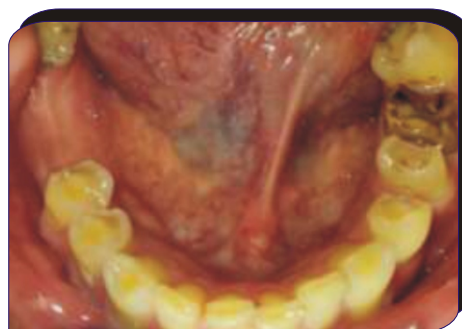
A 37 year old male patient came to the department with chief complaint of rapid wear of his dentition and sensitivity in #16. Intra-oral and radiographic examination revealed generalised attrition of teeth with freeway space no more than 2mm; Root canal treated #35, #36, #37. Missing #46, #47

Pre-operative intra-oral photographs

Treatment plan - fabrication of vertical stops in the form of various indirect restorations and RPD fabrication wrt #46, #47 followed by soft splint fabrication

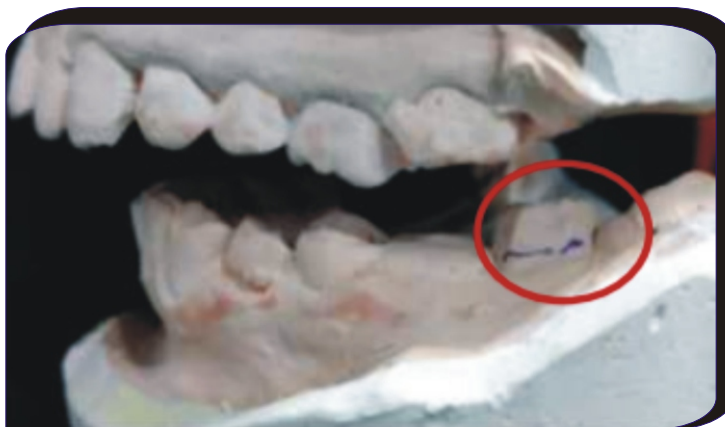
Extra-oral left lateral view presenting absence of positive occlusal contact for #17 and severely attrited buccal surface of #37

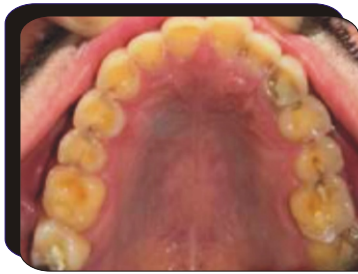
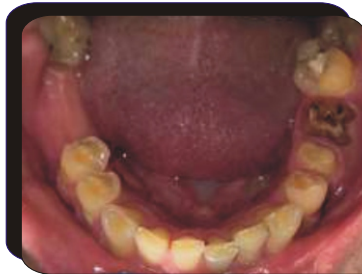
**Tooth Preparation
WRT**
#16- Onlay
#35- For pfm full
veneer crown
#36- Endo crown
#37- Buccal half
preparation

In present case report, further wear of teeth was prevented by creating vertical stops bilaterally in the form of various indirect restoration. Full coverage metal ceramic crown was planned for #35, All ceramic endocrown for #36 because of inadequate inter-occlusal space (supra-erupted 26) and less crown height wrt #36. #37 was excessively lingually tilted and required RCT for full crown. A conservative buccal half crown was given instead of full coverage crown because of which we were able to avoid the root canal treatment. Onlay was planned for #16 which acted as vertical stop as well as protected the tooth from sensitivity.

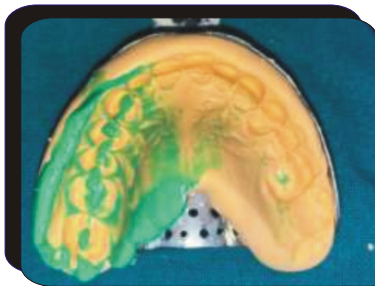
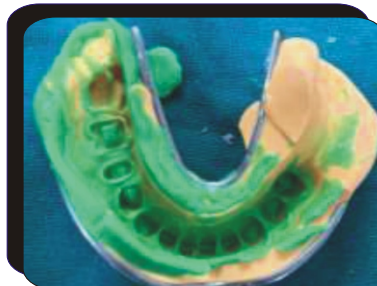
**2 Stage dual consistency
impression of maxillary &
mandibular arch**

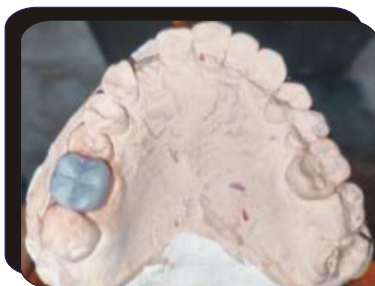
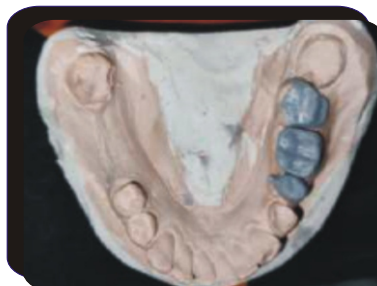
**Full contour wax up #16,
#36
Wax up for metal coping
wrt #35, #37 (with step
created for occlusal stop
buccally wrt #37)**

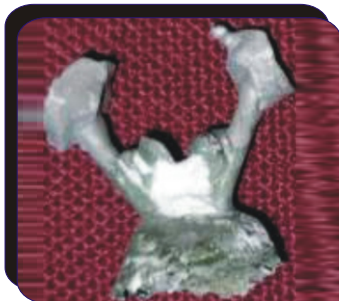
Crowns retrieved from investment material

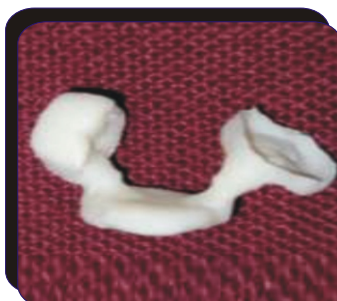
Ceramic layering wrt #35, #37

Polished crowns on the cast
