A Morphometric Approach to Bozkurt (Kastamonu-Türkiye) Flood

Vedat Avcı^{1,*}, Ömer Ünsal²

Abstract

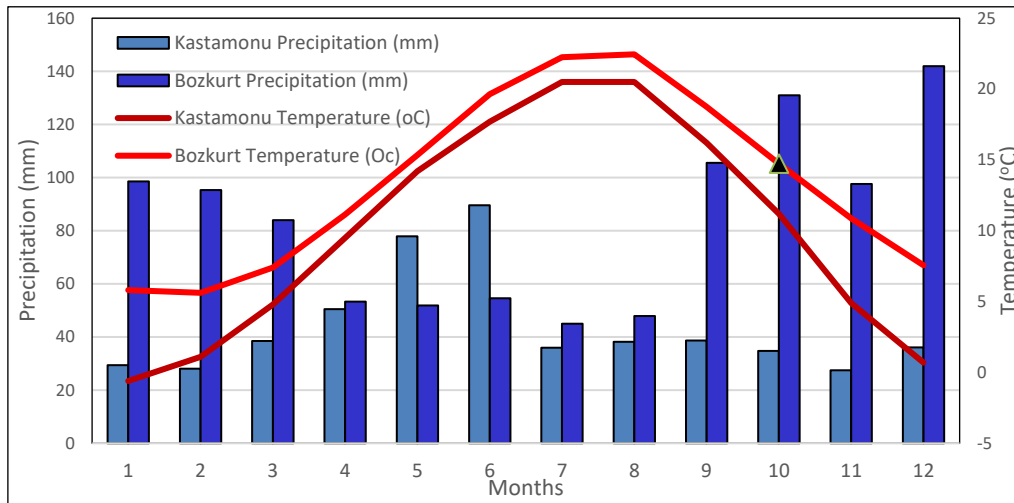
Figure 4: Distribution of temperature and precipitation by months at Kastamonu and Bozkurt stations (TSMS 2022)

While the climate features of the Black Sea region are dominant in Bozkurt, continental conditions are effective in Kastamonu. This situation is mainly caused by the fact that Küre Mountains prevent the marine air masses (Coşkun 2021). In Bozkurt, the average temperature has never fallen below 0 °C in any month due to the marine effects. However, the average temperatures in Kastamonu in January are below 0 °C (Table 1; Figure 4).

According to the distribution of precipitation throughout the year, while the rainiest period in Bozkurt is autumn (33.2%), the rainiest season in Kastamonu is spring (31.7%). The least rainy season is summer in Bozkurt (9.8%) and winter in Kastamonu (17.8%) (Figure 4).

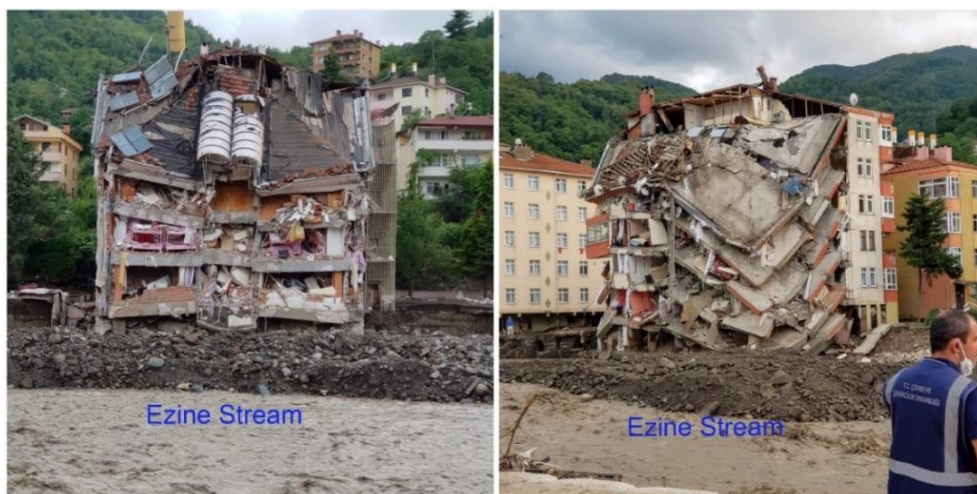
Figure 6: Many buildings located on the edge of the Ezine Stream were destroyed in Bozkurt flood (Photos: Vedat Avcı)

The most damage occurred in Bozkurt district center during the flood on 10-12 August. Bozkurt settlement was established on the edge of Ezine Stream. The houses located in the district center, which were situated on the edge of Ezine Stream at low elevations, were demolished (Figure 6). It has been reported that 168 buildings, including 135 residences, 27 shops and 6 public buildings, were damaged in the flood-affected districts and villages of Kastamonu (URL-3 2022). The flood causing the disaster was related to the severe erosion in the Basin of Ezine Stream and the material carried to the stream bed (Figure 7). Gaps of the bridge crossing in the flood channel were clogged with tree branches and logs carried by the flood, so the channel could not carry the water flow. The settlement area of Bozkurt was covered with large amounts of mud, sand, flood debris, tree branches and logs (Bilgen et al. 2022).

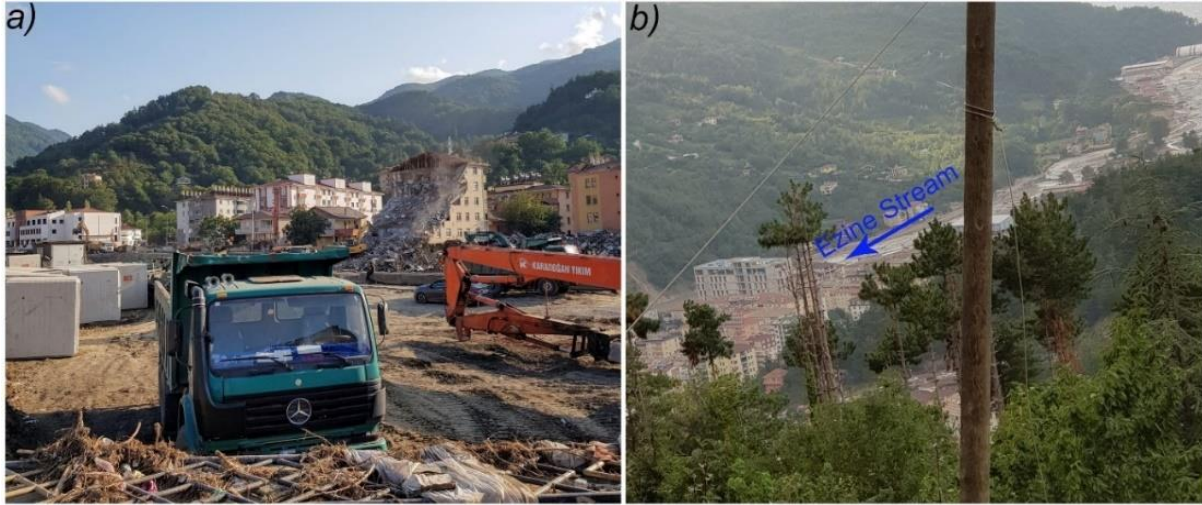
Figure 7: Severe erosion and the stream with increasing flow caused flood in the Basin of Ezine Stream (Photos: Vedat Avci)

Other reasons of the disaster are the discharge of the excavation material from the tunnel, dam and road construction works into the river beds, the plants growing in the river beds and not being cleared, the material carried by the landslides blocking the bridges and culverts (URL-4 2021).

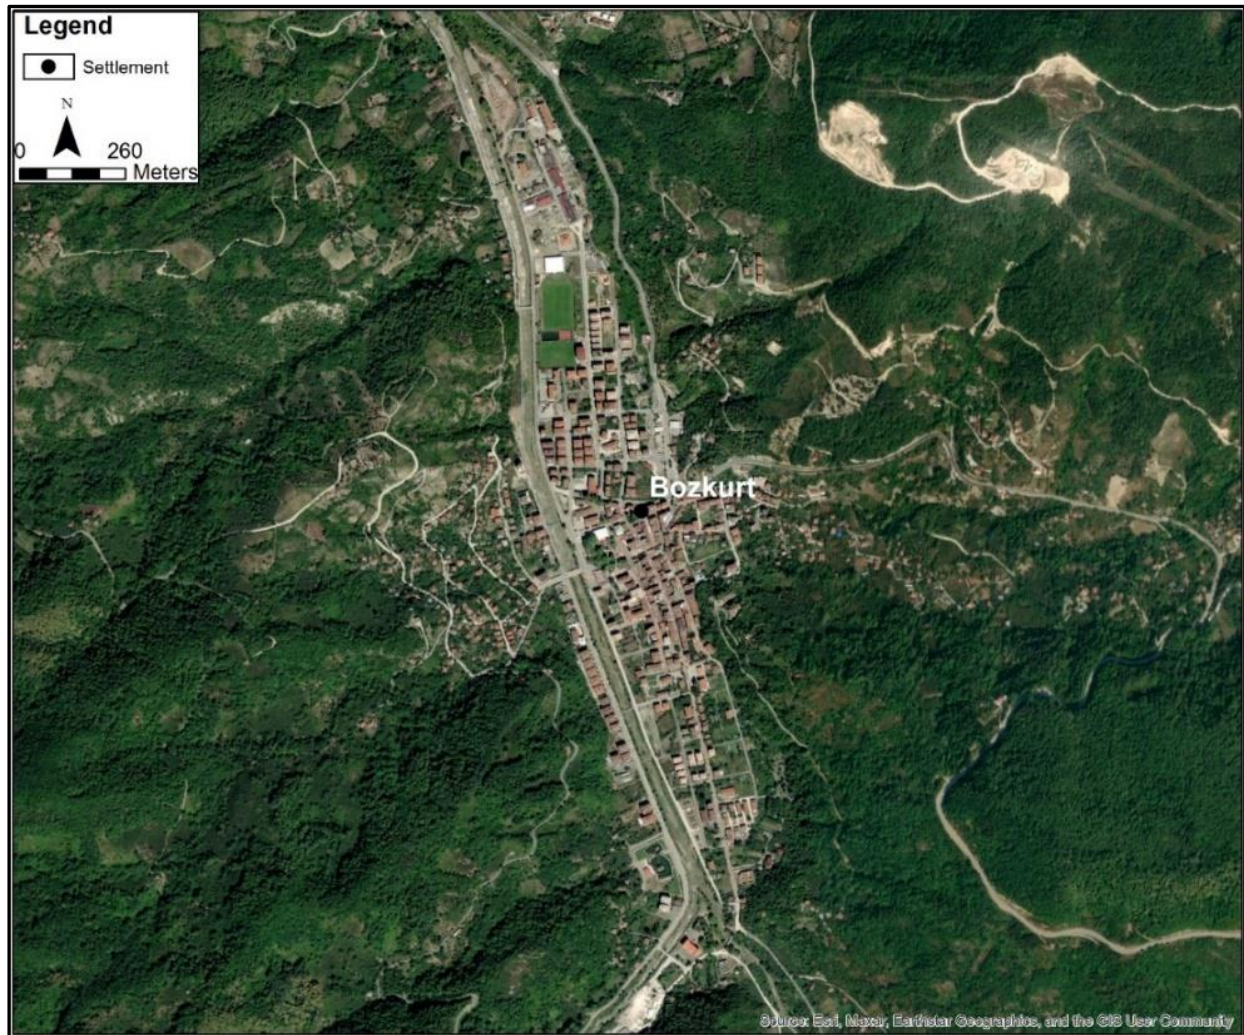
Figure 9: Some of the buildings in Bozkurt town center are very close to the floor of Ezine Stream valley (ESRI 2022)

The elevation difference between the floor of Ezine Stream valley and the buildings located on the left and right sections is quite small. These buildings were built just behind the flood reclamation barrier, the elevation difference between the buildings and the valley floor varies between 5-10 m. For this reason, especially the 1st row buildings located on the right were under water. On the left side, the building density is relatively low (Figure 9). Curved reclamation sets also facilitated the overflow of water.

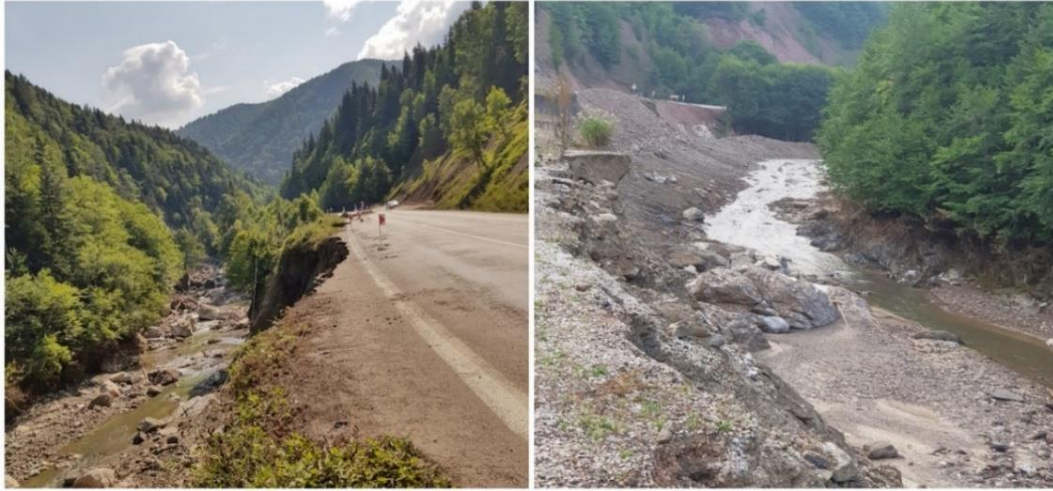
Figure 10: The rain that led to the flood caused landslides on the valley slopes (Photos: Vedat Avcı)

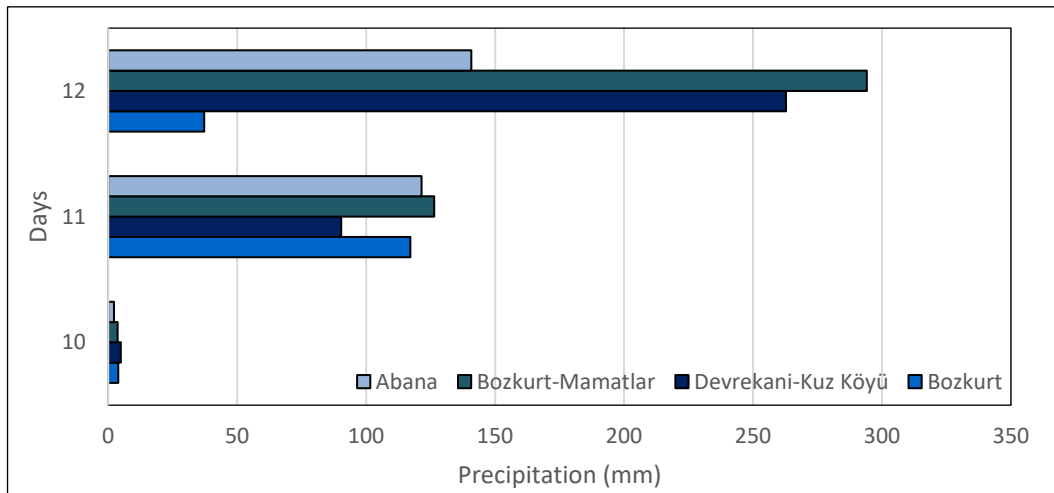
Figure 11: Distribution of precipitation falling on Abana, Mamatlar, Kuz and Bozkurt on 10-12 August (TSMS 2022)

On 10-12 August 2021 (48 hours), 158.2 mm precipitation was measured at Bozkurt station (TSMS 2022). The average precipitation for many years is 1006 mm in Bozkurt, and the total precipitation in August 2021 is 249 mm. More than half of the August 2021 precipitation at Bozkurt station fell on 10-12 August. More precipitation was measured at Bozkurt/Mamatlar and Devrekani/Kuz Village stations located in the upper part of the basin. Between these dates, 358 mm of precipitation fell in Devrekani-Kuz village, 424.1 mm in Bozkurt-Mamatlar village and 264.5 mm in Abana. The precipitation in Bozkurt-Mamatlar village was close to half of the annual precipitation in Bozkurt station in 2021 (TSMS 2022). This precipitation is close to twice the precipitation in August (Figure 11). The fact that most of this precipitation passed into the overland flow caused the flood.
