Situation of the Yukarıköy's Traditional Stone Masonry Houses Affected by 2017 Ayvacık Earthquakes

2017 Ayvacık Depremlerinden Etkilenen Yukarıköy Geleneksel Taş Evlerinin Durumu

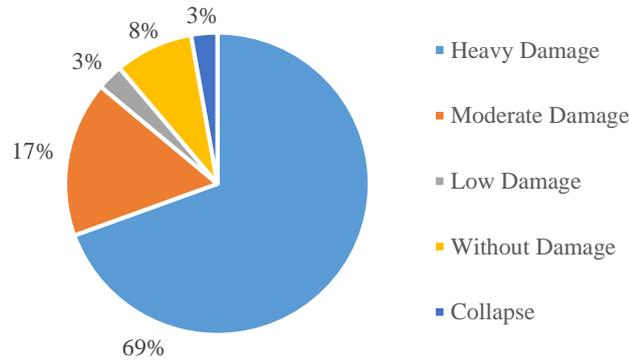
Figure 5: Damage Status of Structures under Investigation in Yukarıköy

The statistical values in Graph 1 show that most of the structures examined in Yukarıköy are severely and moderately damaged.

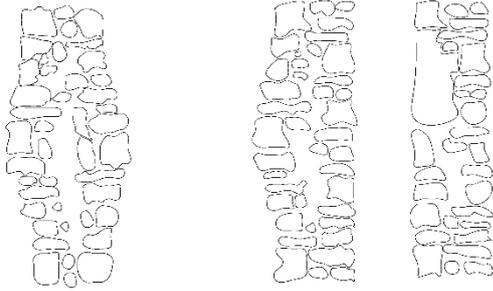
The inner and outer double walls, which are not connected to each other, move independently of each other under the influence of the vertical loads in the amount exceeding the capacity of the wall. In this case, the bearing capacity of the wall weakens and causes damage to the structure during the earthquake (Figure 8).

Figure 8a: Bent or unbent double wall (Arun 2010)

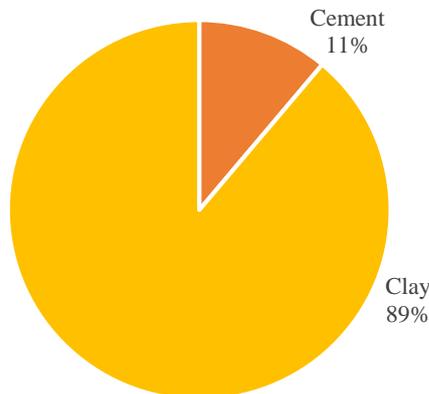
In buildings with little or no damage at all, cement mortar was found to be used. As seen in the figure 10, it was determined that clay-based soil mortar was used in 89 % of the analyzed structures.

Figure 10: Distribution of mortar type used in region

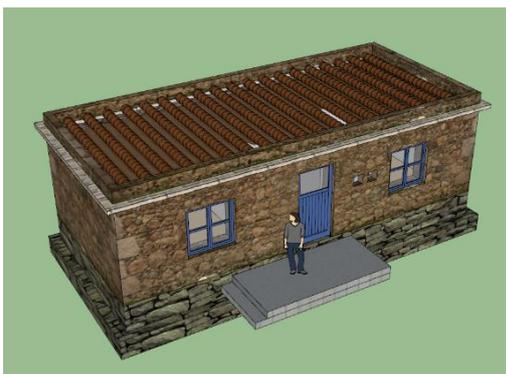
In most of the structures built in rural areas, floor beams are placed on the wall with no connection to the wall. The circular cross-section of these beams also reduces the friction effect and weakens the diaphragm function of the floor by facilitating the movement of the beam. In this case, the wall does not support the floor and structure can collapse due to this deformation. Figure 12a shows the typical wall-beam relationship applied in the region and a damaged structure is displayed in figure 12b due to this application. Furthermore, the friction forces between the stone surfaces are marginal, since the stones are of irregular shapes, not prismatic, and the contact surfaces are not sufficient to cause adequate amount of friction. Additionally, wooden beams of roofs are aligned in one direction and the beams are supported by two walls opposite to each other. Therefore, the weight of the heavy roof and corresponding horizontal earthquake loads are transferred to these walls (Celep et. al 2011).

Figure 12a: Draft of the well-designed structure

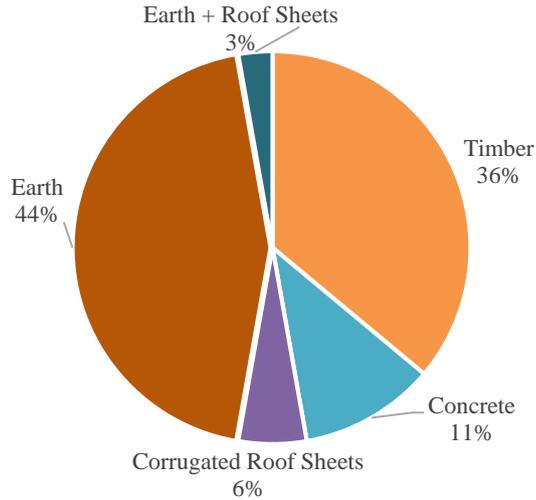
The beams bearing this roof are not connected to the supporting walls, so they move independently of the wall during an earthquake. "Cross cracks in the walls of masonry structures with heavy-weight roofs usually arise from the effect of shear force. Conically shaped breaks on the upper sides of the common corners of the walls are actually the intersection of two crossed cracks cutting the wall. It has been observed that such structures rise up from the ground due to the overturning effects of the wall ends" (Budak 2004). The additional weight of the soil cover naturally caused the structures to be affected by the earthquake more. "The ceilings of rural structures with mud-brick and stone walls are generally covered with mud. One-meter square weight of the wooden bearer and earth covering of the ceiling is about 750-1000 kg. Therefore, a huge ceiling load presses on the walls. The walls are already forced hard, during an earthquake due to their construction, so it is inevitable that they will be damaged during earthquake because of heavy ceiling" (Ergünay 1978). Same types of damages are seemed at the 2010 Kovancılar and Palu (Elazığ) Earthquakes and 2011 Van Earthquakes in Turkey. The features of the roof cover in the structures examined are shown in figure 13. In addition, figure 14 shows the examples of heavily damaged earth roof structures.

Figure 13: The state of the ceiling cover in the structures studied

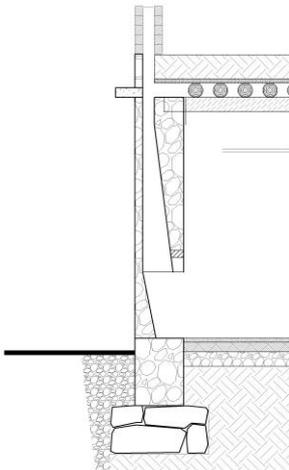
The opening to the wall for the chimney weakens the wall section and increases the risk of damage to the double-walled wall under horizontal loads (Figure 16 and 17). 89% of the damaged structures that studied were damaged due to the chimney opening in the bearing wall.

Figure 16: Chimney section

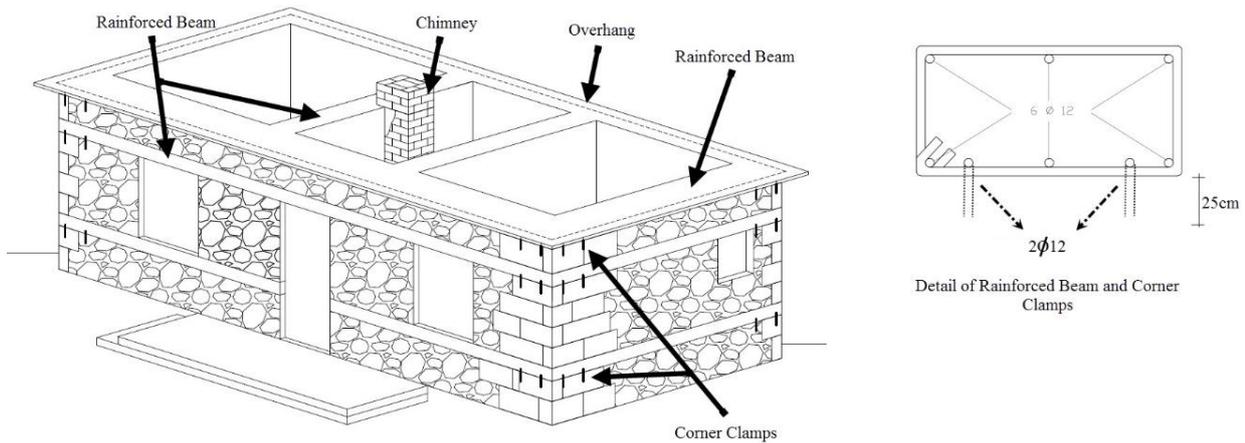
Figure 19: Recommended corner and chimney detail

Corner points are the parts of a structure that are pressured most during an earthquake. Horizontal beam recommendations are presented in figure 19 within the framework of the terms envisaged by Earthquake Code ([Earthquake Regulation 2007](#)) in effect in Turkey. With the recommended horizontal reinforced concrete beams, the provision of the following areas is intended:

The clamps placed in the reinforced concrete beam are placed in two directions and two levels to prevent the walls from moving out of the plane. Figure 19 shows suggestions to prevent the damage caused by the corner deformation of the structure.

When the chimney is located inside the supporting wall, the cross-section and strength of the wall reduce. Chimneys located on the outer wall also cause heat loss and condensation. For this reason, the chimney is suggested to be located outside the chimney wall section and on the inner wall as proposed in figure 19.

No eaves application was found in existing constructions. Eaves protect the building against external factors in the long run. For this reason, it is suggested to make the overhang as shown in figure 19.

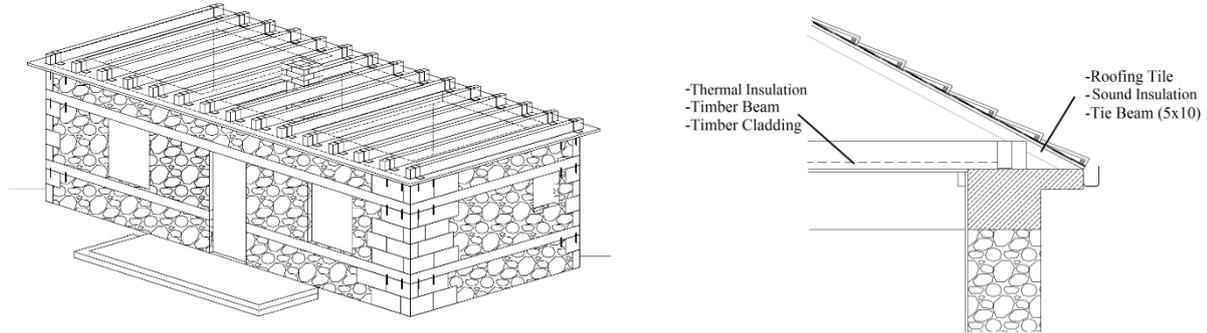
Figure 21: Beam-wall connection and roof details

The proposal developed in this study recommends the ceiling-wall connection detail as shown in figure 21. In the detail presented in the figure, “TÜBİTAK approved insulation material” (Kanca 1977). is recommended instead of earth roof which is used as thermal insulation in rural buildings.

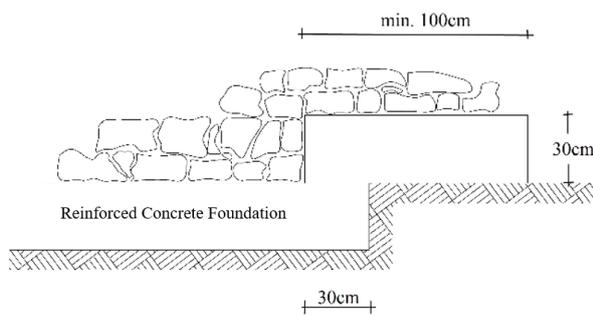
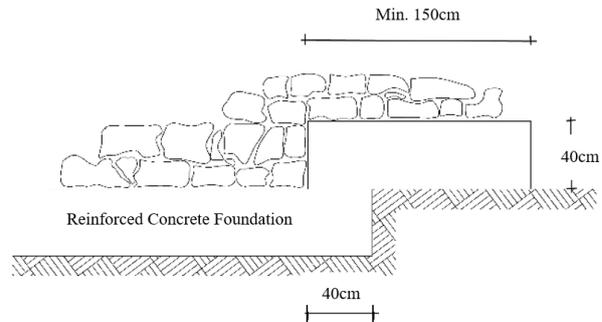
Figure 22a: Foundation Detail for (G1), (G2)

Figure 22b: Foundation Detail for (G3), (G4)

The foundations of the buildings built on sloping grounds need to have a gradual structure. Figure 22 shows the foundation details to be built on sloping lands in earthquake areas.

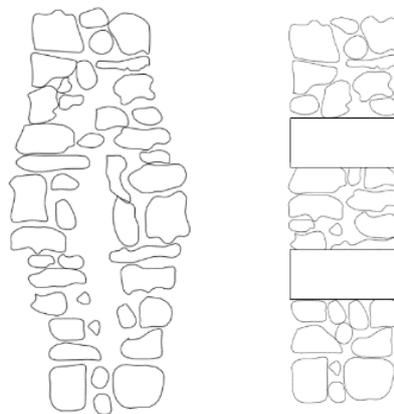
Figure 23: The connection of inner and outer wall layer (Earthquake Regulation 2007)

It is necessary to prevent double-walled walls from moving independently of each other. In figure 23, a block stone connecting the two sides of the wall at regular intervals is proposed. In this way, the two layers work together.

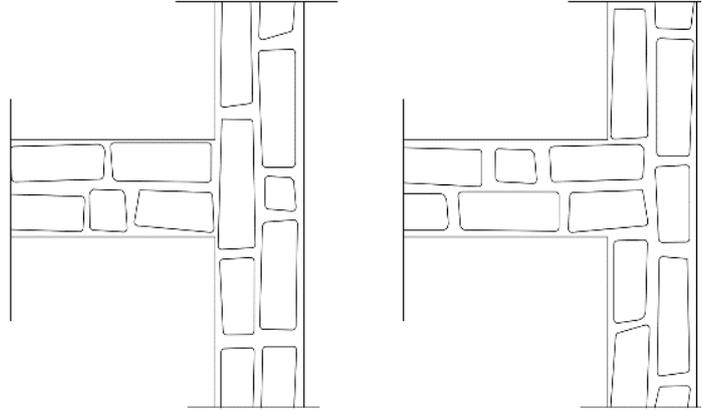
Figure 24b: Connection details of outer wall with inner wall

It was observed during the study that the connections between the inner and outer walls were inadequate in all of the damaged structures in the region. These walls suffered significant damage after the earthquake. Figure 24a shows the damaged structure in this respect. In figure 24b, the alignment of the stone blocks is shown as a proposal for connecting the inner and outer walls against horizontal loads.
