Surface Rupture and Geotechnical Features of The July 2, 2013 Tanah Gayo Earthquake

Abstract - An assessment of surface rupture and collateral ground failures can help to evaluate the impact of future earthquakes. This paper presents the results of a field survey conducted to map the surface rupture and geotechnical phenomena associated with the ground shaking during the July 2, 2013 earthquakes in Tanah Gayo Highland. The objectives of this survey are to document and to characterize the surface ruptures as well as to identify types of earthquake-induced ground failures. Results of the survey identified four best sites of possible surface rupture. Two locations are obvious surface ruptures that can be traced on primary topographic feature of the active fault segment from the north to the south, crossing Pantan Terong Hill. The fault segment has a total mapped length of 19 km, with WNW trending zone and a dextral rupture offset. The ground shaking also resulted in landslides and liquefaction in areas underlain by very fine-grained tuffaceous sands. Based on the field survey, it can be concluded that the newly defined active fault segment, the Pantan Terong segment, is likely the se

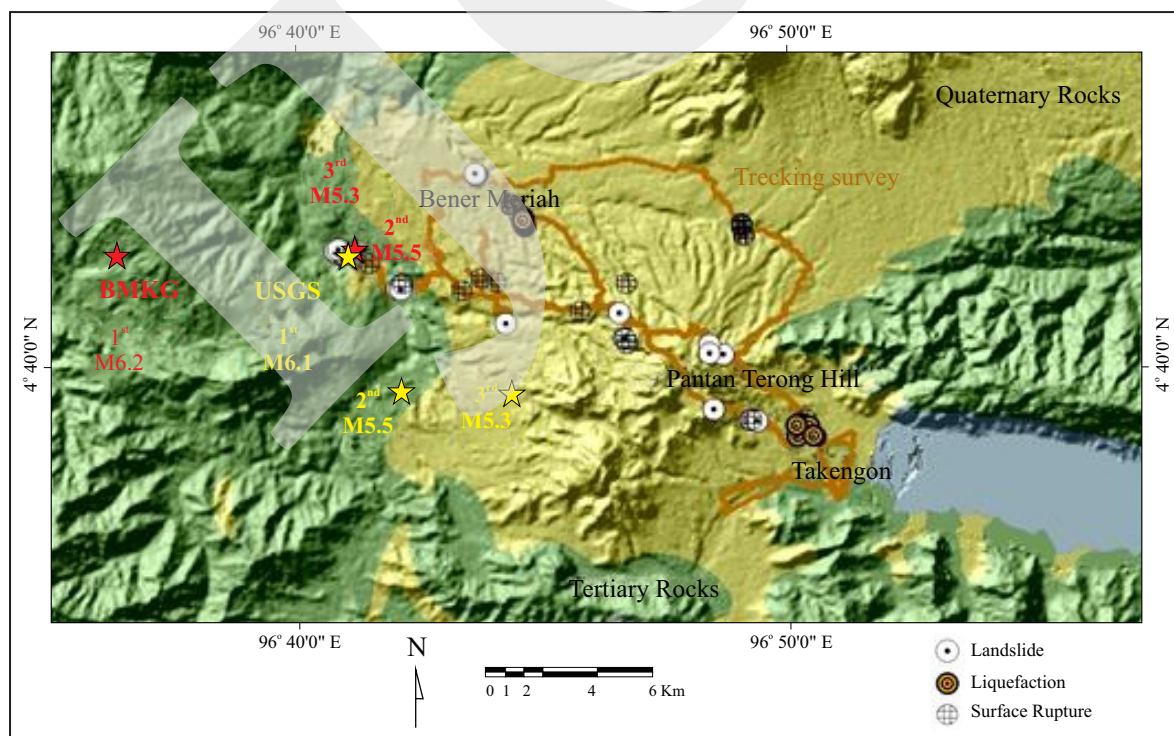
gencies. Eighty-six sites with ground cracks were observed. On the site of probable surface rupture, the length of segmentation, the magnitude of lateral and vertical movement, and the orientation of the rupture were documented. The survey at the southern Takengon crossed the probable active fault line. During the field work, the local geotechnical features that controlled ground failures was also studied during the earthquake (Figure 3).

Figure 3. Locality map of surveyed surface ruptures, liquefactions, and landslides due to the July 2, 2013 Tanah Gayo earthquake. Lithologically, the yellow area is Quaternary rocks and the green area is Tertiary rocks (Cameron *et al.*, 1983).

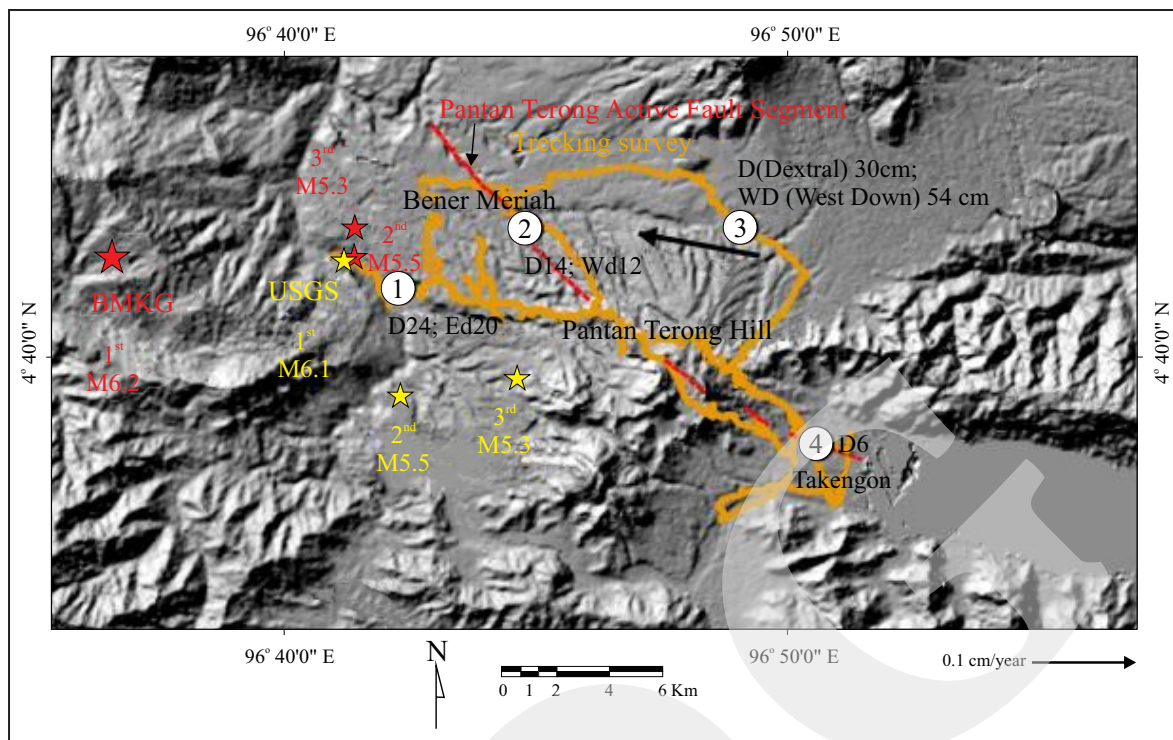
The comparison of these mapped rupture locations to geomorphic features visible on ASTER GDEM (Team, 2010) and World30m DEM topographic data, is visualized using a Swiss hillshade technique (Anonymous, 2010). An active fault line can be traced from Site 2 to Site 4, crossing Pantan Terong Hill. Based on the surface mapping, Pantan Terong fault is proposed to rupture during the July 2, 2013 Tanah Gayo earthquake (Figure 14). This fault has a total mapped length of about 19 km. This length is close to the segment length of the Sumatran Fault that ruptured during the 2007 West Sumatra doublet strike-slip earthquake sequence, which ruptured about 22.5 km of fault length (Daryono *et al.*, 2012). This also correlates with the minimum segment length of about 20 - 30 km proposed by Klinger (2010).

Figure 14. Geological and seismological setting of the previously unidentified Pantan Terong segment. The brown lines show the surveyed path. The red stars indicate earthquake epicentres from BMKG, and the yellow stars indicate earthquake epicentres from NEIC-USGS. The blue circles indicate the best surface rupture sites. The black arrows indicate the GPS results of Ito et al. (2012).
