# Geotechnical site investigation and evaluation of 20 March 2019 Mw 5.5 Acıpayam (Denizli) earthquake

### Abstract

An earthquake with a magnitude of (M<sub>w</sub>) 5.5 occurred in Yeniköy village of Acıpayam district (Denizli) on 20 Mart 2019 caused heavy damages on masonry structures in Acıpayam basin. Groundwater level from ground surface in the basin varies between 1m and 11m, and soil structure of the basin is made up of silty, gravelly and sandy clay. Soil liquefaction was not observed in the basin after the earthquake. The main reasons of the heavy damage on the structures are mainly, high value of soil amplification, use of clayey adobe bricks and hollow bricks for building masonry houses, unpermitted construction of roof floors by using hollow bricks.

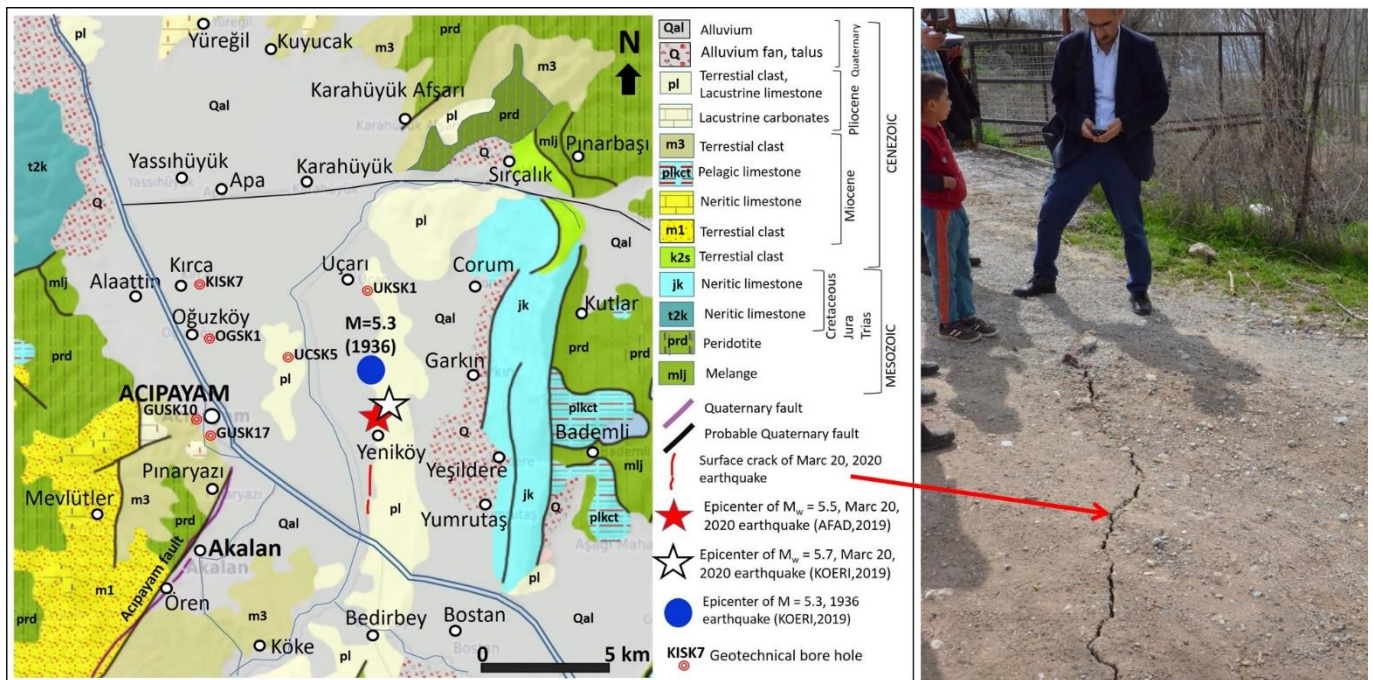
Figure 3. Geology and tectonic outlines of Acıpayam and surroundings [23],[24],[25],[14], earthquakes M>5 since 1900 [1],[2] and geotechnical borehole locations.

After 20 March 2019 earthquake, surface cracks were observed in the south of Yeniköy district, with a direction of N5°E and a length of approximately 1500 m and a width of 1-4 cm (Figure 3). The surface crack developed on a possible fault surface in the contact zone between the Pliocene lacustrine limestone and alluvium [14].

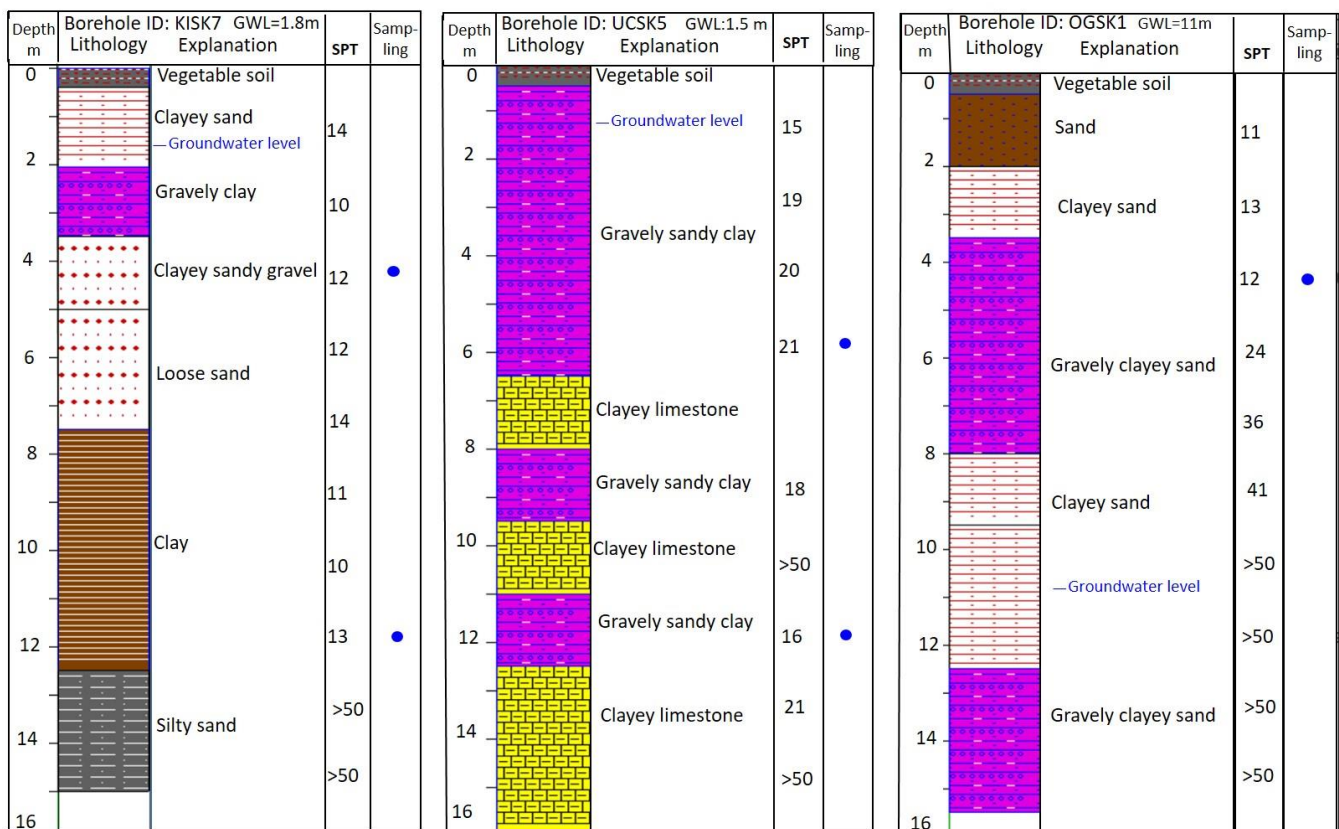
Figure 4. Geotechnical logs of the boreholes numbered as KISK7, OGSK1 and UCK5 in the Acipayam Basin.

KISK7 geotechnical borehole was drilled in the Kırca village having 15m depth [29]. Groundwater level in the borehole is 1.8 m deep from ground surface. Soil profile of the borehole made up of soft sediments in the first 12.5 m from the ground surface. Standart penetration test (SPT) values at this depth change from 10 to 14. Grain size distribution curves of soil samples are given in Figure 7. Soil sample of 4m depth consists of 13.33% gravel, 70.28% sand and 13.33% silt and clay. Soil type of the sample according to Unified Soil Classification System [37] is SW (well graded sands and gravely sands). This soil is

liquefiable soil but in the field liquefaction was not observed in this location after M=5.5 earthquake on 19 March 2019. Soil sample of 12 m depth contains 0.75% gravel, 28.9% sand and 70.35% silt and clay. Soil type of the sample in Unified Soil Classification System [37] is CL (inorganic clays of low to medium plasticity, gravely, sandy and silty clays).

According to the bounds for liquefiable soils [35] and 70.35% of silt and clay content, this soil is not liquefiable (Figure 4).

OGSK1 geotechnical borehole was drilled in Oğuz village and it has 15.5m depth [28]. Groundwater level in the borehole is 1.1m deep from ground surface. Soil profile of the borehole from ground surface to the bottom contains 0.4m of vegetable soil, 1.6m tick sand, 4.5m gravely clayey sand, 4.5m clayey sand and 3m gravely clayey sand (Figure 4).

SPT values from 1.5 m to 6 m varies from 11 to 24. The soil profile after 6 m gets stiffer with increasing SPT values from 36 to over 50. Grain size distribution curves of soil samples are given in Figure 4. Soil sample of 4.5 m depth consists of 21.58% gravel, 33.06% sand and 43.36% silt and clay. Soil type of the sample in Unified Soil Classification System [37] is SC (clayey sands, sand clay mixture). This soil is not liquefiable [35] (Figure 7).

UCSK5 geotechnical borehole was drilled in Uçarı village and it has a depth of 16 m. The Groundwater level in the borehole is 1.5 m below the ground surface [26].

Soil profile of the borehole from ground surface to the bottom contains 0.4 m vegetable soil and succession of gravely sandy clay and clayey limestone. Gravely sandy clay layers have STP vales between 15 and 21 while clayey limestone levels have SPT values bigger than 50 (Figure 4). Soil samples of 6 m and 12 m depths contain 82.44% and 76.04% silt and clay respectively. Soil type of the both samples in Unified Soil Classification System [37] are CL. Soils in both levels are not liquefiable [35] (Figure 7).

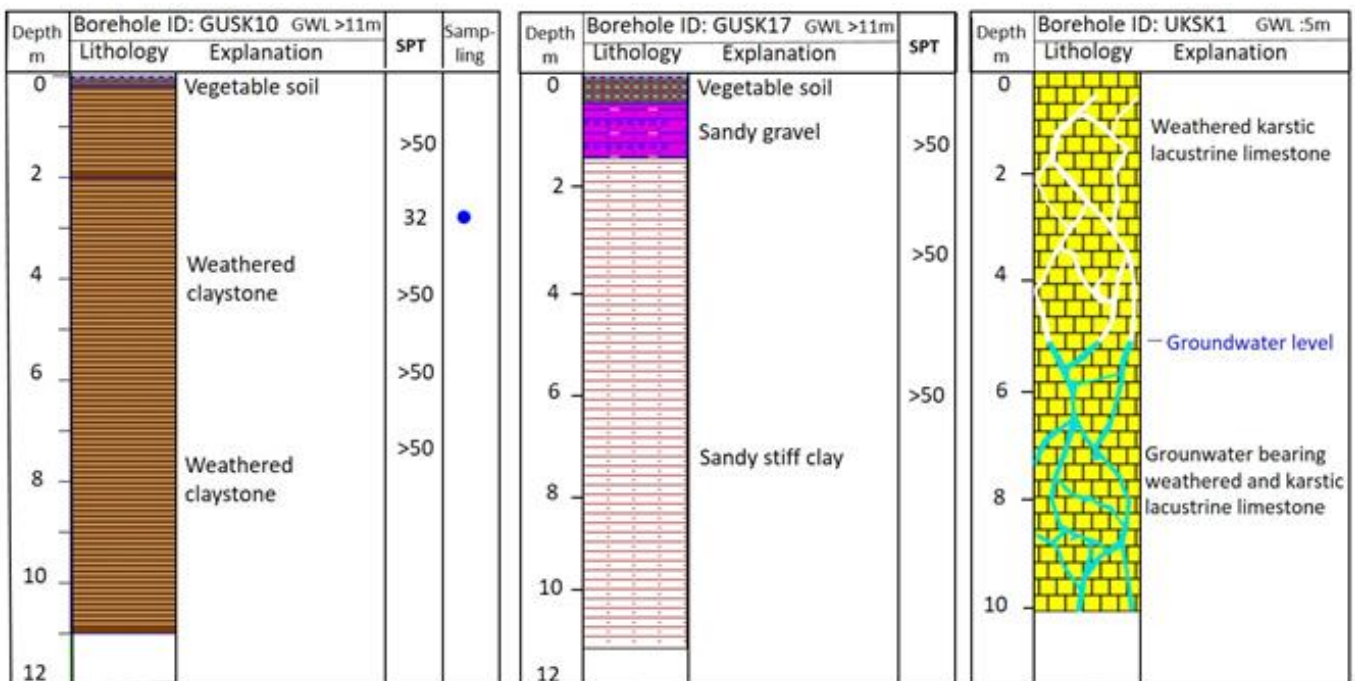
Figure 5. Geotechnical logs of the boreholes numbered as GUSK10, GUSK17, UKSK1 in the Acipayam Basin.

GUSK10 geotechnical borehole was drilled in the center of the Acipayam District having 11m depth [29]. Groundwater level is deeper than the depth of the borehole. Soil profile from ground surface to the bottom of the borehole contains 0.4 m vegetable soil and 10.6 m weathered claystone (Figure 5). Soil sample taken at 3 m depth consists of 28.42% sand and 71.58% clay. Soil type of the sample in Unified Soil Classification System [37] is CL. Soil liquefaction is not possible in this borehole location [35] (Figure 7).

GUSK17 borehole was drilled in the center of the Acipayam District having 11m depth. Groundwater level is deeper than the depth of the borehole. Soil profile of GUSK17 borehole, having 11m depth and located in the district center, from ground surface to the bottom contains 0.4 m organic soil and 10.6 m sandy stiff clay. The SPT values in the borehole were bigger than 50 (Figure 5).

UKSK1 borehole was drilled in Uçarı village and 10 m in the lacustrine limestone was cut through the borehole. The groundwater level is 5 m deeper than the ground surface [30]. Lacustrine limestone is weathered and, has pores and karstic cavity (Figure 5). Groundwater discharging through karstic limestone in western area of Uçarı village forms the lake of Uçarı (Figure 6). Weathering, karstic cavity, groundwater pressure in lacustrine limestone and close distance to the earthquake epicenter location had an important influence on the heavy damages of the masonry structures in Uçarı village.

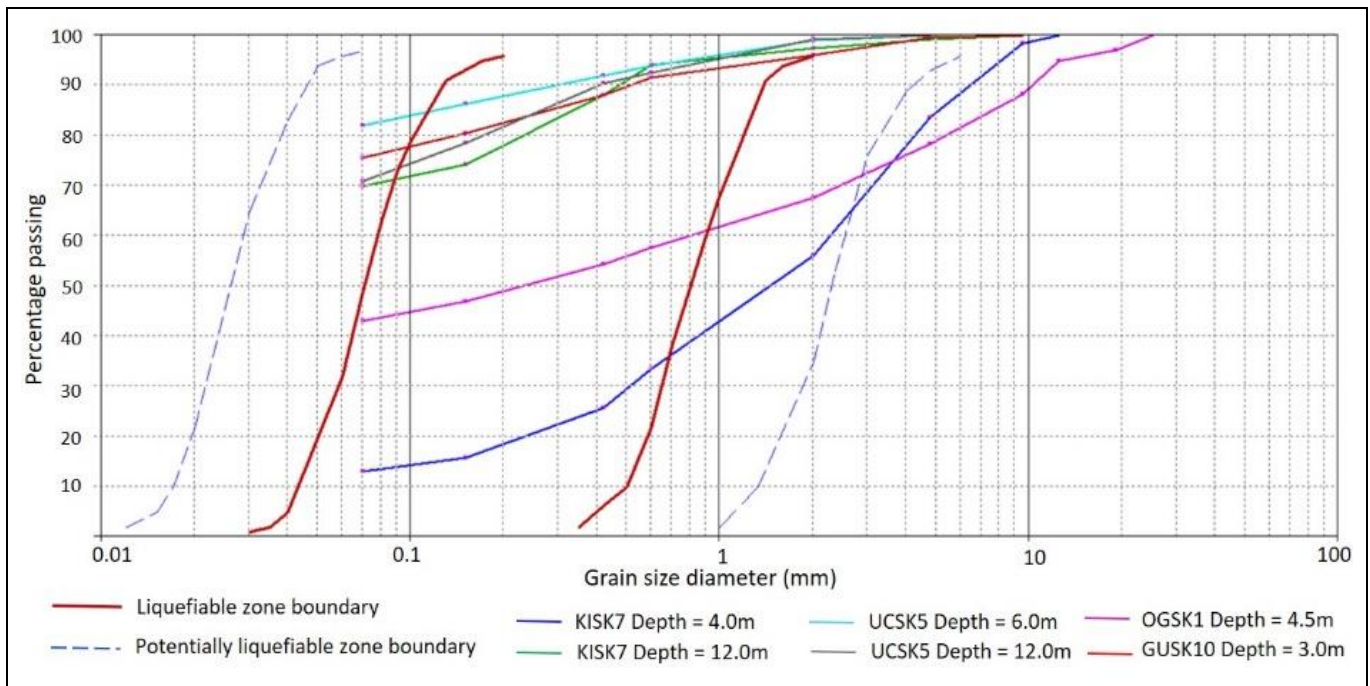
Figure 7. Grain size distribution of soils sampled in different boreholes in the Acıpayam basin with known bounds for liquefiable soils [35].

Liquefaction analyses of the soils sampled in OGSK1, UCSK5, KRSK7 and GUSK10 boreholes were performed by using the suggested method of [36] for the  $M_w 5.5$  earthquake. The factor of safety against liquefaction for all samples were obtained bigger than 1.5. This means that, these soils are not liquefiable under the effect of  $M_w 5.5$  Acipayam earthquake.

Liquefaction phenomenon was not observed in these drilling sites as a result of the earthquake that occurred on 20 March 2019. Due to the fact that  $R$  is less than zero, and high ratio of clay, silty and fine grain in the soil structure of the Acıpayam basin liquefaction did not occurred.
