STUDY OF CAVITATION EROSION PHENOMENON AT STAINLESS STEEL AISI 304 BASE AND WITH SiC COATING

Original scientific paper

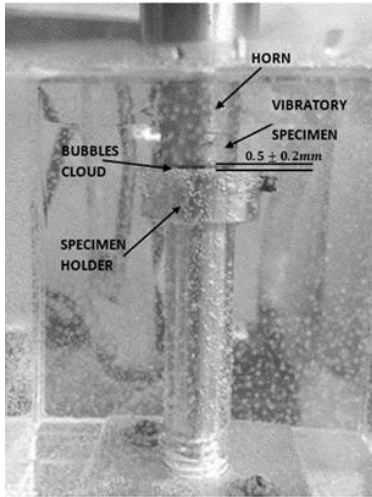
The vibrations are generated at an ultrasonic frequency of 28 kHz \pm 1 kHz, and 50 μm of amplitude, exciting the water and creating bubbles' cloud. The stationary specimen was placed in a specimen holder and was separated separating from the vibratory specimen at approximately 0.5 mm of distance of 0.5 mm, (see Fig. 2).

Fig. 2. Forming bubbles in process of cavitation erosion

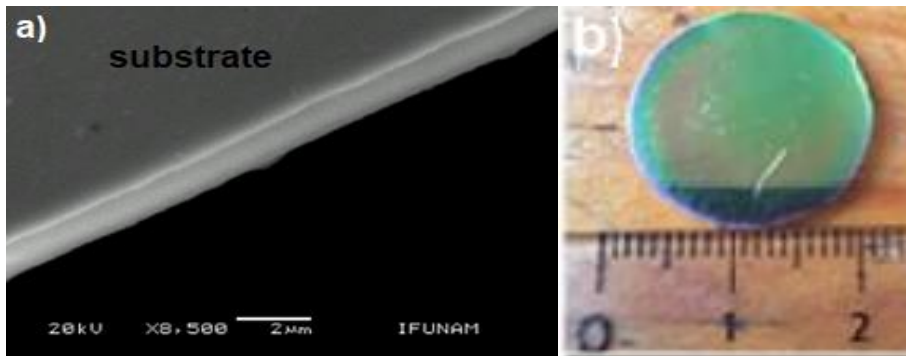
The SiC coating used for this experimental work was 1 μm thick. This coating was produced through the plasma enhanced chemical vapor deposition technique using a continuous discharge with an electrical potential of 900 V inside a reactor manufactured in a Pyrex glass tube of 800 mm and 150 mm internal diameter. On the other hand, the precursor substance used is hexamethyldisilazane (HMDS) - $\text{CH}_3\text{SiH}_2\text{SiH}_2\text{CH}_3$, and the gas mixture was methane (CH_4 UA, ultra-high purity) and UAP argon NH.

In addition, the samples were heated at a temperature of 500° C using an internal resistance located in the sample holder. The deposition time was in a range of 15 to 60 min, and the optimal pressure was 100 Pa. The SiC coating was deposited on 304 AISI stainless steel substrate, (see Fig. 3).

Fig. 3. SiC coating a) SiC cross section SEM, b) SiC coating deposited on stainless steel 304 AISI substrate

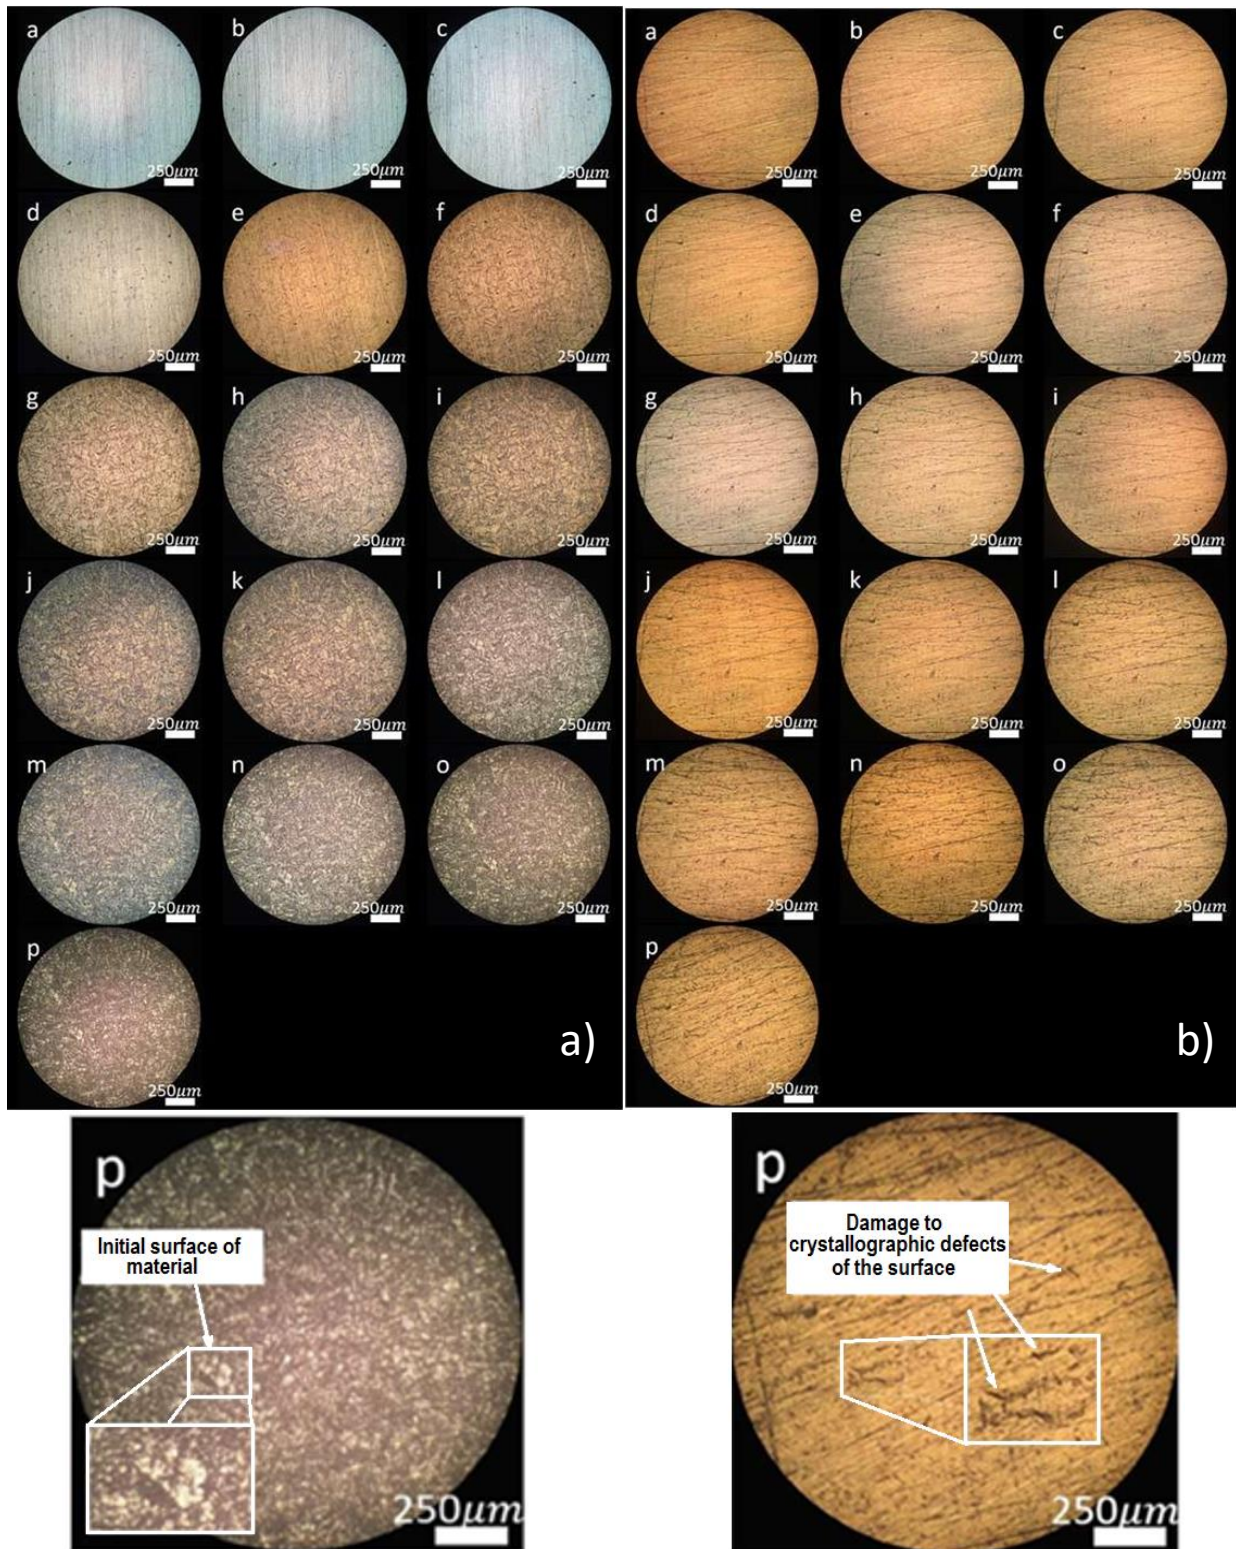
degradation on the specimen surface AISI 304 stainless steel base and SiC coated are displayed in Fig. 4.

Fig. 4. Progress of surface damage in specimens during the different time intervals.

a) AISI 304 stainless steel base a) 0 h, b) 1 h, c) 2 h, d) 3 h, e) 4 h, f) 5 h, g) 6 h, h) 7 h, i) 8 h, j) 9 h, k) 10 h, l) 12h, m) 14 h, n) 16 h, o) 18 h, p) 20 h, **b)** AISI 304 stainless steel coated SiC a) 0 h, b) 1 h, c) 2 h, d) 3 h, e) 4 h, f) 5 h, g) 6 h, h) 7 h, i) 8 h, j) 9 h, k) 10 h, l) 12 h, m) 14 h, n) 16 h, o) 18 h, p) 20 h

After 4 h test, the material began to erode without damaging the grains surface. However, the damage was remarkable after 6 h when pitting appeared at some parts of the eroded surface as seen in Fig. 4 g.

Some pitting emerged after 6h of testing, (see Fig. 4 g) with erosion on the stainless steel AISI 304

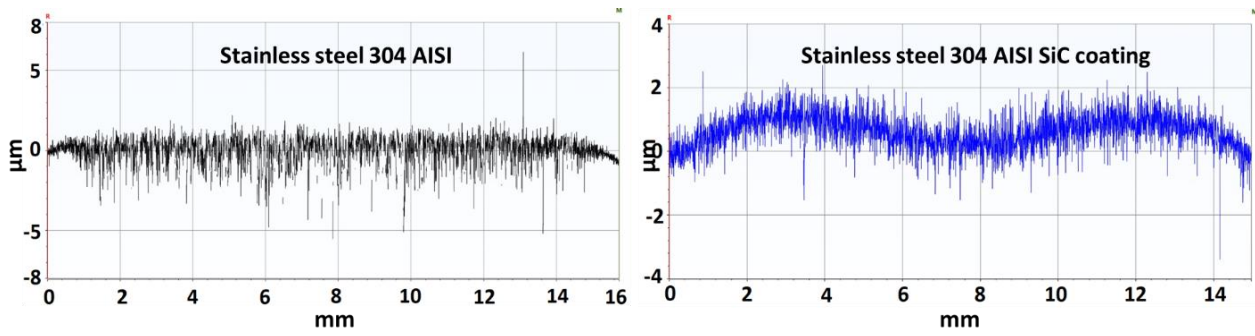
The final profiles of the specimen's worn surfaces were obtained after a 20 h test is show in the Fig. 5.

Fig. 5. Profiles of the specimens worn surfaces after 20 h: a) stainless steel 304 AISI base, b) stainless steel 304 AISI SiC coating

Fig. 5 shows the damage that appeared on the AISI 304 stainless steel base surface during the first hours of the process, principally in the border of grains due to the austenitic structure that this type of steel has [23].

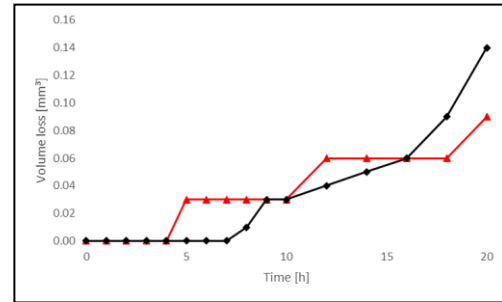
For lost volume comparison between AISI 304 Stainless Steel base and AISI 304 Stainless Steel with SiC coating, see Fig. 6.

Fig. 6. Volume loss by cavitation erosion a) ■ AISI 304 stainless steel base, b) ▲ SiC coating on AISI 304 stainless steel

Consequently, it was lesser the lost volume in stainless steel specimen with coating SiC than the lost volume of the 304 AISI stainless steel base specimen as shown in Fig. 6.

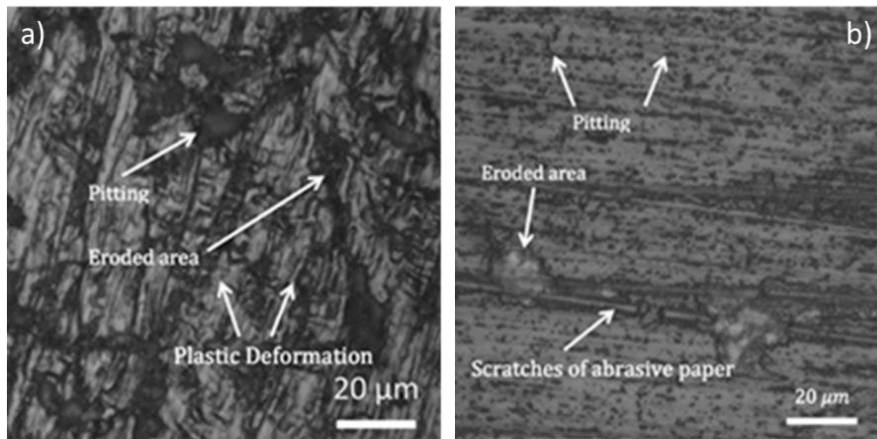
Whereas the main failure mechanisms identified in stainless steel specimens were pitting, plastic deformation fracture, and scratches, in SiC coated stainless steel were plastic deformation, pitting, and fissure, as displayed in Fig. 7.

Fig. 7. Mechanisms wear Magnification X50. a) AISI 304 stainless steel base, b) AISI 304 stainless steel with SiC coating
