DAMAGES TO TURBINE ENGINE COMPONENTS

Summary. This article defines the typical damage to components of turbine engines, highlighting the differences between them and indicating possible causes. The distinction between various types of defects helps to explain the occurrence and supports personnel in defining the most suitable maintenance action to be performed. The defects described below are common in high-airflow turbine aviation engines on commercial and cargo aircrafts.

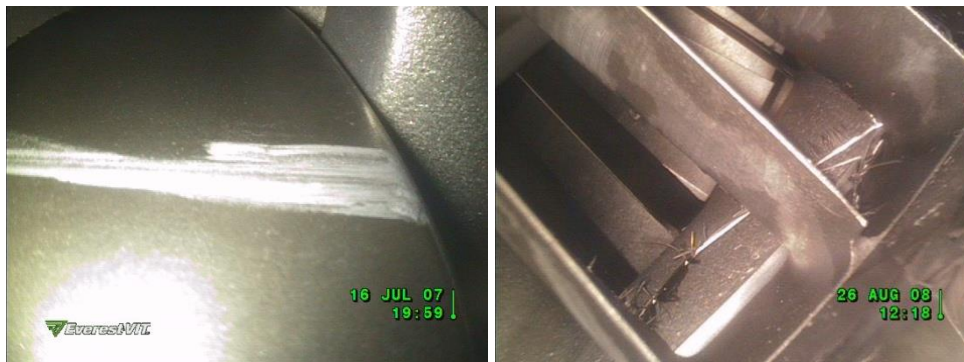
Fig. 1. Evidence of a bird strike

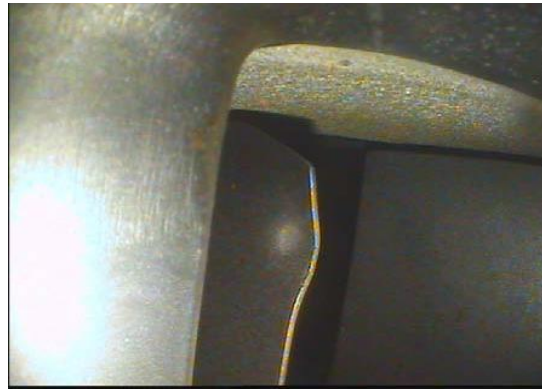
An object is *bent* when the angular distortion from the original contour occurs. This damage is typical on leading and trailing edges of engine blades and caused by a lateral force. Such damage poses more danger to airfoil strength values than aerodynamics and, as such, bents are sometimes considered as dents by some manuals. In this scenario, it is to be measured in a lateral not an axial direction. A typical bend often appears on trailing edges as a result of foreign object impact. A large-scale bent in various dimensions is called *buckling*, which is caused by a foreign object or mechanical or thermal overload. An example of a trailing edge bend, which is to be investigated as a dent, is illustrated below.

Fig. 2. Low-pressure compressor's trailing edge blade bend.

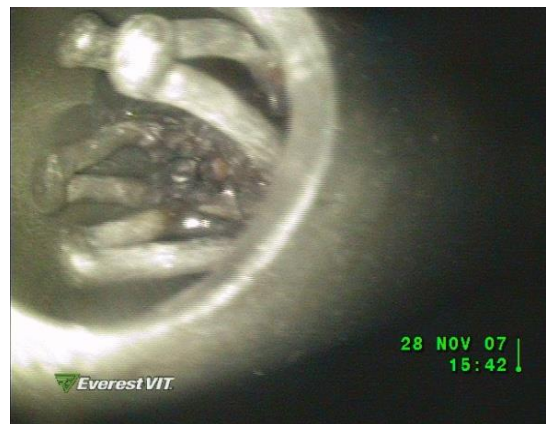
A *burn* refers to structural damage due to heat influence with no or improper protection, lubrication, clearance and shielding, or uneven temperature spread. It is accompanied by discoloration and, if not corrected, breaks the flow of material, which means the total loss of characteristics.

Fig. 3. Chromel-alumel thermocouple junction burnt.

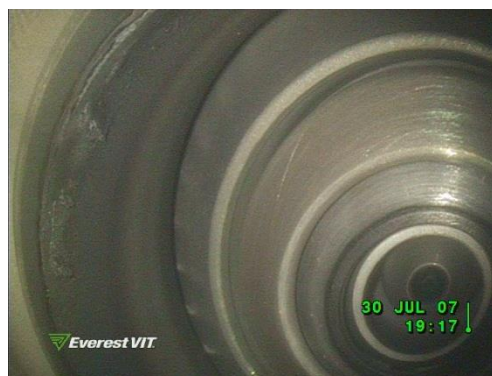
Carboning refers to layers of carbon stocked on a material. Fuel nozzles are the parts of the engine where such a phenomenon most often occurs. This is the by-product of a combustion process, which is not often perfect. The area of accumulation is the result of fuel atomization, mixture swirling and low axial flow. Carboning of fuel nozzles is not a cause for rejection, provided it is not excessive. Excessive carboning will affect fuel spaying, which will further result in an uneven fuel/air mixture and stream temperature.

Fig. 4. Minor carboning on the fuel nozzle

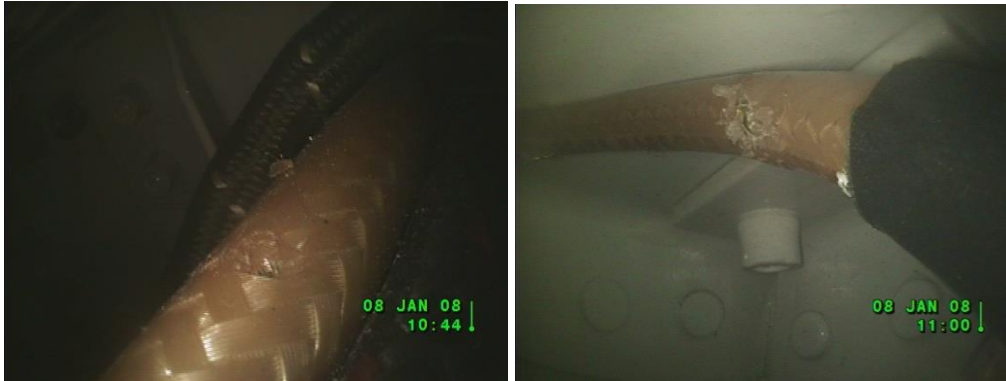
Chafing is typical description for the abrasion of two adjacent components, if at least one of them moves in a limited area against the other. This effect is often discovered between two tubes or pipes if they are not sufficiently separated from each other.

Fig. 5. Chafing between two adjacent cables due to insufficient separation

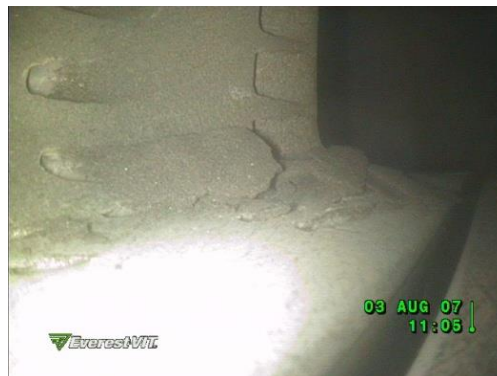
Chipping refers to the breaking away of small pieces under mechanical force, which is quite often an acceptable condition. This will result in local stress concentration due to material discontinuity. Contrary to flaking, chipping has a significant depth.

Fig. 6. Chunks of surface coating at the trailing edge of a high-pressure turbine blade

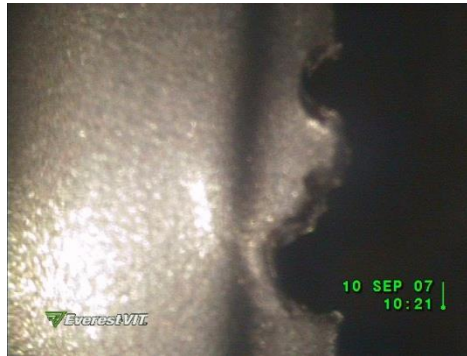
A *dent* is a round-bottomed, smooth and shallow cavity, which results from impact or prolonged constant overload. Material is displaced, but not removed.

Fig. 7. Dents on a compressor blade's leading edge

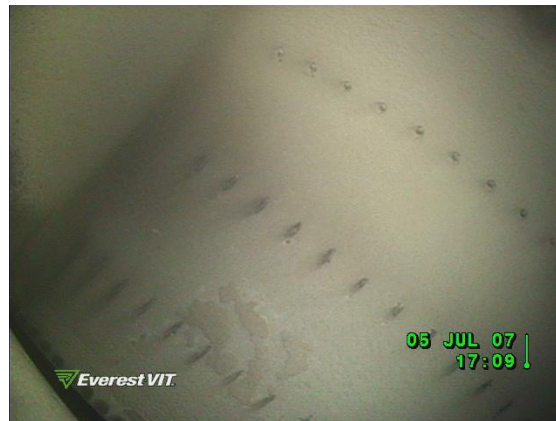
Flaking is the disintegration of paint or other external surface due to poor bonding or excessive load. An example of this deterioration is a when the coating flakes on high-pressure turbine vanes and blades. Due to high-temperature exposure, those airfoils are covered by bonding and ceramic coatings, which significantly increase the operational level of the blade by more than 100°. A bonding layer is an alloy of nickel, cobalt, chromium, aluminium and yttrium, while ceramic coating is a zirconia-stabilized yttrium oxide. The bonding layer produces oxide when exposed to high temperature and is porous enough to accommodate the outer zirconia layer, which decreases thermal shock on the airfoil. Given the design of high-pressure compressor vanes and blades, the flaking of protective layers affects engines' long-term condition.

Fig. 8. Coating missing from the high-pressure turbine blade's concave side due to flaking
