Environmental Impact of Embankment Breaching: A Case Study along Lower Reaches of Ajay River, West Bengal, India

Dr. Debasis Ghosh*, Mrinal Mandal,**And Monali Banerjee***

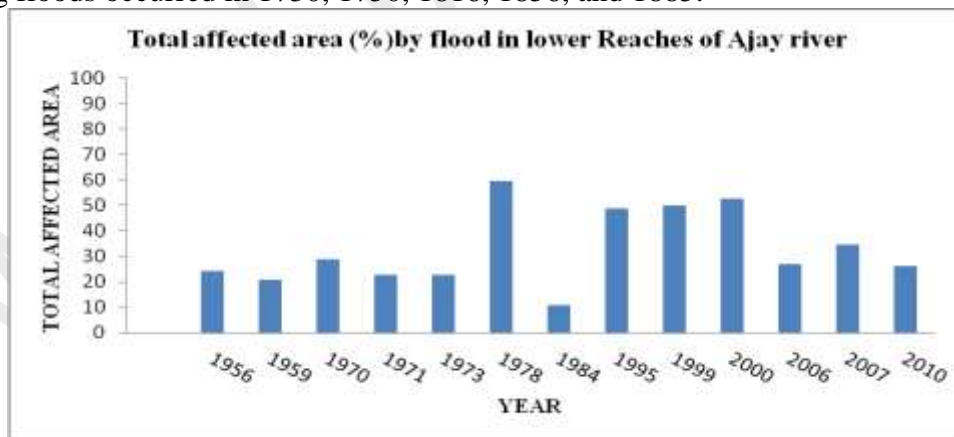
Fig: 3 Irrigation and Waterways Department, Government of West Bengal

In the flood year of 1978, the maximum area (59.64%) of the Ajay river basin was affected by the severity of the flood followed by the year 1995 (48.99%), 1999 (49.98%) and 2000 (52.82%).

Comparatively, least affected by the flood was 1984 (10.85%). Mainly, the lower reaches of the basin comprising the Bolpur, Nanur, Mongalkot, and Ketugram-I & II CD Blocks.

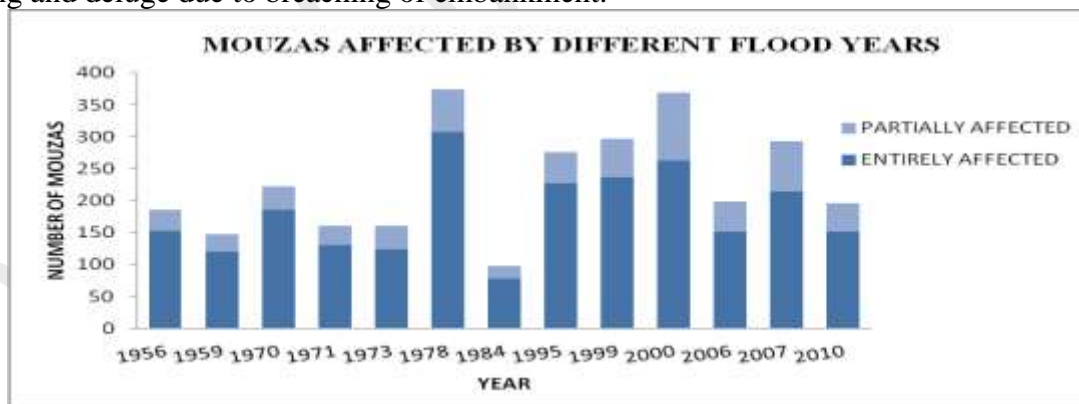
Fig: 4 Irrigation and Waterways Department, Government of West Bengal

From the Fig No.4 it is clearly showed that the number of flood affected mouzas (374) is maximum in 1978 and in this year out of 374 mouzas, 307 mouzas were entirely affected by the flood. In 1984, only 98 mouzas were affected and out of that 78 mouzas were severely affected. In 1995, 279 mouzas were affected and out of that 227 mouzas are entirely affected. In 1999, 297

mouzas were affected and out of that 237 mouzas are entirely affected, In 2000, 369 mouzas were affected and out of that 263 mouzas are entirely affected, In 2007, 293 mouzas were affected and out of that 214 mouzas are entirely affected,

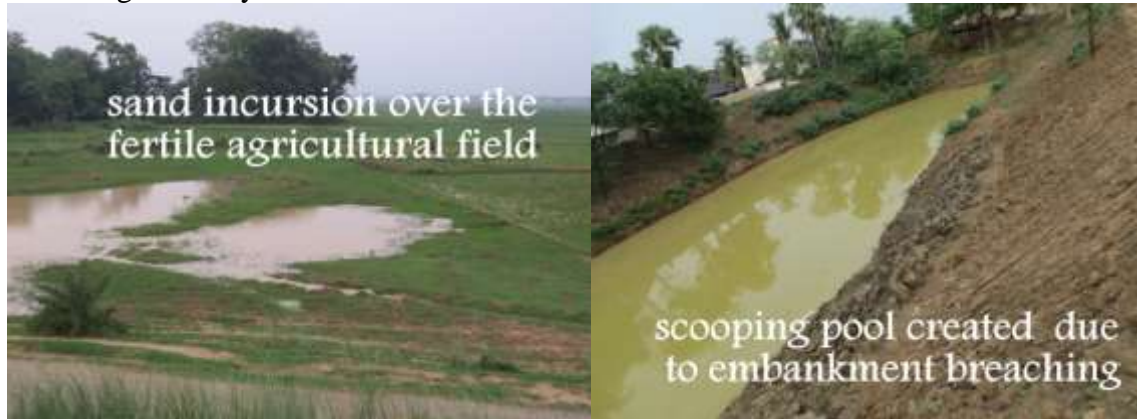
Fig: 7 Showing the Lateral shifting of Ajay river and present condition of channel (Source: Google Images)

the river, alignment of embankment, poor maintenance of the embankment and other anthropogenic activities. In Ajay River Basin, it has been found that the breaching tendency of embankment is more on the right bank from Illambazar to Bhedia. Bhedia to downstream the breaching tendency is more on the left bank of the river.

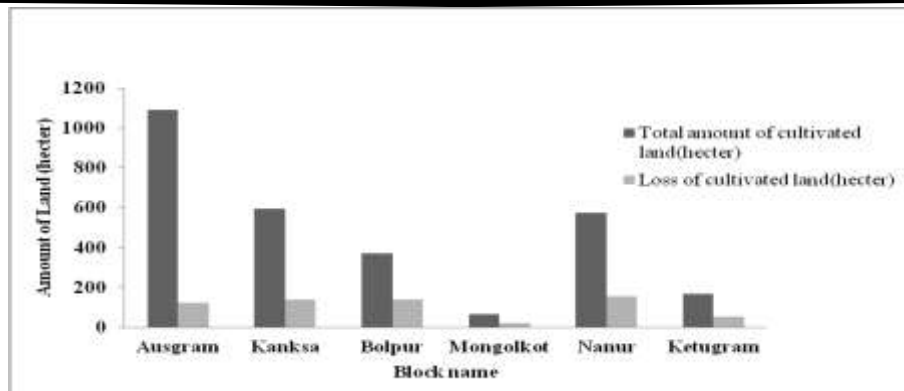
Fig: 8 Effect of sandsplay in cultivable land

(Source: Irrigation and Waterways Department, Government of West Bengal.)

Fertile cultivable land highly affected by Sandsplay in Nanur, Bolpur, Ketugram and Kanksa blocks followed by Ausgram and Mongolkot blocks. In post, breaching period cultivable land became unproductive for at least seven to ten years and land has been reclaimed through crop rotational method. Generally, the rate of damage is comparatively low in case of the Ausgram block by the embankment breaching in the year 1978 and 2000.
